MADRAS WATER-WORKS.

**R E P O R T**

**COMMITTEE APPOINTED IN G.O. No. 1576 M.,  
15TH SEPTEMBER 1917.**

**1918.**

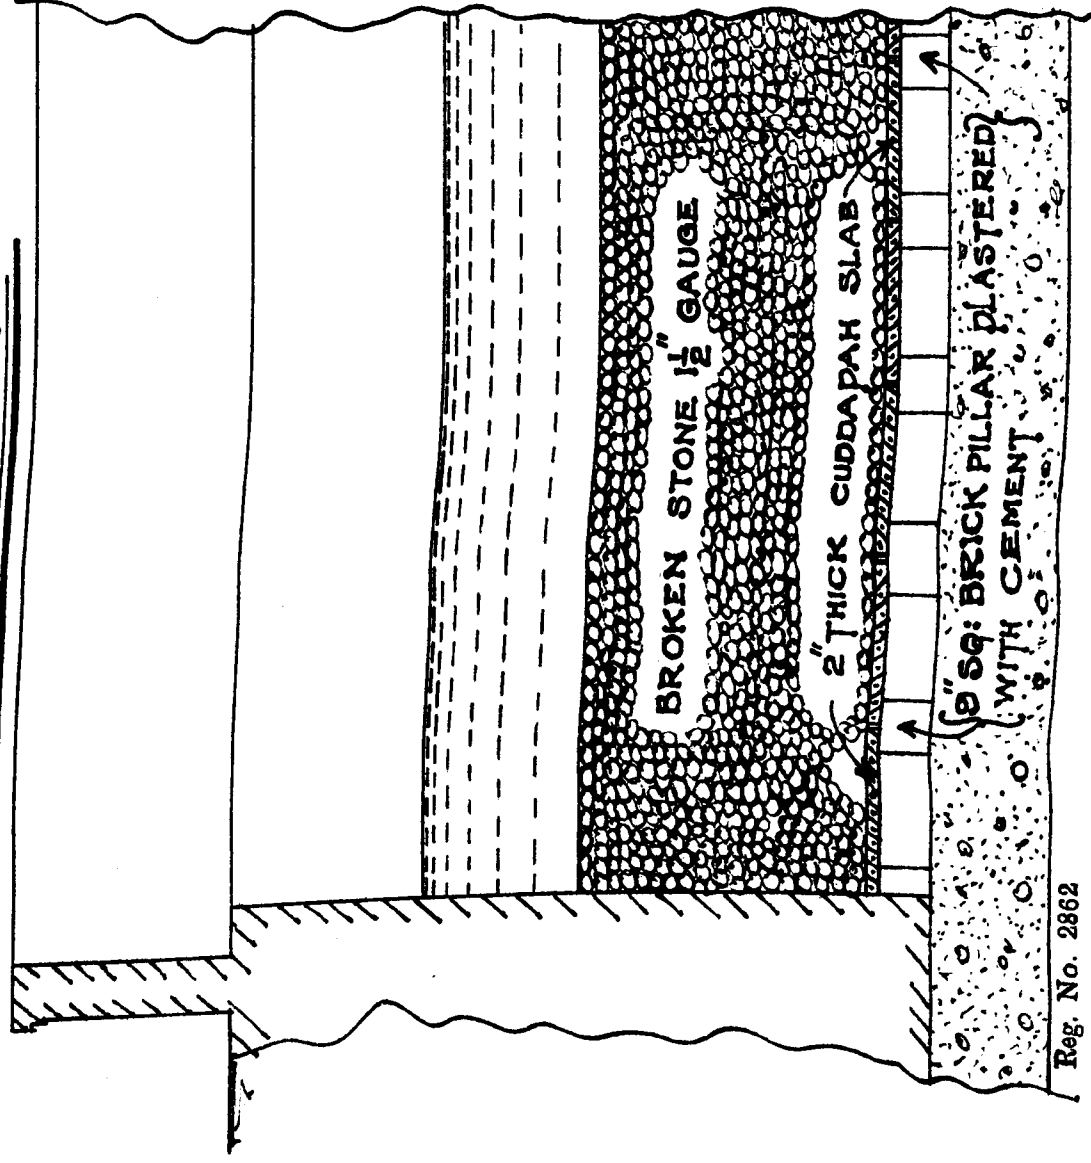
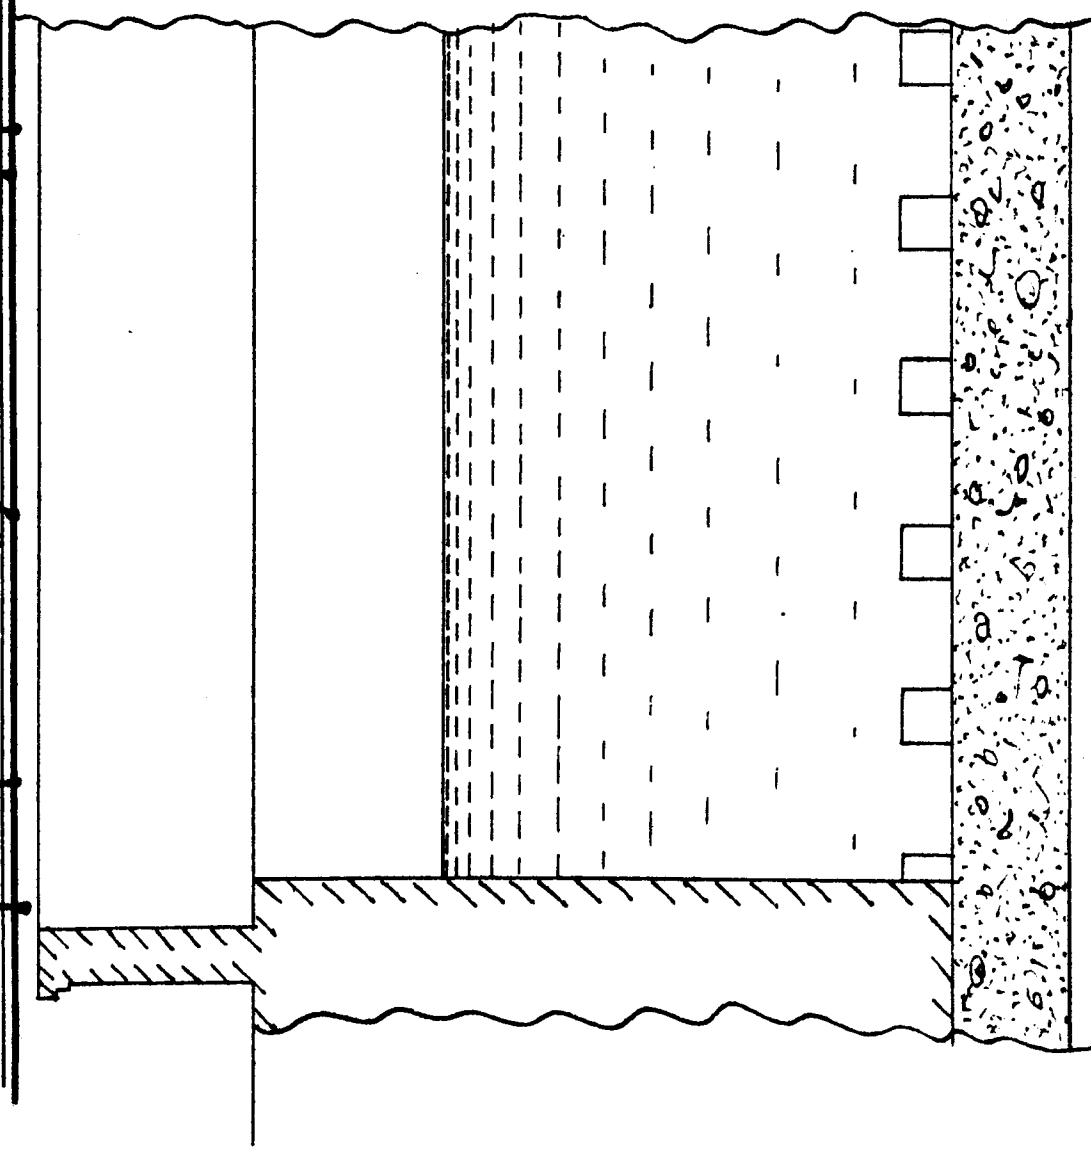
# MADRAS WATER SUPPLY SECTION OF ROUGHING FILTER

The Committee are impressed with the fact that even if the roughing filter is cleaned every six months there will still be considerable deposit on the stones of the filter and such deposit is seen to affect the quality of the drinking water and form foci for the breeding of larvæ, etc. (which will be referred to under the next paragraph). The Committee would mention that roughing filters are commonly used for the purification of sewage but when applied to water-supplies, such as the Red Hills they are more likely to adversely affect the quality of the water than otherwise because the broken stone is never aerated at the Red Hills and consequently the multiplication of the requisite number of bacteria for purification purposes is not facilitated. The Committee consider that the basins as constructed are suitable as sunning and sedimentation tanks and the materials from them which consists of broken stone can be usefully employed in improving the paths and roadways in the enclosure at the headworks. The Committee consider that the roughing filters should be emptied of material, and thoroughly cleaned of all deposit on the walls and floor. Each should be cement washed and the iron work repainted. In future the roughing filters should only be used as sunning and sedimentation basins.

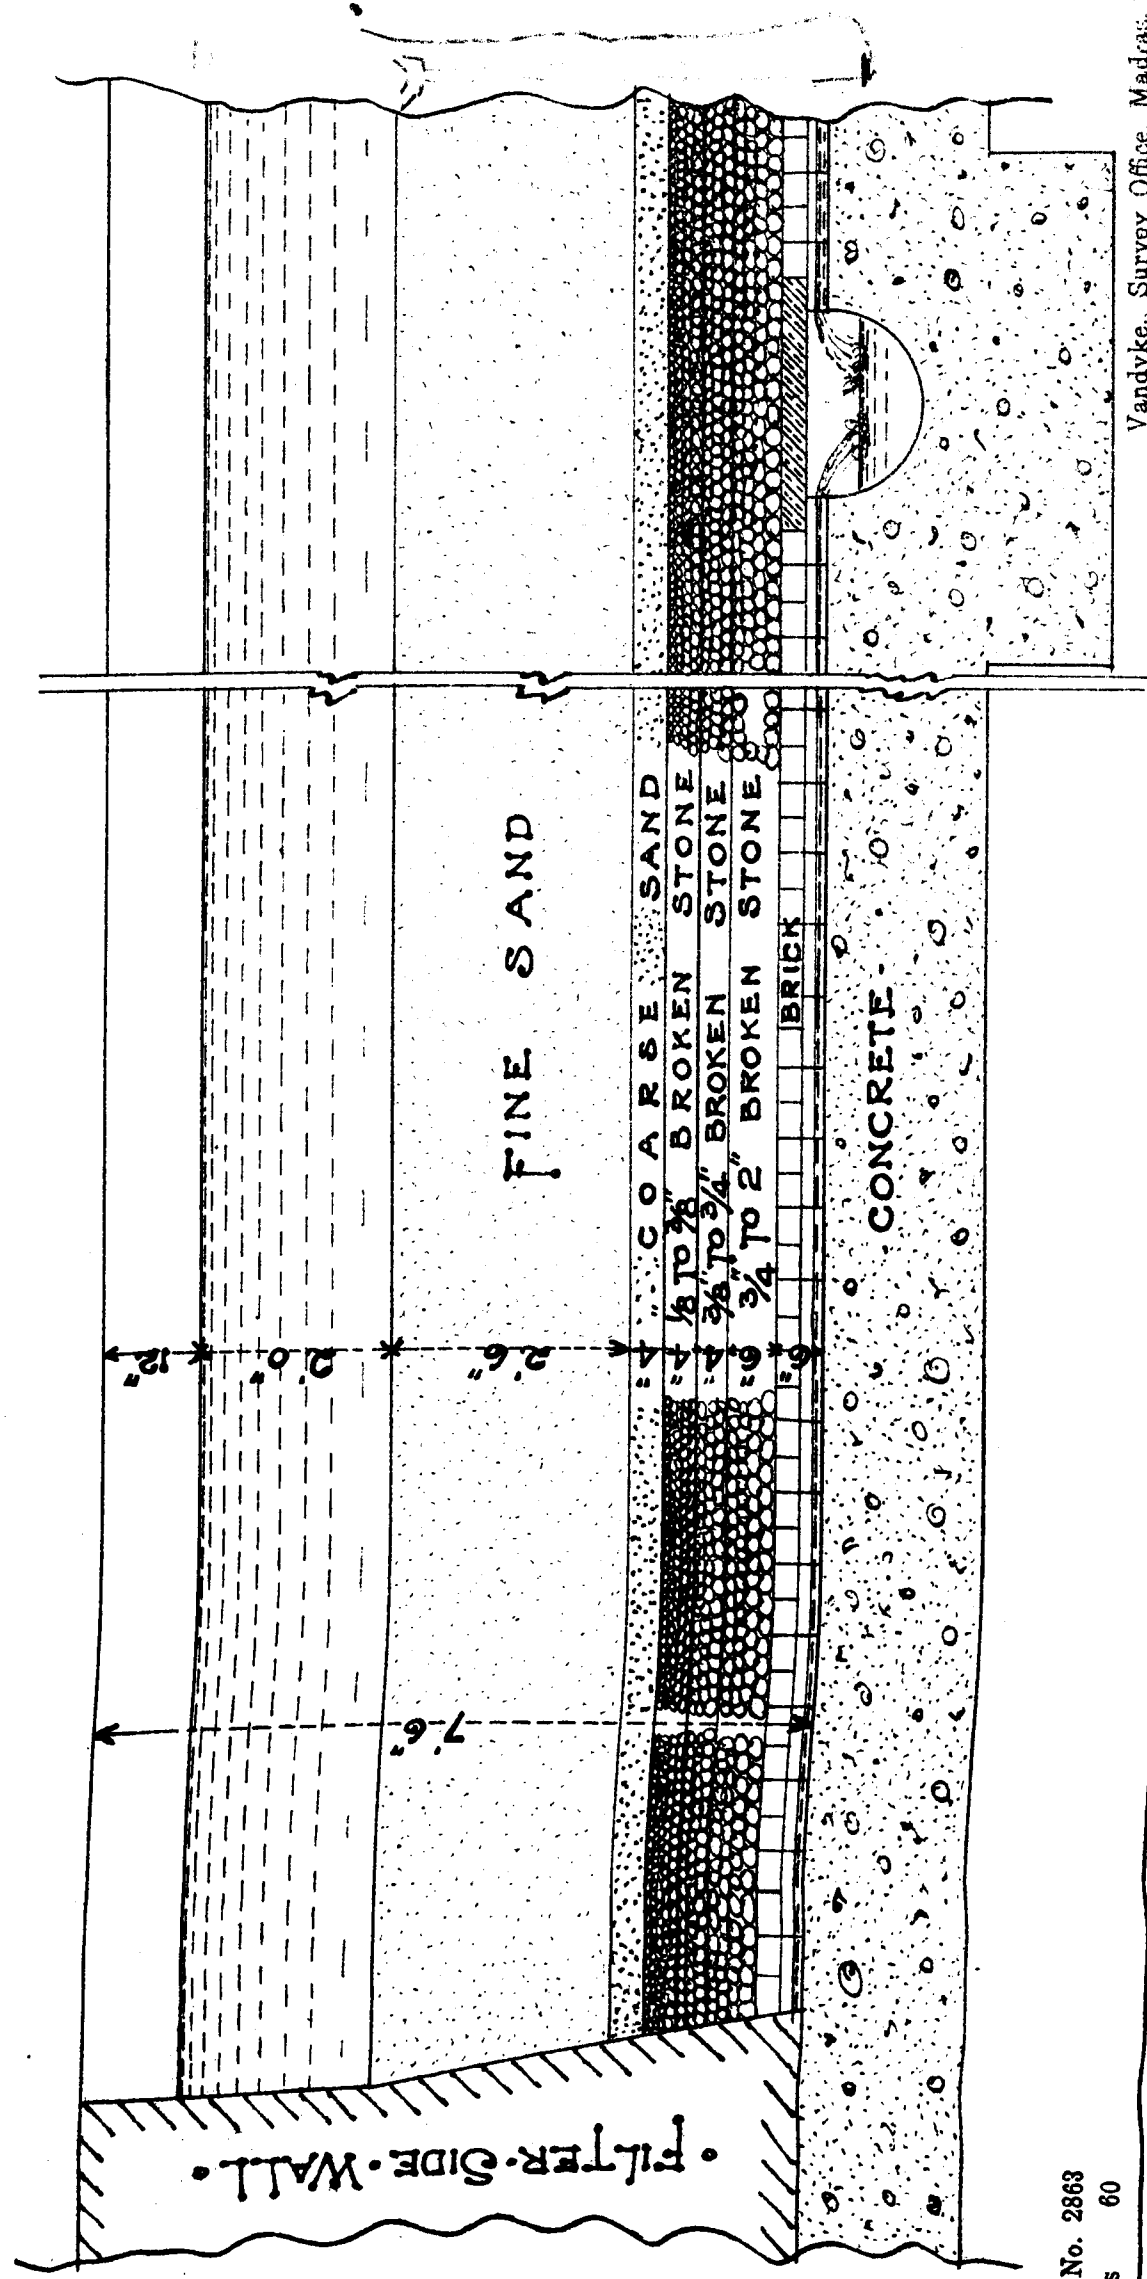
# • MADRAS • WATER • SUPPLY • SECTION • OF • FILTER • BED • AS • IN • ORIGINAL • SKETCH •

The thickness of the layer of broken stone in the Madras filter beds including a coarse sand layer of 4 inches was 18 inches in the original scheme. See plan No. 3. In the scheme as executed this provision has been cut down to 6 inches including a coarse sand layer of 2 inches. See plan No. 4. We are aware that the trend of opinion of the proper thickness of broken stone layer in a sand filter bed is in favour of reducing it to a minimum on the plea that this layer serves only the purpose of supporting the superimposed fine sand filtering layer. While admitting that this is an important function of the broken stone layer we are convinced that another important function of this layer is to facilitate the passage of filtered water from the sand layer to the underdrains and that consequently the thickness of this broken stone layer cannot be unduly reduced; especially is this so with the treatment of a water like the Madras water which contains a high organic matter content. We consider that the extension of the brick drains and broken stone layer to the walls of the filter is immediately essential removing at the same time the sand impregnated with black silt and substituting clean sand. In addition when all the sand of a filter bed is removed for periodical renewal it would be advisable to increase the thickness of the broken stone 6 inches. The increased thickness should be composed of stone 1½ inches to ¾ inch. See plan No. 5.

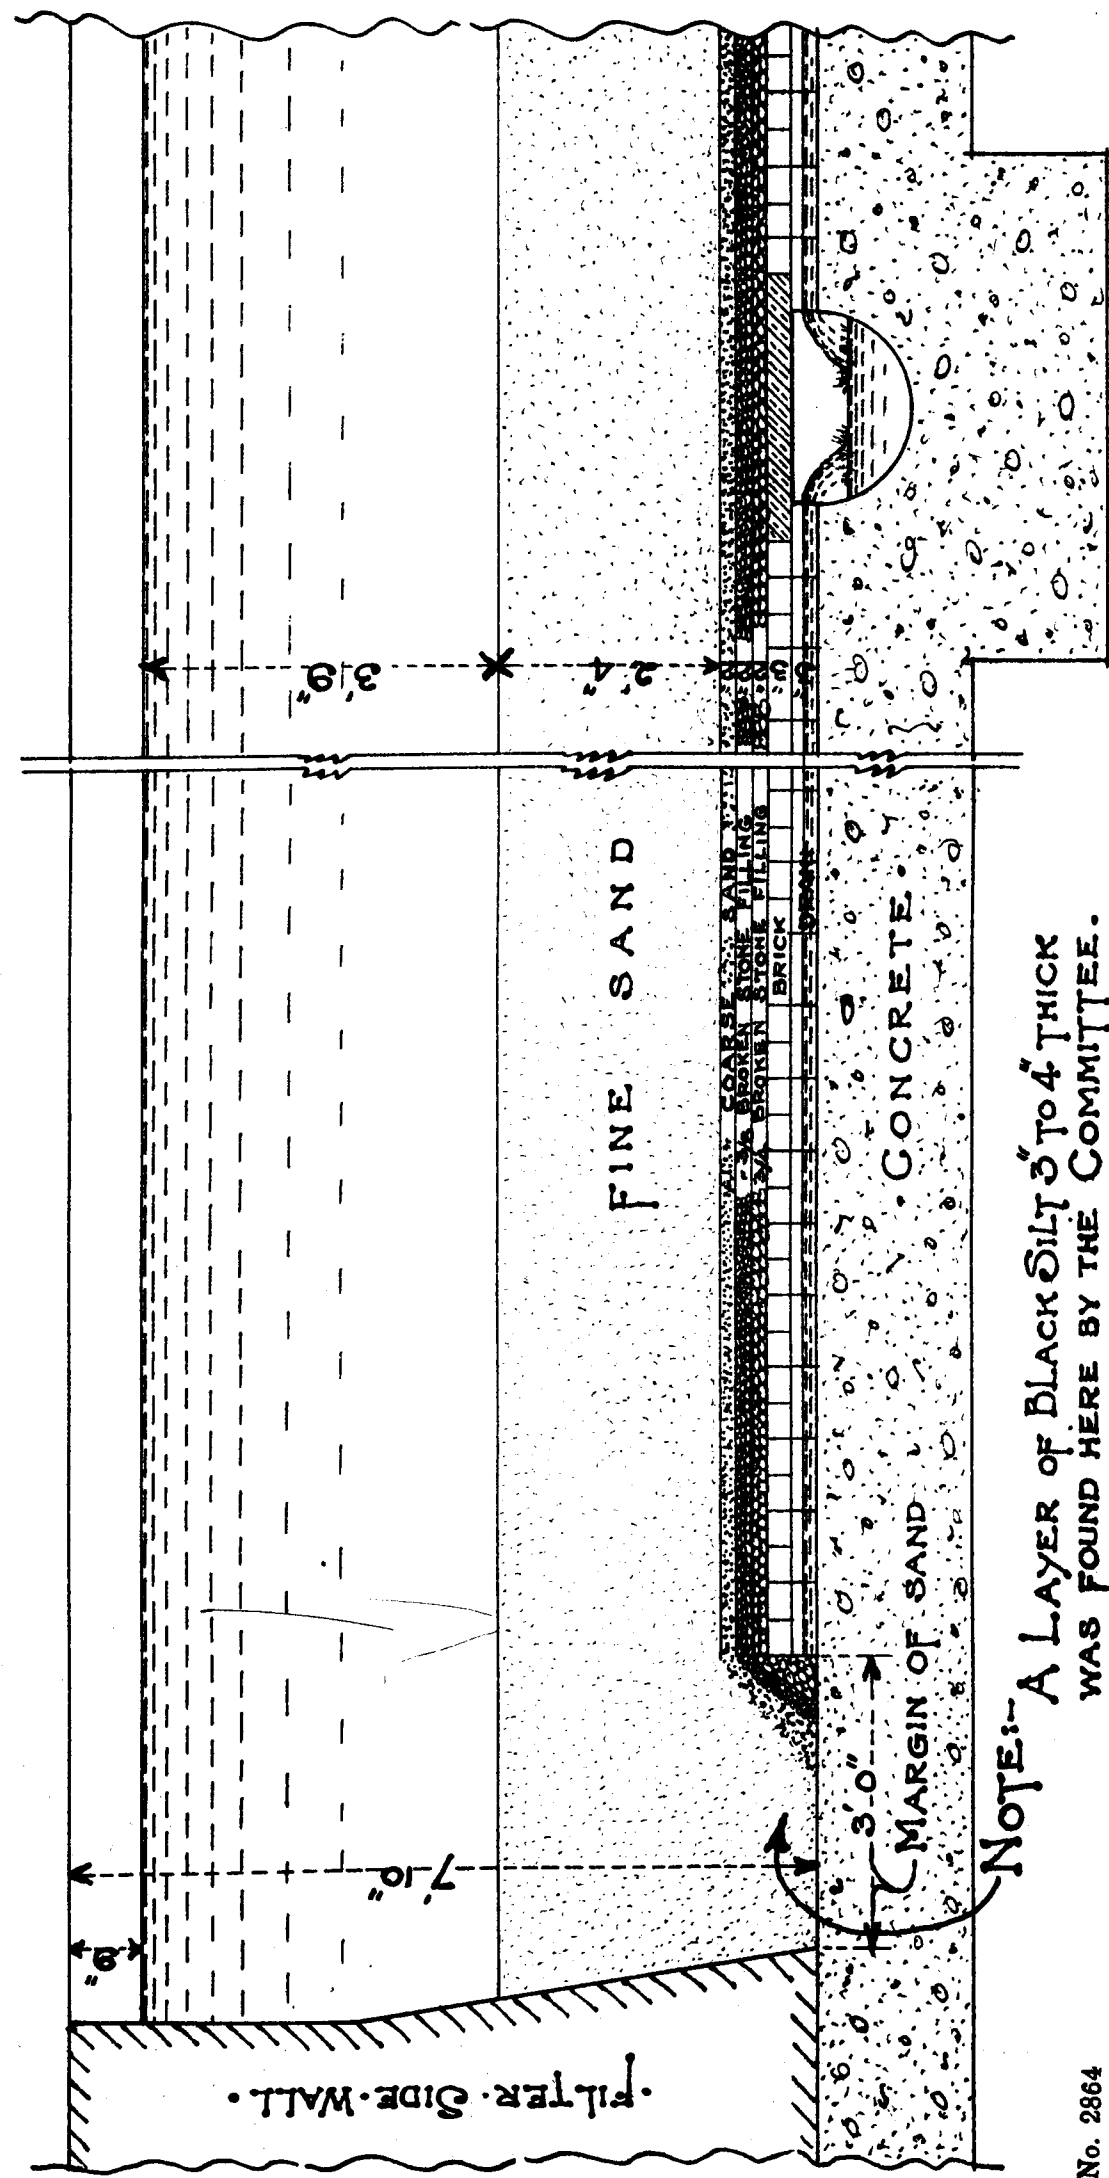
# • MADRAS • WATER • Supply • • SECTION • OF • FILTER • BED • IN • USE •

The broken stone and brick collecting drains and coarse sand layer in the Madras filters do not extend to the walls of the filter but a space three feet wide from the walls is filled with fine sand similar to two feet four inches sand layer. The Committee remark that this is not the customary way of filling in a filter bed. They were informed that it was done with the object 'to prevent short circuiting of the unfiltered water by creeping down the walls.' See plan No. 4.

We consider this stagnation of water is caused by the unusual construction of the Madras filter beds. Instead of extending the broken stones and brick underdrains to the walls of the filter bed these underdrains and the stones have been stopped three feet from the walls and water in order to escape has to pass through this additional thickness of fine sand before reaching the underdrains. The flow of the water here is therefore retarded or in other words there is stagnation as compared with the other parts of the filter bed. This peculiar construction of the Madras filter beds was, we understand, intended to prevent creep of unfiltered water down the walls of the filter beds. In a filter bed where a filtering skin is carefully formed and preserved there can be no creep down the side walls. Experiments were conducted at the experimental filters at the King Institute of Preventive Medicine to test the amount of creep if any which occurs in a filter bed. The experiments showed that this did not occur and we think the possibility of creep of unfiltered water in a filter bed is a problem which has never been proved to exist in a well-regulated filter bed and which the King Institute experiment has disproved.

The Committee are of opinion that if the broken stone and brick underdrains are extended to the walls of the filter an important step will have been taken to solve the problem of eliminating the smell of sulphuretted hydrogen from the filtered water.
