HISTORY  
OF THE  
HARDINGE BRIDGE  
UP TO 1941

by  
T. S. N. Rao, ENGINEER-IN-CHARGE, HARDINGE BRIDGE,  
B. A. RAILWAY.

Technical Paper No. 318.

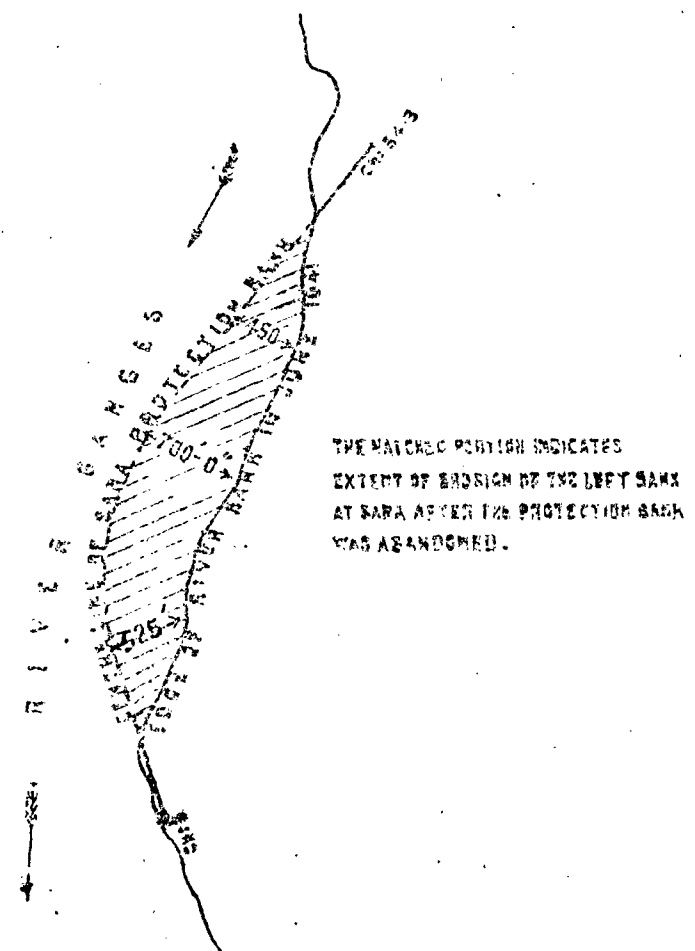
FIG. 18

**EXTENT OF EROSION**  
**AT SARA**  
**SCALE 4 INCH = 1 MILE.**

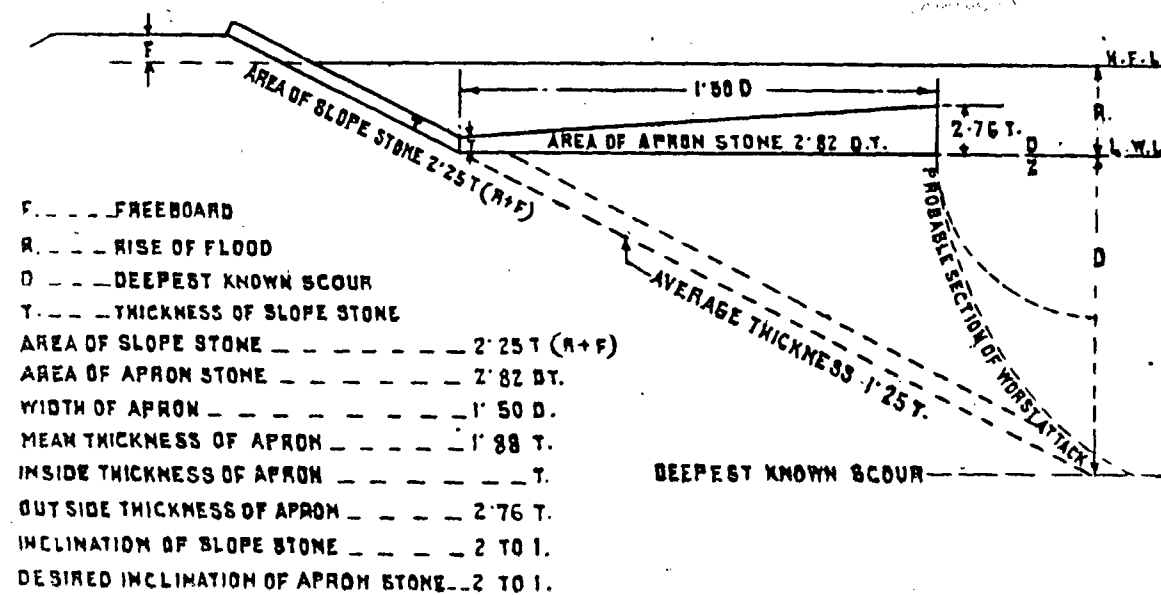
FIG 20

**Revision of Sir Francis Spring's design of Guide Bank Aprons.**—A copy of Spring's recommended dimensions of Guide Bank Aprons, is shown in Fig. 20.

This design is based on the assumption that the apron launches itself in such a manner that, commencing from the outer edge of the apron and working back to the actual toe of built-up guide bank, the "probable section of worst attack" is such that the point of deepest scour is on a line drawn at a slope of  $1/2$  to  $1$  from the outer limit of the apron (throughout its progress of launching) and that every section of launched apron assumes a  $2$  to  $1$  slope down to the point of deepest scour.

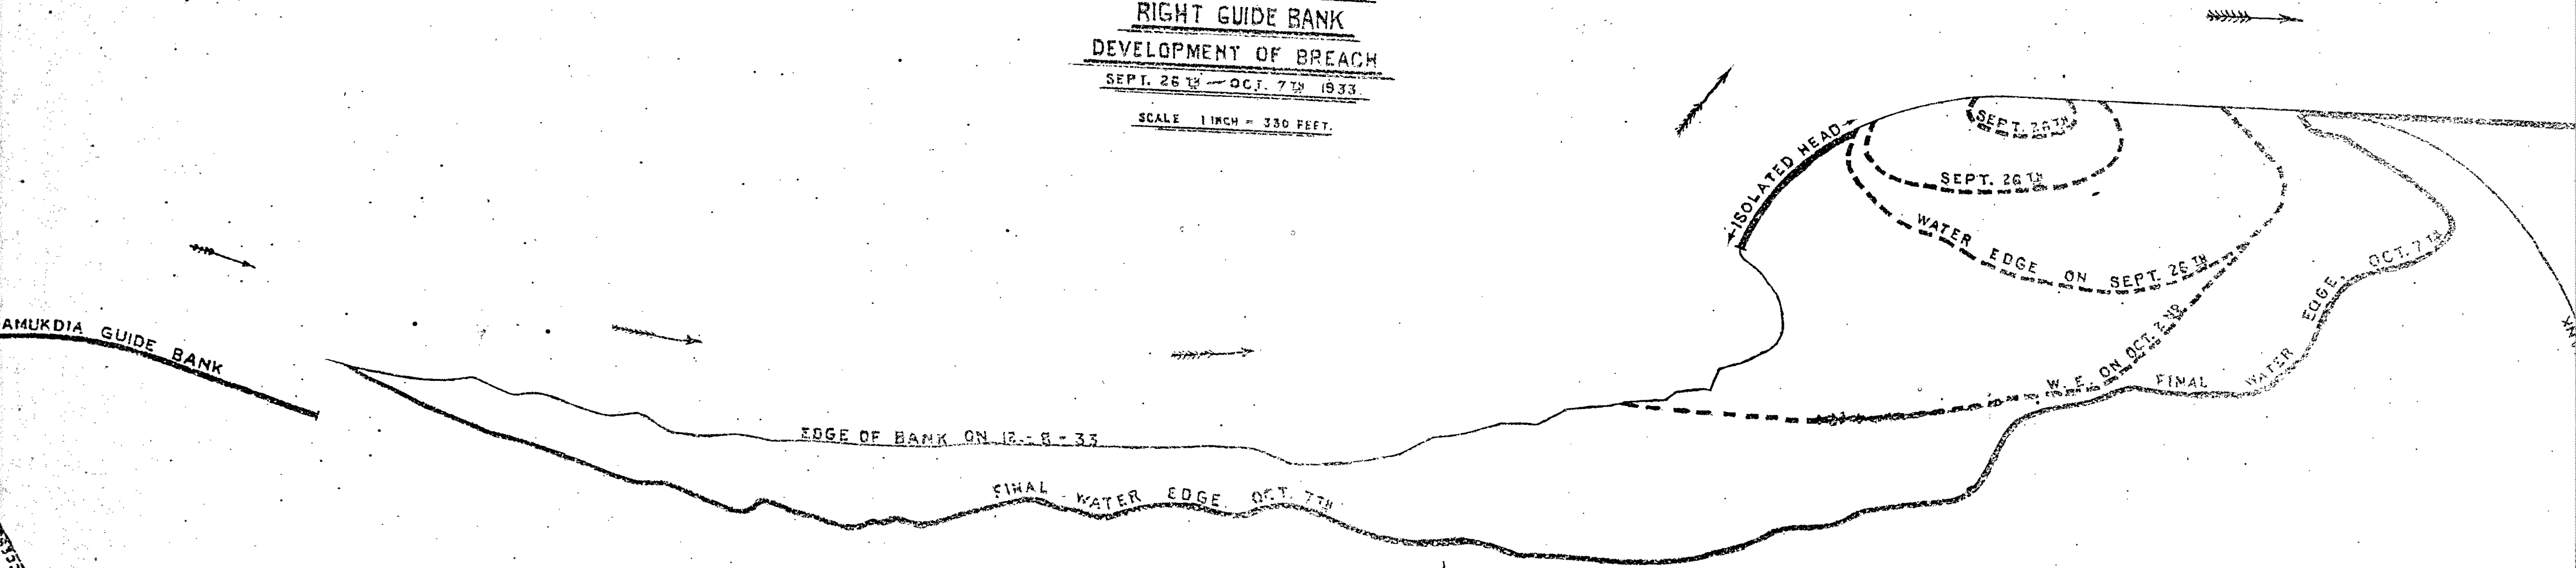
HARDINGE BRIDGE  
RIGHT GUIDE BANK  
DEVELOPMENT OF BREACH  
SEPT. 26<sup>TH</sup> - OCT. 7<sup>TH</sup> 1933.

The Hardinge Bridge Committee were of opinion that the breach of Right Guide Bank was due to under-cutting of the stone protection caused by "diving flow" of the water.

The original apron of the Right Guide Bank was designed for a scour 100 feet deep below low water level. During the floods of 1931, when the upstream portion of the guide bank was attacked and the river bed along the apron between chainages 10 and 30 scoured to a depth of 80 feet to 100 feet below low water level it was apprehended that the original protection was inadequate. Precautions were immediately taken and the Right Guide Bank was reinforced from chainages 15 to 30 by pitching in water about 400 cubic feet per foot run in continuation of the apron stone already launched. This additional pitching was supposed to protect the guide bank against scour down to 160 feet below low water level but actually, according to Spring's principles, it was sufficient to withstand a scour 140 feet below low water level. Also the thickness of this pitching was 4 feet and it appears to be inadequate for the purpose intended. The pitching was done at a level which was about 40 feet higher than the final position the stone was expected to take when launched and no allowance for dissipation was made. It has been found from experience at Raita that a "carpetting", of thickness less than 6 feet, accurately laid through grids, is liable to be washed away when the bank is attacked severely by the river. The inherent defects in the method of this sort of pitching necessitates a thickness of 6 feet "carpetting" at least, so as to ensure a minimum thickness of 4 feet on the entire area pitched; otherwise the risk of sand beneath the carpeted area being sucked out and of stone being washed away by the fast flowing current, should be incurred.

Another defect in the apron of the Right Guide Bank was at its inner belt. This portion of the apron being only 4'-6" thick was not thick enough to provide on the developed 2 to 1 slope a minimum thickness of stone required to prevent the mixture of Ganges sand and silt from being washed out. So long as the horizontal inner belt of the apron remained intact there might not be danger to the bank but when once it launched to a slope of 2 to 1 slips on the face of the slope might be expected.

It has been found by experience that when the river attacks a curved protection bank and subsequently leaves it, the maximum depth of flow along the bank generally occurs about 600 feet below the point where the stream leaves the bank. At the Right Guide Bank, the main-stream, after impinging on the curved head, left the bank at chainage 25, and so, it might be expected that the pot-hole which existed at chainage 19 in 1932 (vide fig. 10) had deepened, before the breach, to a level which was lower than that recorded opposite chainage 22 in November, 1933, viz., R. L. 107. How deep the bed scoured, whether the scour reached a level below R. L. 80, the level to which the guide bank was actually reinforced in 1932, will never be known; and to what extent the additional pitching of 4 feet thick did, or did not help to protect the guide bank is impossible to say. Lack of these informations, therefore, makes it difficult to assign the cause of breach to toe-scour. Had the scour hole been really too deep and the pitching been inadequate, the breach would probably have occurred during the fall of flood when the scour hole was formed. However, it seems certain that the scour hole made the stone protection at chainage 19 to slip further, causing a portion of, if not all, the inner belt of the apron, which was 4'-6" thick, to take a slope of 2 to 1 with a covering of stone not greater than 3 feet thick.

All this appears to have happened during the first fall of flood, i.e., from 9th to 24th September, 1933. Had the river continued to fall further, probably the guide bank would have remained safe. The river, however, rose suddenly, and at the beginning of the rise when the stream was leaving the guide bank at chainage 25, the resulting eddy between the edge of the main-stream and the bank appears to have washed out sand through the interstices of a 3 feet covering mentioned above and caused the breach.
