# MADRAS RECORD OFFICE.

No. 3. Read the following letter from Colonel C. E. FABER, Chief Engineer; to J. D. BOURDILLON, Esq., Secretary to Government, dated 23rd March 1859, No. 8923.

Letter from Captain JOHN MULLINS, District Engineer, Nellore; to Colonel C. E. FABER, Chief Engineer, dated Ongole, 7th March 1859, No. 454.

### Summary of Works performed at the Pennair Annicut in 1858, No. 28.

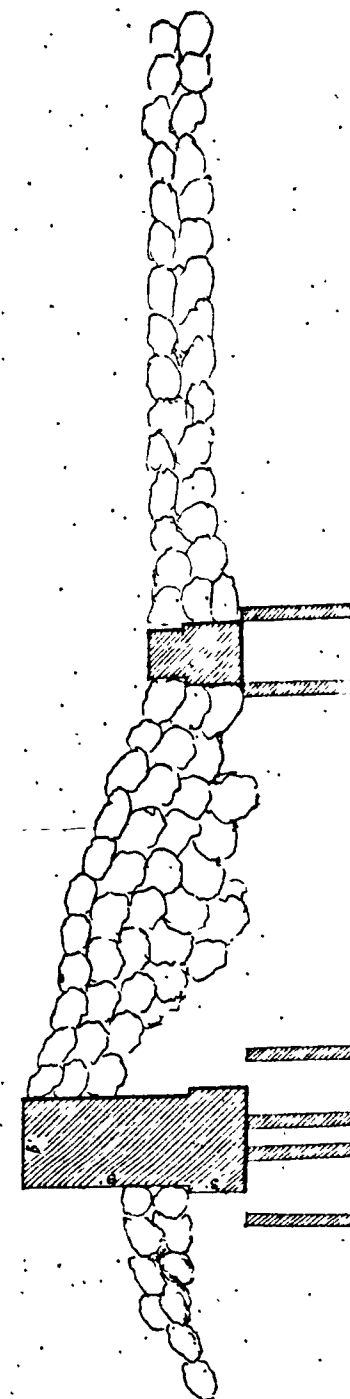
*Section A.*

*showing the arrangement originally proposed  
but not sanctioned.*

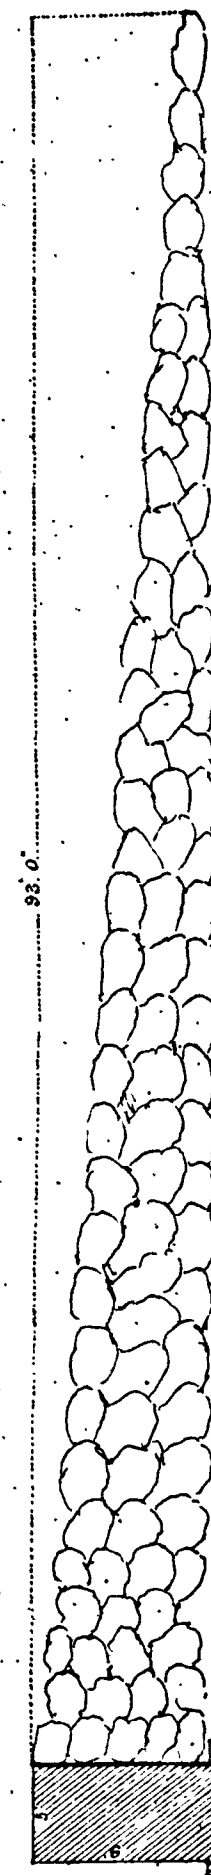
*Section B.*

2. As Government is in possession of the views of Colonel A. T. Cotton, it is needless for me to say more than that I believe the failure of the Annicut may be attributed, first to far too slight a Section having been adopted; and secondly, to insufficiently massive materials having been used in its construction.

*Showing the section sanctioned by the Revenue Board in the D.P.W.  
and on which the work was first constructed in 1854 and 1855.*

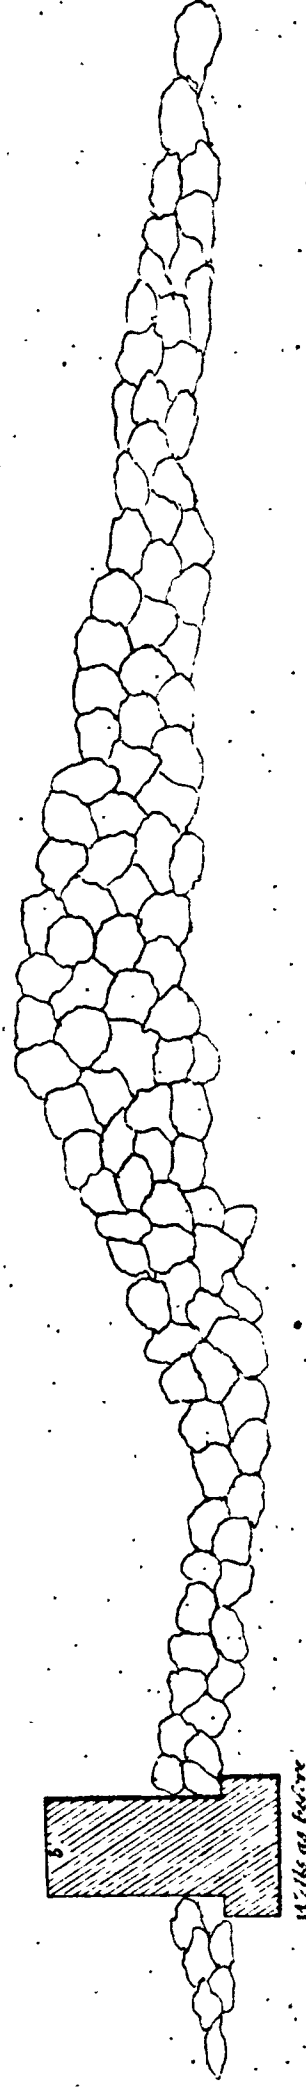
*Section D.*

4. The masonry work was very well executed in laterite stone, and the under Sluices were most excellent specimens of work in this material, and stood many freshes without injury, but the freshes at the end of 1855, which however never rose to a greater height than 9 feet above the crown of the work, showed that the rough stone Apron was not capable of resisting the action of the water. The effect of these freshes is shown in the Section marked D, and it seems highly probable that had stone of proper size been brought from the quarries by a Railway, instead of the small¶ sizes which alone could be conveyed by bandies, very small modifications of the Section would have sufficed to render the Annicut permanently stable.

*Showing the effect of the freshes of 1855 on Section B.*

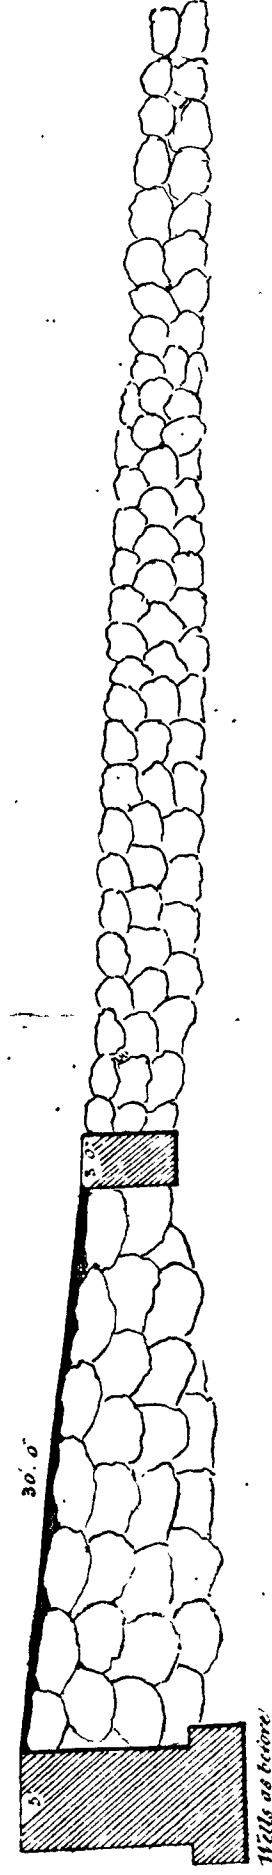
*Section E.*

*Showing the first modification of Section B executed in 1856.*

5. These freshes of 1855 showed that some improvement was necessary to prevent the disturbance of the Apron for the future, and in December 1855, the Civil Engineer was directed\* to construct a rough stone retaining wall in the Apron at a distance of 30 feet from the front wall, and to cover the surface of the rough stone between the two walls with a layer of jelly 3 inches thick. This arrangement was completed in 1856, at a cost of Rupees 2,812-7-0, and is shewn in the Section marked E.

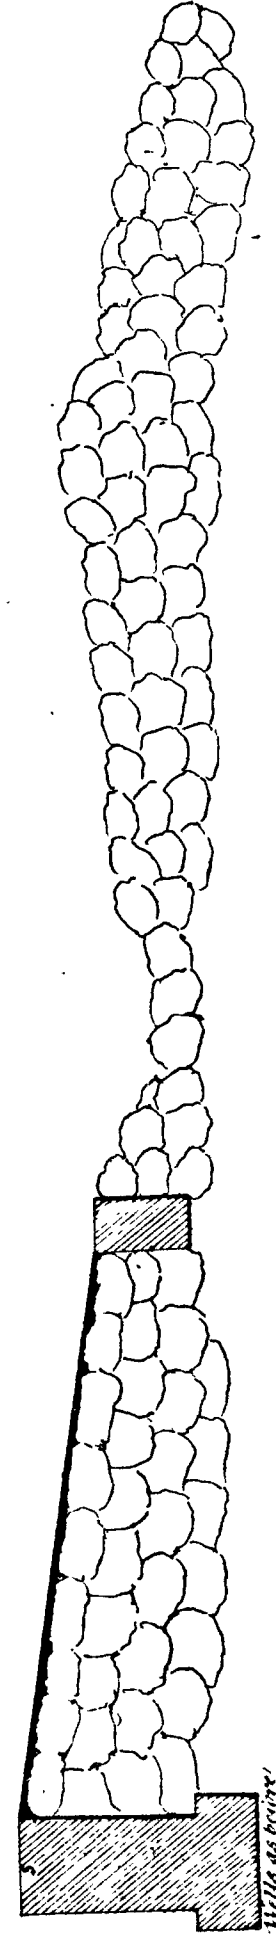
*Section F.*

6. On the recurrence of freshes in July 1856, it was found that the upper part of the work had been secured by the additions just described, but that the water worked out the rough stone immediately below the retaining wall, producing an exactly similar effect to that originally experienced, but at a different part of the work. This result is shewn in the Section marked F.

*Showing the effect of the early freshes of 1856 on Section E.*

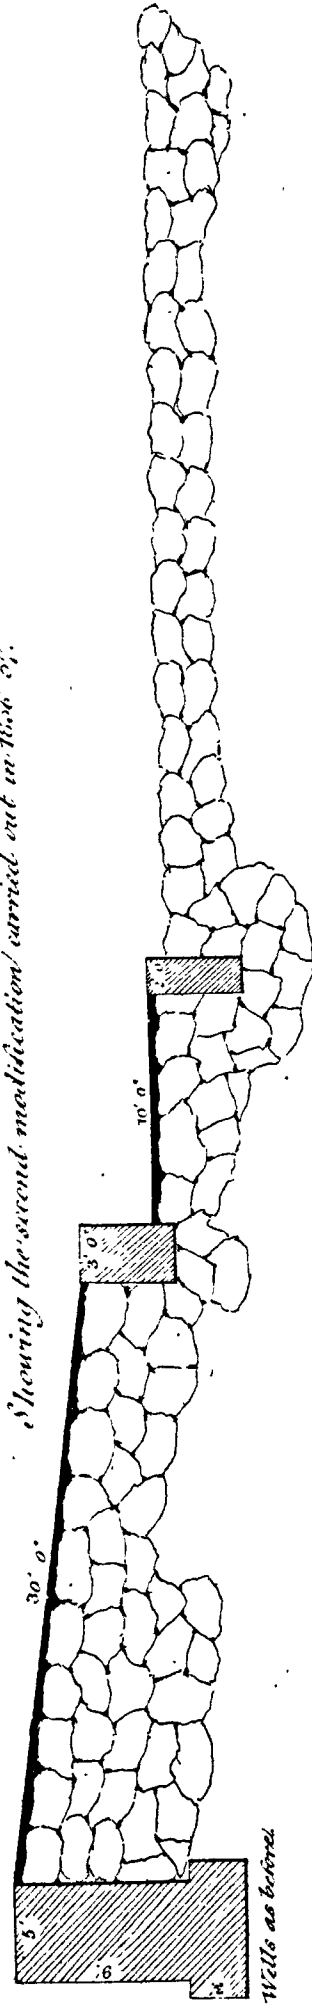
# Section G.

Showing the second modification carried out in 1856 & 57.

7. To obviate this source of injury, after some discussion,† the arrangement shewn in the Section marked G was, in the last communication marginally noted, ordered to be carried out. As will be seen from the Extract|| from the river register shewn in the margin, the river was frequently in flood between the 1st August and the end of the year, but the damage was comparatively speaking slight, and the cost of the repairs was but little. The arrangements shewn in Section G were completed early in 1857, and no accident happened afterwards to the Annicut until November 1857, when the river rose to 11 feet above the crown or 20 feet above the floor of the under Sluices on the 21st of that month and a breach of 102\* yards occurred a little to the north of the centre Sluices. Besides this damage the lowest retaining wall, all the rough stone† beyond it, and most of the small Apron above it were carried away, but the upper retaining wall and the Annicut above it were, except at the breach, left quite uninjured.

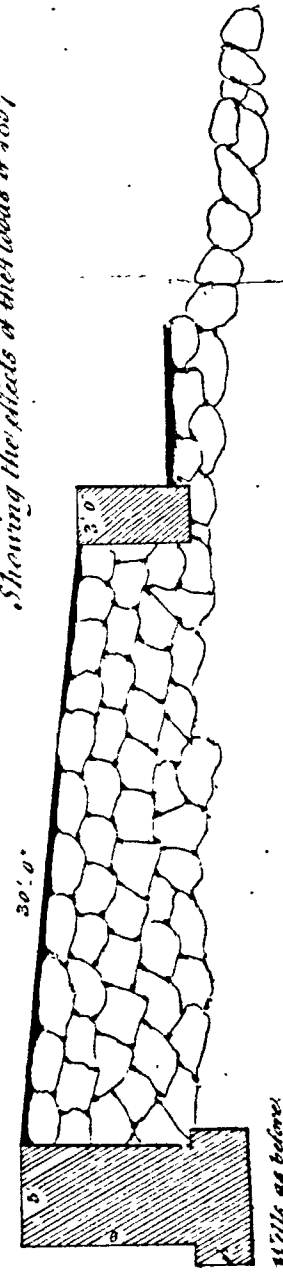
# Section H.

8. This fresh was one of unusual height and there is but little doubt that had it lasted for a few days longer at a depth on the crown of 5 to 7 feet, the damage would have been much more extensive. It was evident that the rough stone was quite unable to withstand the force of the water, and this, the protecting material for the masonry walls having been removed, the destruction of the latter bit by bit was merely a work of time. Here again had massive blocks of stone formed the lowest Apron, very little if any damage would have resulted, but there being no means of transporting such stone to the work, it was obliged to rely on the material that was available.

Showing the effects of the floods of 1857

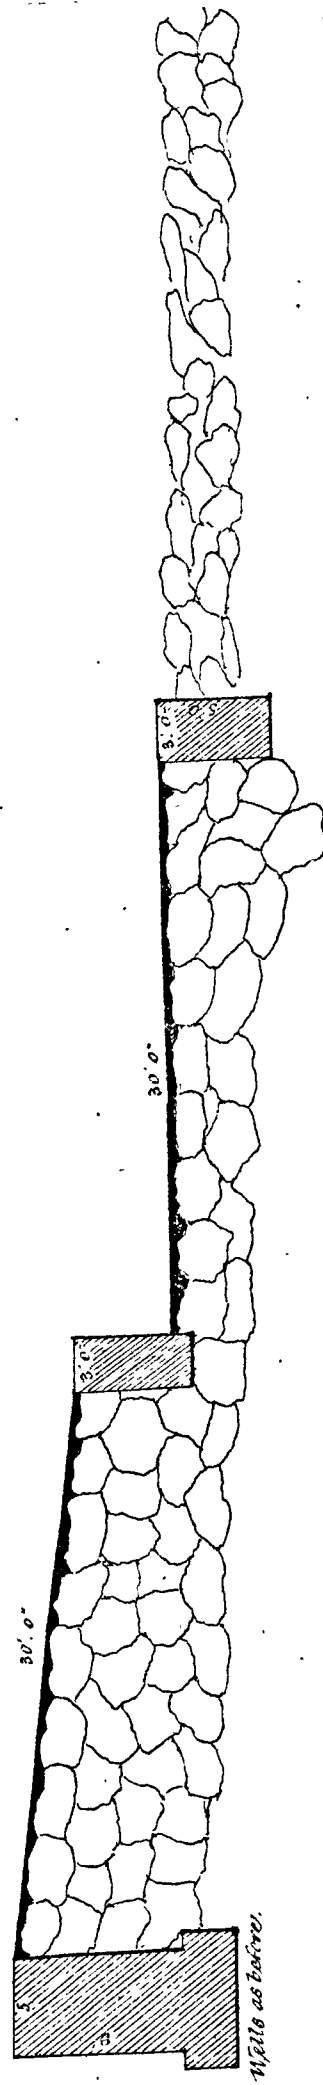
# Section K.

Showing the modification proposed by the District Engineer in Nov. & Dec. 1857.

9. The frequent failure of the work and the great and continual expense of keeping it efficient having rendered it necessary that considerable alterations should be made, and an arrangement shown in the Section marked K, which was submitted in November 1857, not having been altogether approved of, while opinions among those qualified from experience to judge, differed as to the best form to adopt in the then existing state of the work, the Superintending Engineer of the Southern Circle was authorized to pay a visit to the Annicut and to decide on the best Section to be given in restoring it to an efficient and permanently stable condition, and after making the necessary investigation, that Officer adopted the arrangement shewn in the Section marked L, which, together with a Railway from the Quarries, was approved of and sanctioned in Extract Minutes Consultation No. 305, dated 22nd February 1858.

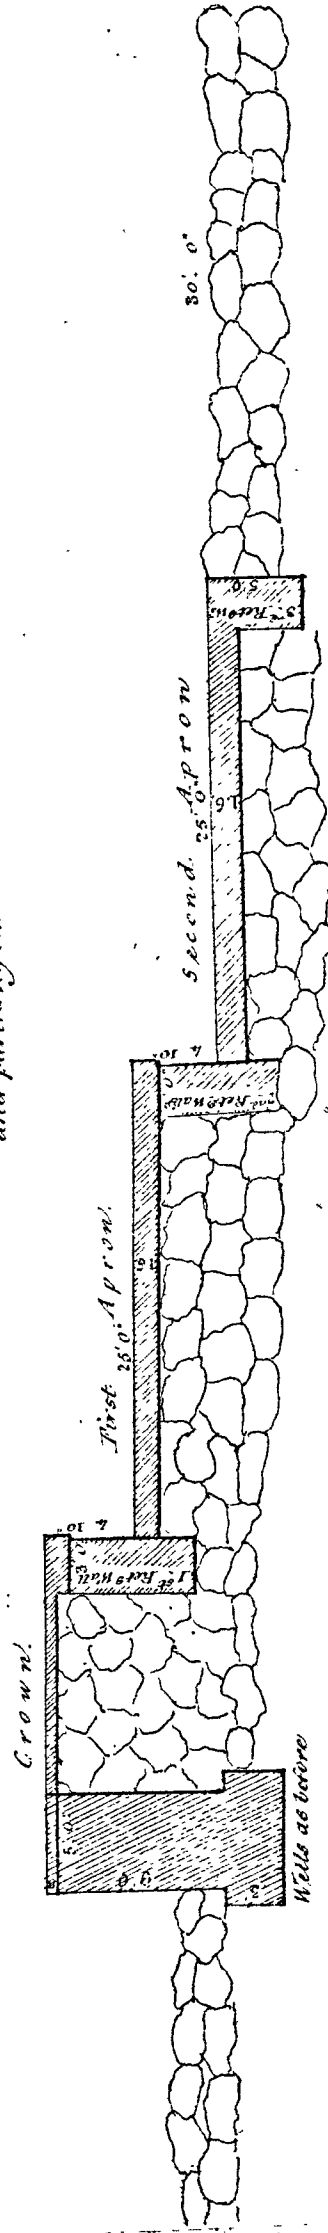
# Section L.

19. The Section adopted\* would, I believe it completed and allowed time to dry, have stood even with such a flood as that experienced this last mon-

Showing the revised Section, designed by Lt. Col. Langford and partially carried out in 1858.

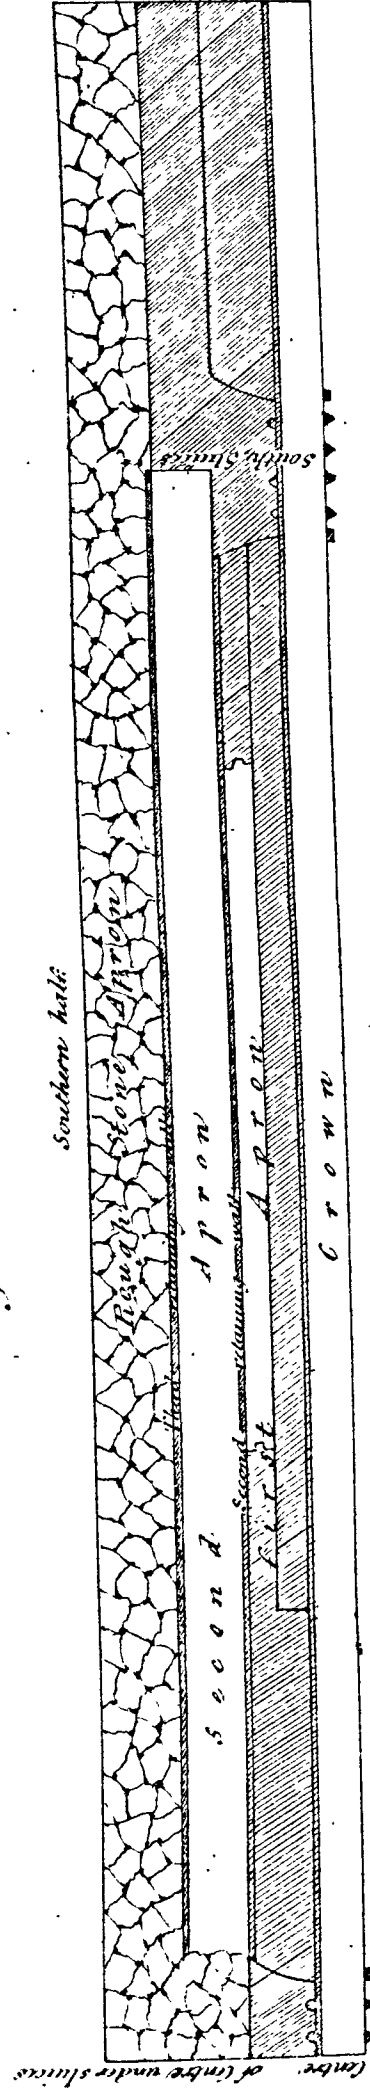
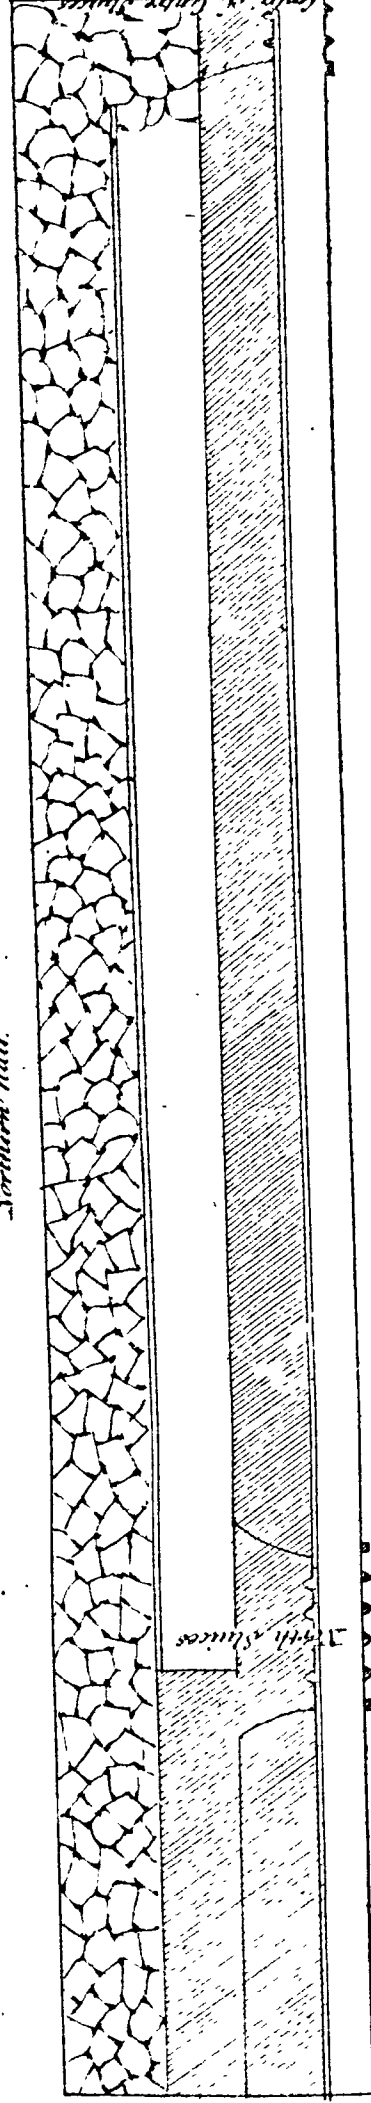
# Plan M.

Showing the state of the works immediately before the freshes of Sept. 1853.

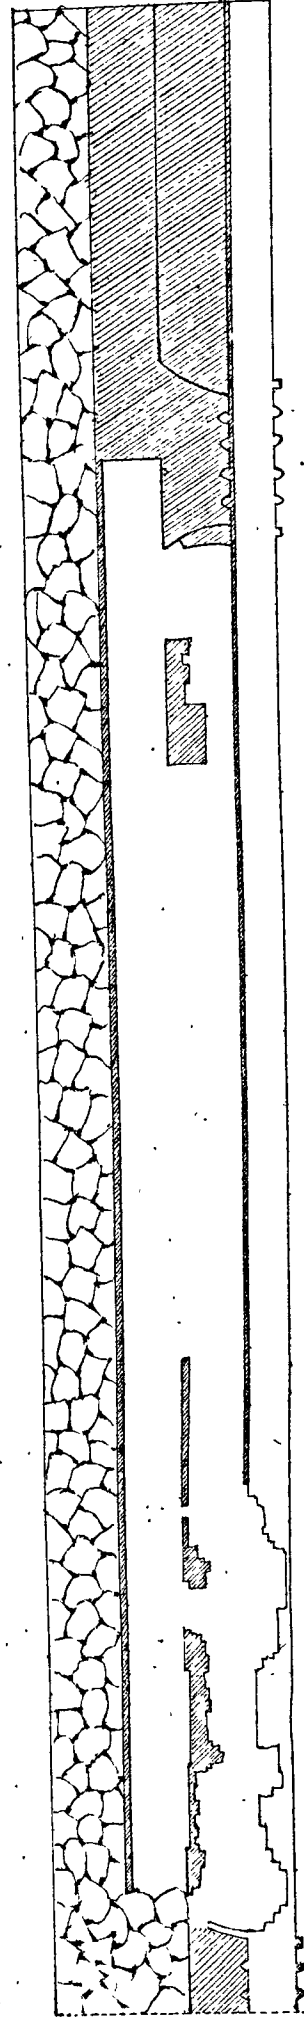
# Plan N.

but on the 7th of September the river commenced rising\* and on the 8th, 5 feet of water were flowing over the crown of the work. The results of the fresh, which was occasioned by the heavy rains falling on the western portions of the extensive basin† south west monsoon, were particularly unfortunate, as not only was the work stopped at this critical period for a fortnight, but in addition to the extensive damage\* done to newly completed parts of the Aprons and retaining walls, the level of the river was afterwards never low enough to admit of the 2nd or lowest cut stone Apron being gone on with, and it became necessary to endeavour to secure the 1st Apron and its retaining wall with rough stone. To accomplish this the people of the villages under the Annicut Channels were called upon to subscribe labour and for a few days about 800 coolies were, in addition to the usual supply kept at work and no portion of the 2nd wall was left unsupported. The repairs of the retaining walls and of the 2nd Apron was pushed on with the greatest possible rapidity, and at the commencement of October not more than a week was required to complete all that could be done that year, with the exception of continuing to strengthen up to the last moment the lowest portion of the work with rough stone.

Showing the state of the works immediately after the freshes of September.

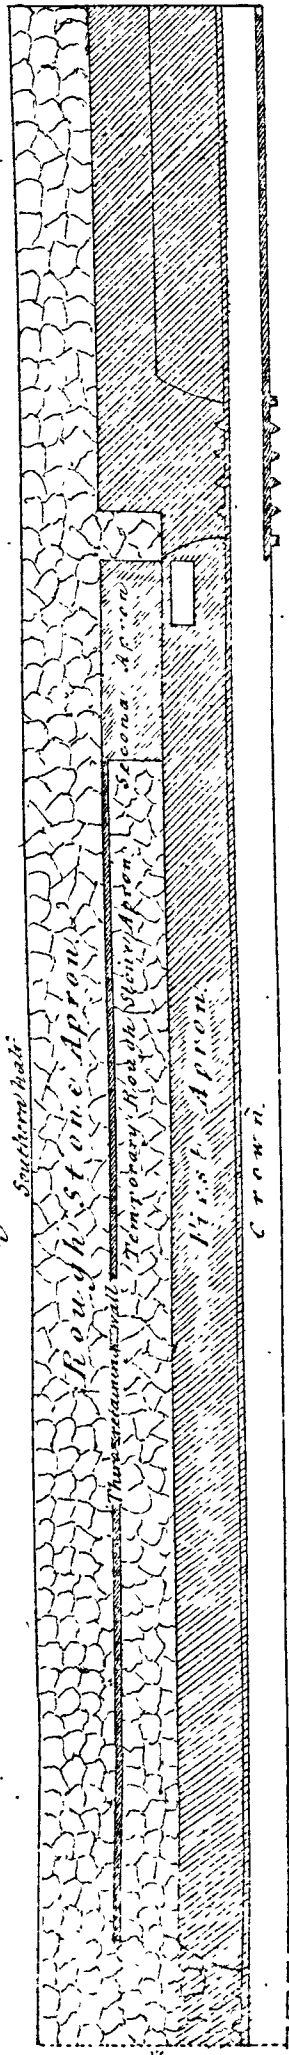
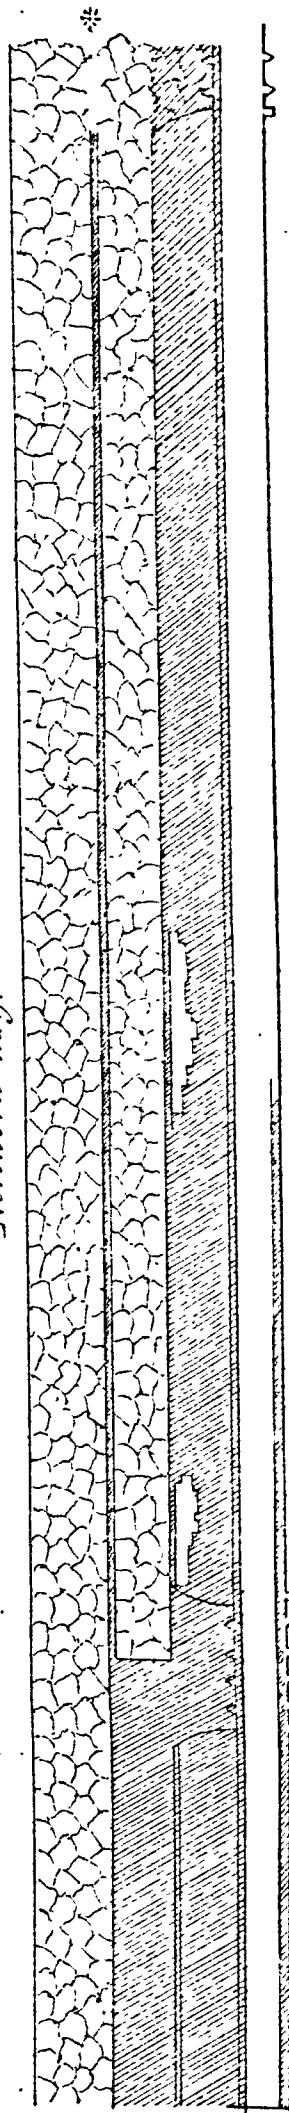
# Plan O.

16. Such was the condition\* of the Annicut, when on the night of the 8th and 9th Oc-

Showing the state of the works immediately before the start of October 1858.

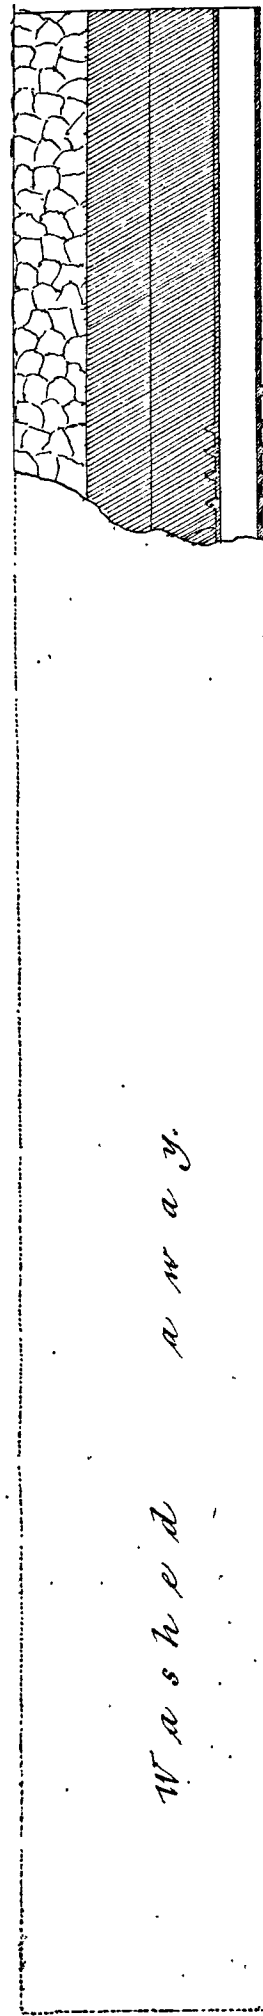
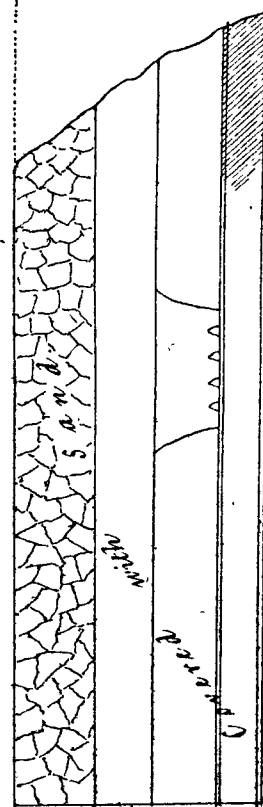
# Plan P.

have been already detailed in the letters as per margin.\* I regret that not having a copy of the sketch of the appearance of the overfall which was submitted with the first named letter, I have been unable to add it to the other Plans and Sections, but should you consider advisable, perhaps you will allow a copy to be added in the Central Office. The effect of the flood may be summed up in a few words. Two-thirds of the Annicut were swept away by it, and to this nothing

18. As regards the cause of the damage amounting to the almost entire ruin of the work, there can be no doubt that its unfinished state was the reason why it fell so easy a prey under the force of the water; still looking at its condition a day or two before the flood, i. e., at the beginning of October, I think it may fairly be supposed, that an ordinary monsoon fresh would not have caused any damage of moment; for the 1st Apron was all but complete, a small portion of the 2nd Apron was finished, the whole of the 3rd retaining wall had been put down many weeks before, and the site of the unfinished 2nd Apron was covered into more than a yard in depth with rough stone, in order to support the 2nd retaining wall. The character of the flood was however, if the usually received theory of the amount of obstruction offered by Dams across Rivers be correct, a very exceptional one. From the observations contained in para. 7 of my letter No. 2745 of the 11th December, it will be seen that the level of the flood waters was raised not far short of 5 feet by the obstruction caused by the Annicut, while the theoretical increase of elevation does not exceed 2 feet. On the other hand, as will be seen by the diagrams referred to at the commencement of para. 17 of this letter, the difference of level between the

Showing the results of the flood of October 1858.

Washed away.

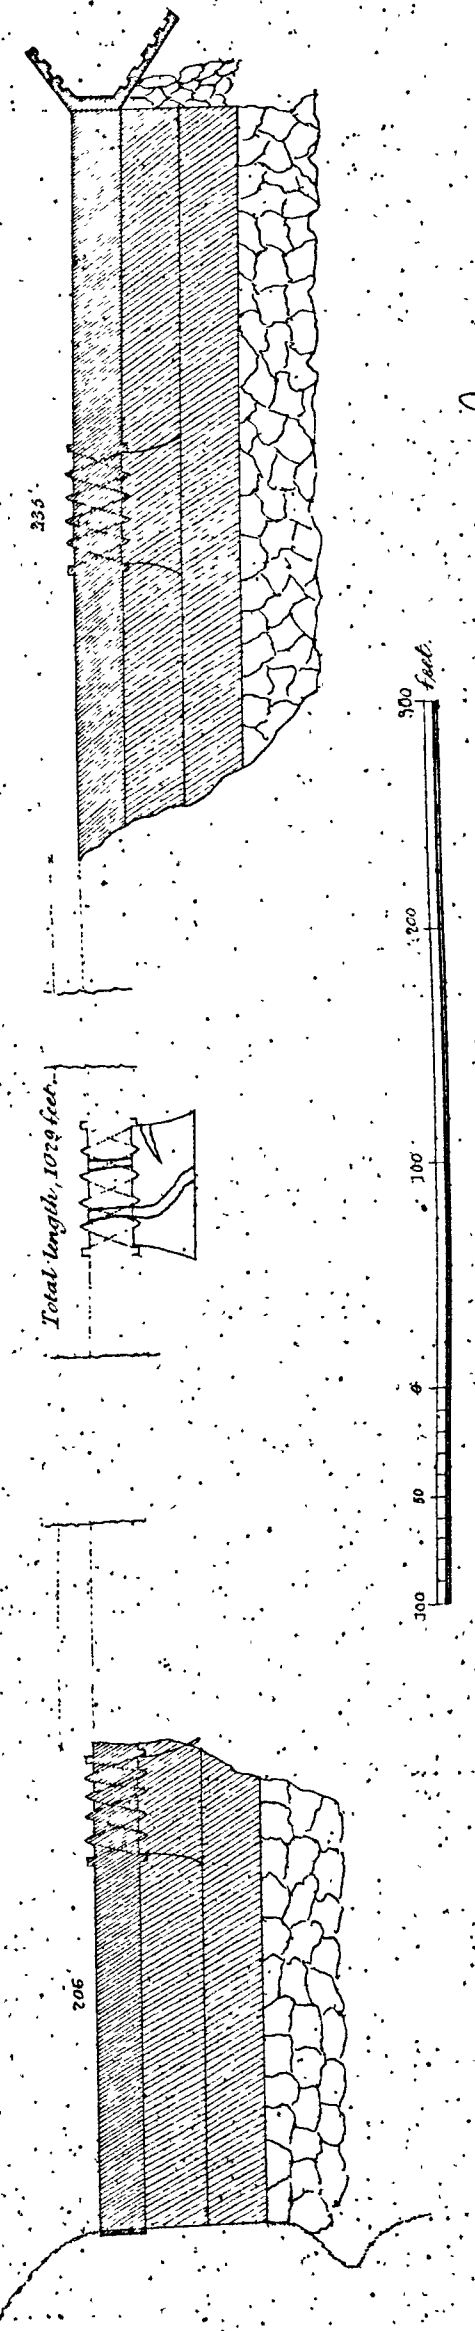
PLAN  
of the  
PENNAIR ANNICUT

Showing the breach made by the fresh on the 12<sup>th</sup> Oct 1858.
