# MADRAS RECORD OFFICE

Government of Madras.

*Fort Saint George, Public Works Consultation of 12th April 1859.*

No. 5. Read the following letter from Colonel C. E. FABER, Chief Engineer; to J. D. BOURDILLON, Esq., Secretary to Government, dated 24th March 1859, No. 8926.

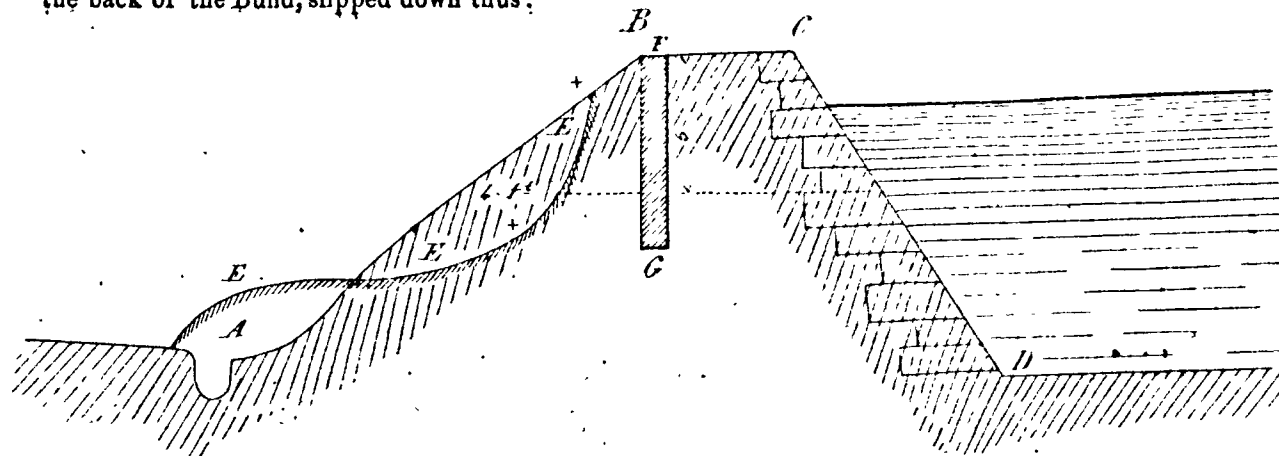
A very serious leak occurred in the Bund of the large Tank, and a considerable portion of the back of the Bund, slipped down thus:

A. B. C. D.—Original Section of Bund.

E. E. E.—Section after the slip.

On cutting down I found a hard stratum at the dotted line in the above Sketch, about 5 feet below the top of the present Bund, and it was over this hard surface the water was pouring in a horizontal sheet. It was evident that at some former period the Bund was raised; that the new material was put upon the hard polished top of the old Bund, without any thing being done to unite them, and thus the leak.

Fortunately I was at Head Quarters, and seeing there was no time to be lost, got a Trench (F. G.) cut longitudinally, until we got 18 inches below the leak; when we filled it with puddle well tramped with water, and in a few hours the leak was stopped and the Tank saved.

It is very likely that, from time to time during high water, other portions of this Bund will require to be treated in the way described above, but it is impossible to say where the weak points are until the leaks make their appearance.
