*Proceedings of the Madras Government, Public Works Department,  
24th August 1864.*

Report on the Sunkasala Ancient and Head Works, and on the }  
1st to 8th Sections of the Main Canal, &c., &c, inspected } (Here enter 2nd July 1864; No. 40.)  
between the 30th May and 30th June 1864.

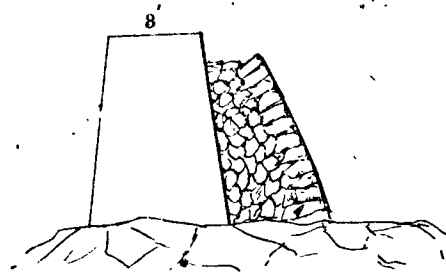
for the supply of the large and important Canal, at the head of which it stands. Some parts have already shown signs of weakness. In the north branch, at places, the rocky bed on which the Anicut was built, appears to be less hard than was anticipated, and at one place a sort of rubble retaining wall 6 feet from the rear of the Anicut at foot, and filled in with concrete had been commenced recently, with a view to keep the over-fall clear of the foot of the wall and cover the damaged rock; but the fresh had stopped this work, and I think its continuance would have been a waste of money; for in the first place its section was so slight, that there was little chance of its standing, and in the next place the formation of the rocks admits of

short retaining walls of small height being built a few yards below the work, and there are close at hand great boulders of rock which, if packed as an apron between the Anicut, and such retaining walls, or the contiguous masses of rock, would form a secure apron. It must be added also that it is very doubtful whether, in all cases, the wall forming the Anicut was founded directly upon the solid rock. Near the south end of the additional work above described, I observed what appeared to me to be a stratum of gravel under the base of the wall, and between it and the rock. This may be a mere patch, extending to but a small distance under the wall, but, if not, it would tend greatly to endanger the stability of the work. The water was running a few inches deep over the Anicut, so that a more accurate examination could not be made.

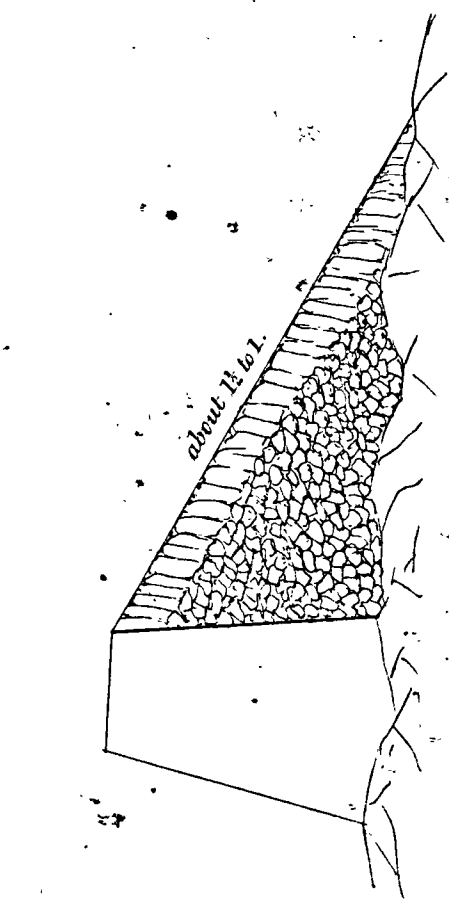
5. In paragraph 3 of General Ludlow's Report, it is mentioned that a gap in the south branch had been stopped by throwing in a mass of rough stone, and that upon this the body of the Anicut had been built. To relieve this part of the work from the effects of the over-fall, a wall was then being raised upon the crest of the work. The result probably would have been as anticipated, had the body wall immediately beyond been as stable as was supposed; but the actual effect was to cause a breach in the Anicut just beyond the termination of the raised portion. The damage has been made good, and to secure both the breached length and the original gap, the arrangement sketched in the margin has been made. This addition consists of a mass of rough stone, covered in with long packed stones, which are grouted with concrete, and the surfaces rendered tolerably smooth with plastering rubbed hard. Its stability is, in my opinion, very doubtful. Plaster does not usually stand with water passing over it at high velocities. The water would, were the plaster removed, soon pick out the concrete, and the displacement of a few of the packed stones would lead to the rapid destruction of the whole of this mass. As a temporary arrangement, it may answer the purpose of preventing a breach; but it cannot be relied on, and as a breach in the Anicut would be a most serious matter, when considerable tracts of land come to be converted from dry into wet cultivation, some more reliable plan of remedying the defects of the present body of the Anicut at this part, requires to be adopted. Probably it would be found economical in the end to make a puddled wall above the breach and gap, and to remove and re-build the body on the solid rock, or the body might be left, the lower part alone puddled, so as to stop the water coming through the rough stone, and then the second body built in rear to about a yard above the level of the present footing of the solid masonry. In the marginal sketch A represents the present body, founded on rough stone, and B would be the additional wall in rear.

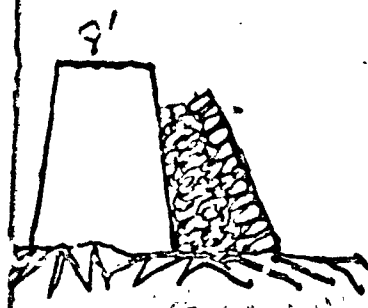
place a sort of rubble retaining wall 6 feet from the rear of the ancient at foot and filled in with concrete had been commenced recently, with a view to keep the overfall clear of the foot of the wall and cover the damaged rock, but the fresh had stopped this work, and I think its continuance would have been a waste of money, for in the first place its section was so slight that there was little chance of its standing, and in the next place the formation of the rocks admits of short retaining walls of small height being built a few yards below the work, and there are close at hand great boulders of rock which, if packed as an apron between the ancient and such retaining walls, or the contiguous masses of rock, would form a secure apron. - It must be added also that it is very doubtful whether, in all cases, the wall forming the ancient was founded directly upon the solid rock. - Near the south end of the additional work above described, I observed what appeared to me to be a stratum of gravel under the base of the wall, and between it and the rock. - This may be a mere patch, extending to but a small distance under the wall, but, if not, it would tend greatly to endanger the stability of the work. - The water was running a few inches deep over the ancient, so that a more accurate examination could not be made. -

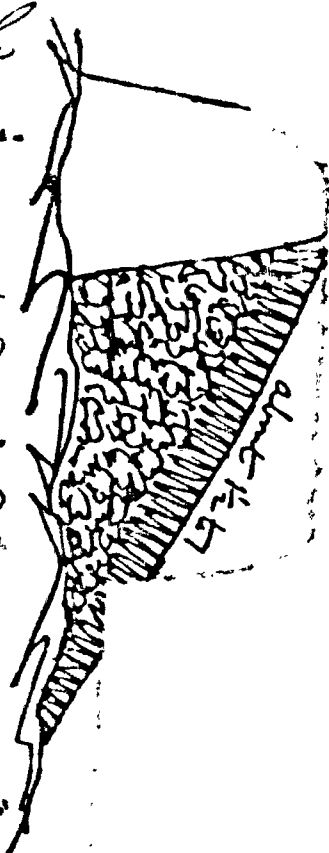
In para. 3 of General Ludlow's Report it is mentioned that a gap in the south branch had been stopped by throwing in a mass of rough stone, and that upon this the body of the ancient had been built. To relieve this part of the work from the effects of the overfall, a wall was then being

being raised upon the crest of the work. - The result probably would have been as anticipated, had the body wall immediately beyond been as stable as was supposed, but the actual effect was because a breach in the ament just beyond the termination of the raised portion. - The damage has been made good and to secure both the breach length and the original gap the arrangement sketched in the margin has been made. - This addition consists of a mass of rough stone covered in with long packed stones, which are grouted with concrete, and the surfaces rendered tolerably smooth with plastering rubbed hard. Its stability is in my opinion very doubtful. Plaster does not usually stand with water passing over it at high velocities. The water would, were the plaster removed, soon pick out the concrete, and the displacement of a few of the packed stones would lead to the rapid decay of the whole of this mass. - As a temporary arrangement it may answer the purpose of preventing a breach, but it cannot be relied on, and as a breach in the Ament would be a most serious matter, when considerable tracts of land come to be converted from dry into wet cultivation, some more reliable plan of remedying the defects of the present body of the ament at this part requires to be adopted. - Probably it would be found economical in the end to make a puddled wall above the breach and gap, and to remove and rebuild the body on the solid rock; or the body might be left the lower part alone

alone puddled so as to stop the water coming through the rough stone, and then the rough stone in rear might be removed and a second body built in rear about a yard above the level of the present footing of the solid masonry. - In the marginal sketch it represents the present body, founded on rough stone, and B would be the additional wall in rear. -

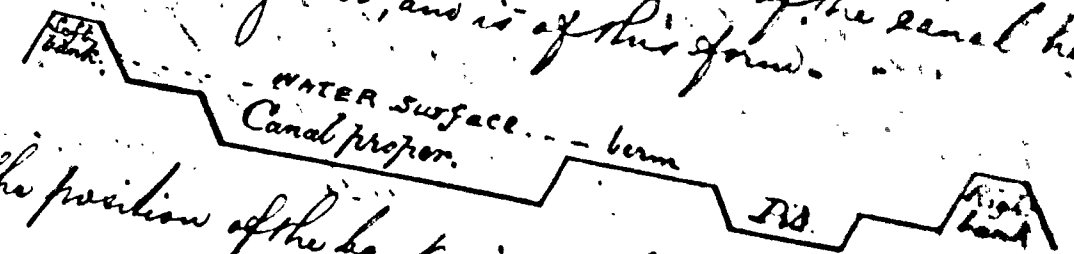
83. 67 mile. An additional culvert at 66-50 is required, as there is a considerable drainage to be provided for. Up to this earthwork  $\frac{1}{2}$  done. The cross section of the canal here is somewhat singular, and is of this form.

The position of the banks is such that the sectional area

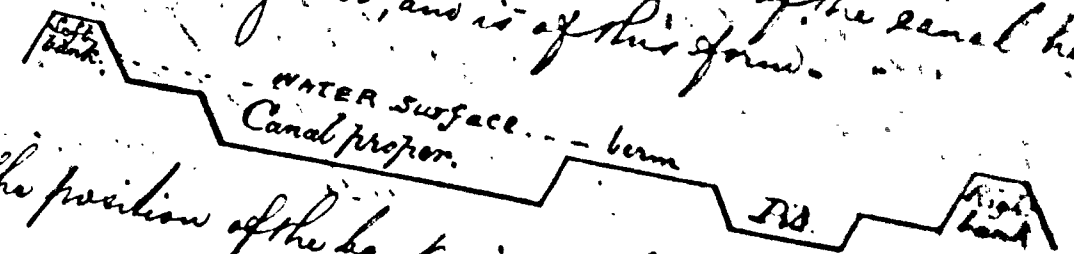
83. 67 mile. An additional culvert at 66-50 is required, as there is a considerable drainage to be provided for. Up to this earthwork  $\frac{1}{2}$  done. The cross section of the canal here is somewhat singular, and is of this form.

ground level, added to that of the canal in cutting, gives the re-  
quired waterway. The cutting is placed near the left bank for  
convenience of towing, and to obtain sufficient soil for the  
right bank. Pits are dug in the lower bottom between the  
canal. It would have been an improved arrangement had the  
banks been placed rather closer together, and the cutting of  
the canal proper increased sufficiently to provide the soil  
required, as thus the navigation would have been improved,  
and the excavations would have answered the double purpose  
of this of small consequence where the cutting is shallow, but  
elsewhere, when the water is low, the width for navigation is  
rather restricted than was necessary. Earthwork of  
this part of mile  $\frac{1}{2}$  done. The excavation for an culvert  
has just been commenced.
