GOVERNMENT OF MADRAS.

PUBLIC WORKS DEPARTMENT.

Division Office at Chettipet

Instructions to Superintending Engineer,  
I Circle, for preparing estimate for a new  
building for the —.

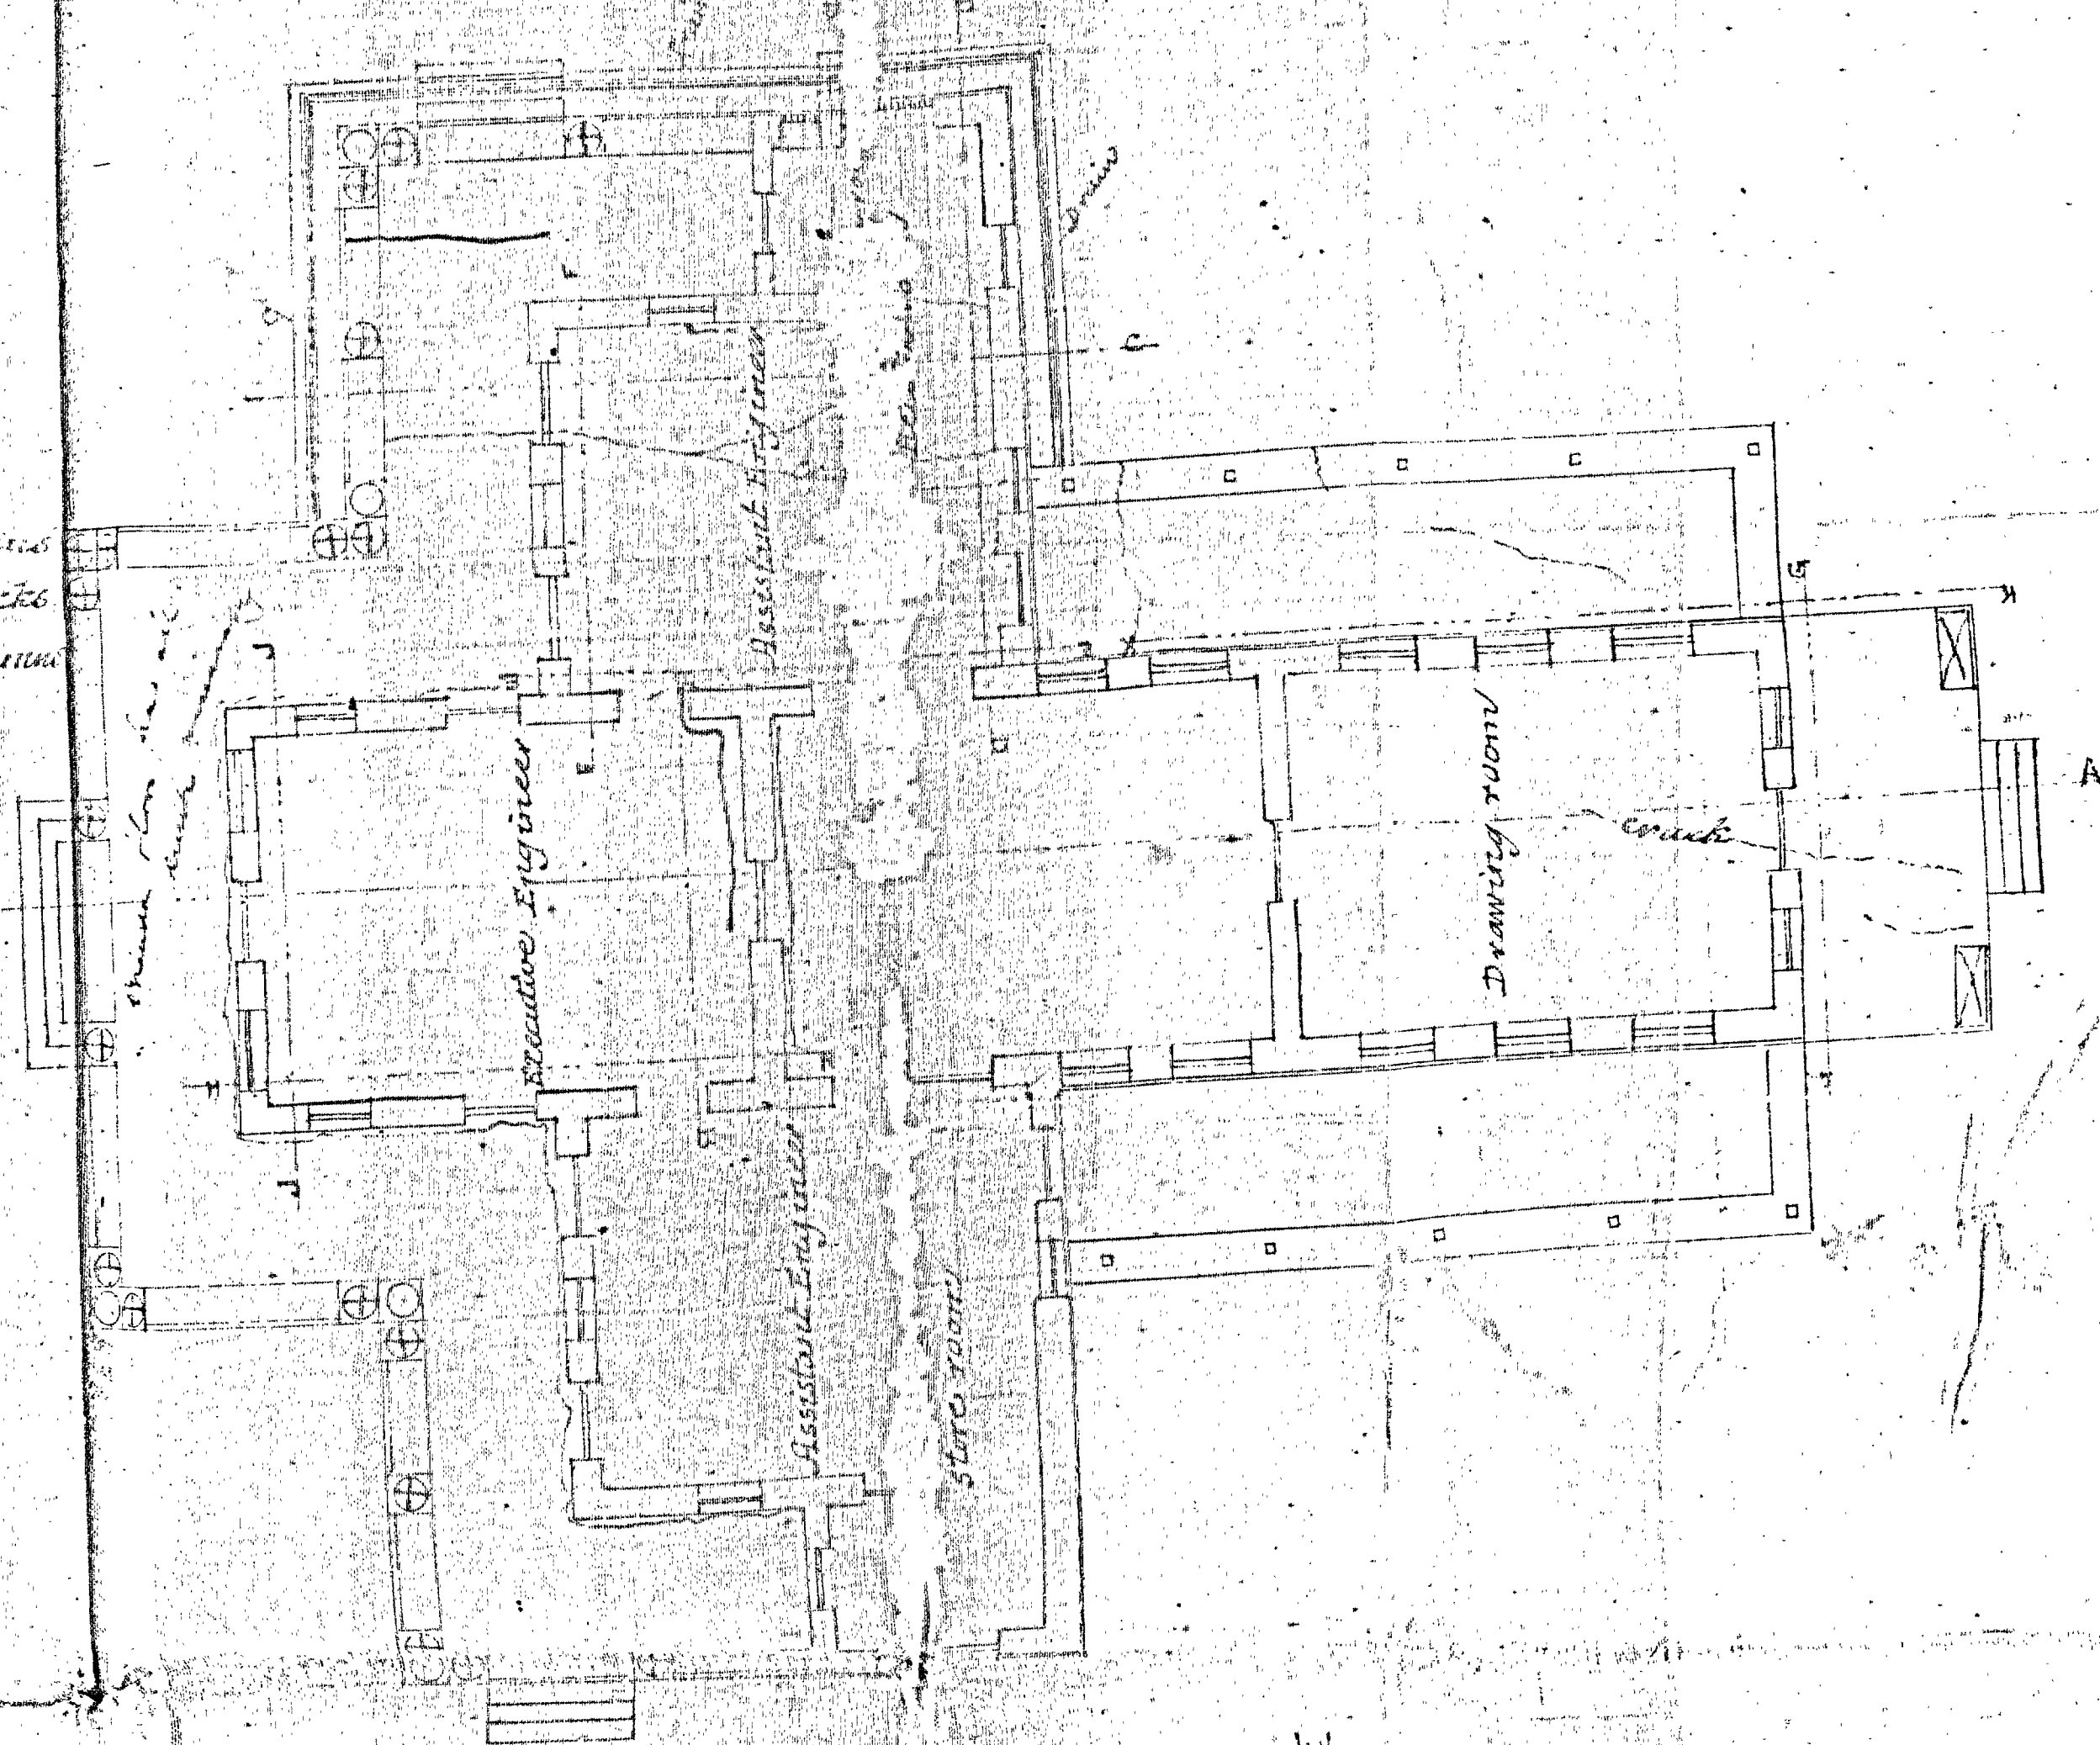
Godavari De...  
Western Det...  
Plan of Dr... office

2. I enclose a tracing and copy of a letter from the Assistant Engineer in charge of the division giving details of the cracks. The office was constructed in the year 1877 at a cost of Rs. 11,882, and for many years showed no signs of cracking; in fact it was not till after the floods of 1886-87, when the compound was under water for several days, that any serious settlement took place, and it is only in the last few months that the cracks have been getting rapidly worse. The soil on which the building stands is extremely bad and I measured some cracks in the vicinity nearly 6' deep, and I think the failure is due to the ground cracking after being thoroughly saturated by the floods.

3. I thought that perhaps the drain (shown in tracing) at the back of the building and which is in rather a peculiar position might have had something to do with the failure, but I examined it and found it in good order.

I am surprised that the building which has stood well for upwards of 12 years should have suddenly come to such grief. There cannot be any doubt whatever that it is entirely due to movement of the ground, due probably to its having been flooded.

4. The *old* cracks in the verandah pillars (on the *outside* of them) undoubtedly arose from the drag inwards of the top of the pillars when the verandah rafters sagged slightly as they had been notched to the bressummers too rigidly; those cracks had nothing to do with the present state of affairs. I see nothing for it but to pull down the building and erect another on the same general plan, so that roof timbers, doors, windows and other woodwork and fittings (the most expensive part of the building) may be used again, and of course the tiles and many of the bricks will be fit to use again.

N.B. sepia colored lines denote  
all cracks in the walls of  
building and foundation

Vertical lines  
denotes cracks  
in the columns

the plaster on the West wall is  
being cracked out at about the  
level of Verandah roof.  
The West cracks at present are  
(1) the one above mentioned  
(2) the three cracks shown in section  
III. The one on the left of the section  
was at one time about 2 months ago  
1" wide but has since closed up the  
lower part of the wall has moved  
up to the W.  $3/4$  to S. The center crack  
is the most dangerous. It is widest  
under the ridge about  $3/4$ " and the  
upper part of the wall is falling  
over towards the Assistant Engi-  
neers Office, this crack has increased  
rapidly & joined quite recently  
to that from the left hand  
angle of door marked W. The  
crack which is shown in the enlarged  
elevation has not increased much  
recently but when it first began  
widened rapidly. This crack shows  
a movement of the lower portion  
of

of the wall of  $3/4$ " west &  $3/4$ " South. The  
cracks in the draftsmen's office are  
all recent and are still increasing.  
New cracks are also appearing in the  
arches of windows in Draftsmen and  
31 Executive Engineers Office rooms. This  
extensive cracking of the office seems  
mainly to have taken place since

5. In rebuilding I would keep further away from the weir channel and from the canal.

Seeing nothing for it but  
 to pull down the building  
 & set another on the same  
 general plan, so that  
 roof timbers - doors -  
 windows & other woodwork  
 & fittings of the most expensive  
 part of the building, being  
 he used again - & of course  
 the tile & beams of the  
 back will be fit to use again.
