*Proceedings of the Madras Government, Public Works Department,  
24th July 1865.*

No. 608. Read the following letter from Captain R. F. OAKES, R. E., Acting  
Superintending Engineer, 6th Division, to Colonel C. A. ORR, R. E.,  
Secretary to Government, Public Works Department, dated Tanjore,  
12th July 1865, No. 520 :—

1. I have the honor to inform you that a large portion of the south branch of  
the lower anicut, which has just been re-built, was destroyed on the 5th instant.

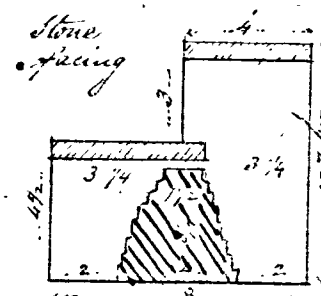
8 With regard to the Workman-ship and material the native Bricklayers all admit that it was of the very best description and that they have never seen such good work done before. It would appear however that when the Dam had been brought to the basement level, bricks began to fail and the shaded portion was built first, as per margin, of bricks of a somewhat inferior quality and the unshaded portion was bonded on most carefully about one week later with the very best bricks.

No uneven settlement appeared to take place but I have thought it necessary to mention the matter as the minutest details are of importance in determining the actual cause of such
