**MADRAS RECORD OFFICE.****Government of Madras.***Public works* **DEPARTMENT.**

| G.O. No. | 492 | Press |

No 396 From the Superintending Engineer, 4th Division, to the Chief Engineer for Irrigation, dated Madras, 16th December 1870, No 3,894.

From Captain A DE C SCOTT, R E, Executive Engineer, Madras Water Works, to the Superintending Engineer, 4th Division, dated Red Hills, 14th December 1870, No 501

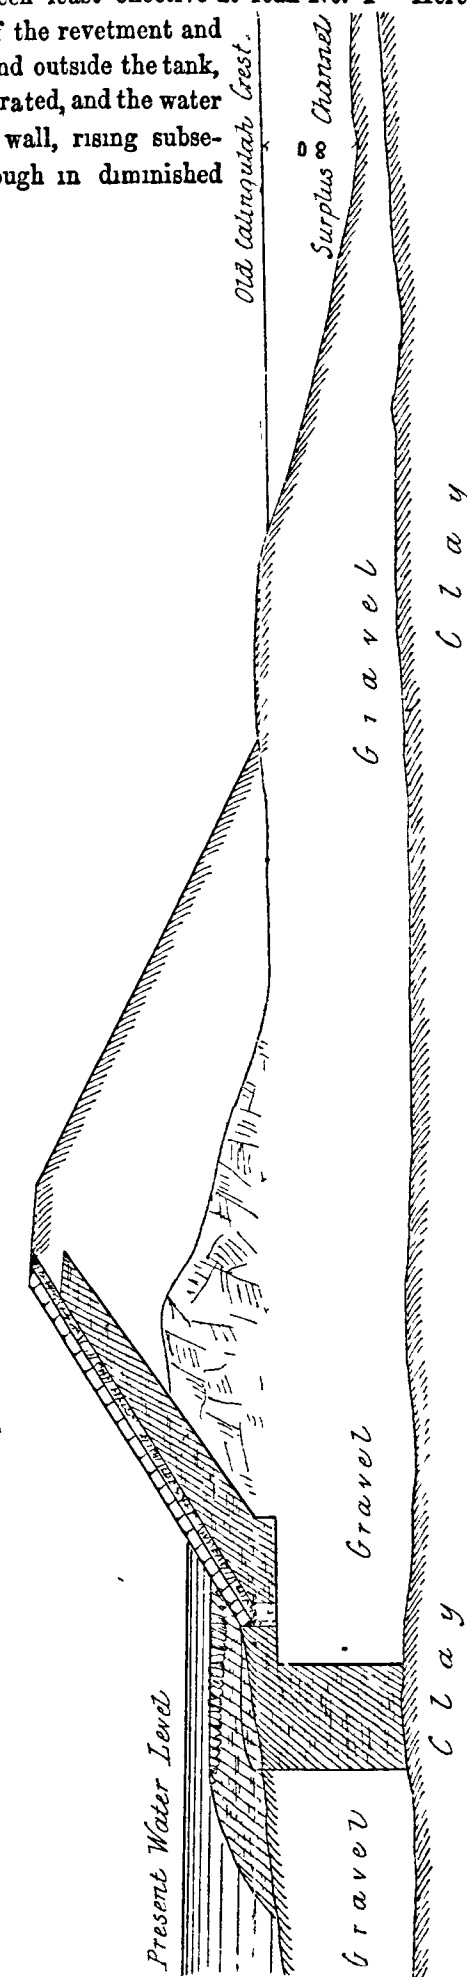
*Section of Embankment and No 5 Leaks*

No 5 lies to the north of the northern irrigation sluice between the sluice and the old calingulah. The base of the bund here rests on gravel and rock.

At Nos 4 and 5 puddle has been laid, but no walls have been built.

5 The effect of the puddling has been most satisfactory at leak No 5. At this point the section of the embankment and the ground on which it rests is that shown below. It will be seen that below a bed of gravel 14 feet in thickness clay was found, and that the puddle in the trench was connected with this clay

The puddle wall has been least effective at leak No. 1. Here, though it was carried down 12 to 15 feet below the toe of the revetment and 4 feet below the level of ground outside the tank, the bed of gravel was not penetrated, and the water appears to pass under the wall, rising subsequently to the surface, though in diminished quantity.

6 The conclusion to be drawn from the results of the work already executed as a guide for further operations would seem to be that the puddle wall should be carried, if possible, down to clay, or to a depth of not less than 10 feet below the level of the land outside the embankment
