*Proceedings of the Madras Government, Public Works Department,  
28th August 1872.*

*Note on requirements under the head "Military" to be provided from the Department Public Works Grant for Coorg.*

*Extract from a letter from the Assistant Engineer, Coorg Division, to the Assistant Chief Engineer of Mysore, dated 7th May 1872, No. 113-757.*

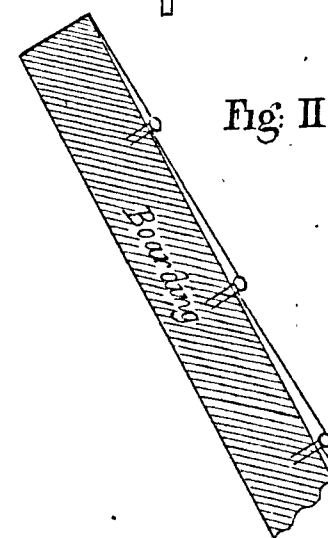
Fig. II.

traction of the sheeting occasioned by the variation of temperature, for this purpose the sheeting was held down by straps 5 feet apart, fixed with bolts as shown in annexed sketch Fig. I. At first no other fastenings whatever were fixed between the straps A, but it was found that the high winds blowing during the rainy season lifted up the lower edge of the sheet, and drove the rain below the iron sheeting, on to the boarding, which occasioned considerable leakage on to the ceiling of the upper storey. To remedy this, galvanized clips were inserted between the straps (*vide* Figs. I. and II.), which have lessened the evil but not obviated it, as the roof is still unsound to a great extent. The percolation of water through the roof is of little consequence on the north, west, and south sides of the palace quadrangle, where it falls on a terrace 2½ or 3 feet thick, which is provided with suitable outlets for it, but it makes the east side mess-room and part of the Colonel's quarters, where this terrace has been removed, uninhabitable during the monsoon. To prevent the water passing through the ceiling a layer of concrete 8 inches thick was laid over the ceiling boards, and over it Portland cement about quarter inch thick was plastered. This, I think, would have proved successful, had the concrete been well rammed

and consolidated; but from the spongy appearance it presents now, it is quite evident that this essential part of the work was not done. The layer of Portland cement being exposed to the great heat in the confined space below the roofing showed very soon cracks, which apparently were repaired, but opened again either in the same or in the other places. Through these the water finds its way into the concrete which allows it to percolate into the rooms below. The places in which the ceiling leaked were pointed out to me by the Officer Commanding and the Station Staff Officer, 8th Regiment, Native Infantry, but since then heavy rains having fallen, I had an opportunity of examining them myself. I discovered that the water percolates, not only through the places previously shown to me, which are all situated near the main walls, but also over the whole outer terrace and in several other places in the mess-room and the rooms adjoining it. The provisions made in the estimate forwarded under cover of my No. 61-371 of 1st March 1872 are, therefore, insufficient, and the piping proposed by you (sketch returned) would not meet these new requirements. How these leaks have sprung up since the last monsoon, I am unable to state, but I imagine that Portland cement expands and contracts to a greater extent than concrete, and as the variations of temperature must be considerable below the iron roofing, this may be the cause of the appearance of fresh cracks and consequent leaks.

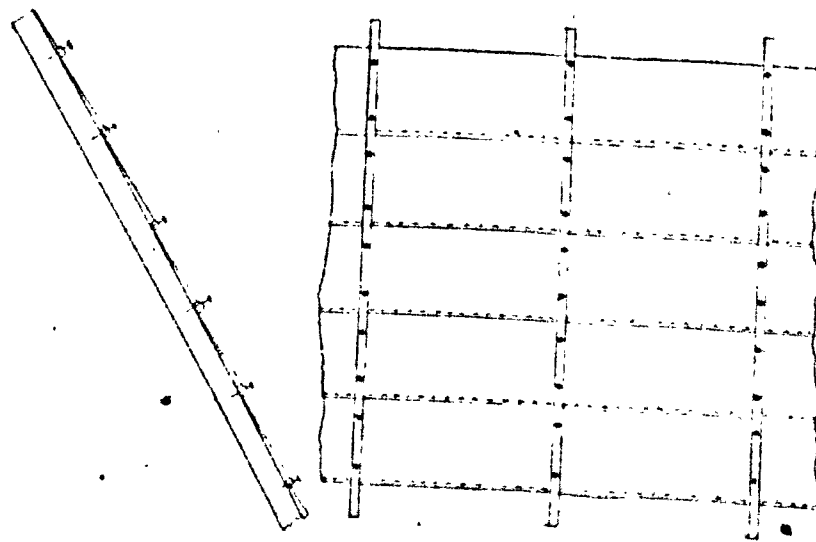
Fig. III.

3. In the above mentioned estimate, provision was made to asphalt the terrace over the balcony (marked B. in plan No. III.), but now it will become necessary to lay a coat of this material all over the terrace, covering a part of the mess-room and Colonel's quarters (A. in plan I). This surface is nearly seventeen squares, and at Rupees 50 per square would cost Rupees 892 inclusive of contingencies.

5. I.—To repair the roof and make it sound, I would first remove the clips, insert between

the sheets a piece of wooden stuff 2 inches wide soaked in white lead paint, and nail the lap down with galvanized wire nails one inch apart. This procedure is recommended by the manufacturers of the continuous iron sheeting (Morewood and Co.); and as this work could be done without disturbing the present roof covering, I beg to recommend it for your favourable consideration. The only objection that could be raised against this procedure would be that the iron is rigidly fixed and does not allow of expansion. Molesworth in his pocket book, page 181, gives the expansion of wrought iron between 32° and 212° as .0012. Taking

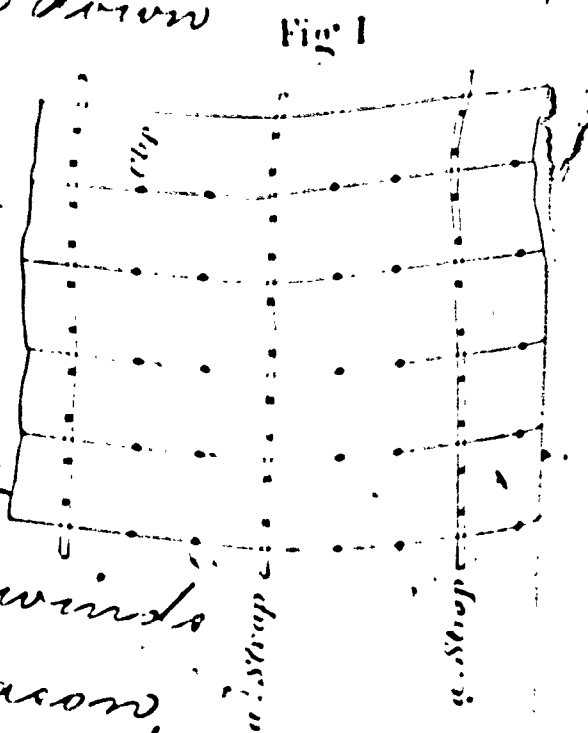
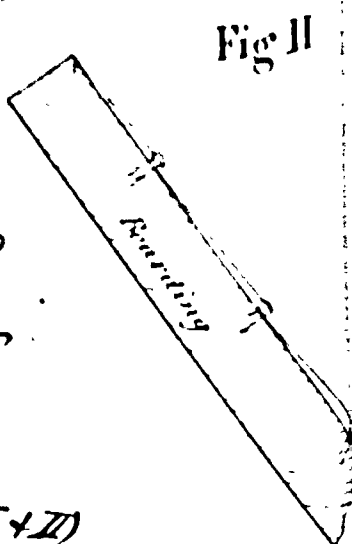
make provision for the expansion and contraction of the sheeting occasioned by the variation of temperature; for this purpose, the sheeting was held down by straps 5-feet-apart, fixed with bolts, as shown in annexed sketch Figure I. At first no other fastenings whatever were fixed between the straps, but it was found that the high winds blowing during the rainy season, lifted up the lower edge of the sheeting, and drove the rain below the Iron sheeting, on to the boarding, which occasioned considerable leakage on to the ceiling of the Upper Storey. To remedy this, galvanized clips were inserted between the straps (vide Figs I & II) which have lessened the evil but not obviated it, as the roof is still unsound to a great extent. The percolation of water through the roof is of little consequence on the north, west, and south side of the Palace Quadrangle, where it falls over a terrace  $2\frac{1}{2}$  or 3 feet high

thick, which is provided with suitable outlets for it, but it makes the east side mess room and part of the colonel's quarters, where this terrace has been removed, uninhabitable during the monsoon. To prevent the water passing through the ceiling, a layer of concrete 8 inches thick, was laid over the ceiling boards, and over it Portland Cement about  $\frac{1}{4}$  inch thick was plastered. This I think would have proved successful, had the concrete been well rammed, and consolidated; but from the spongy appearance it presents now, it is quite evident that this essential part of the work was not done. The layer of Portland Cement being exposed to the great heat in the confined space below the roofing, showed very soon cracks, which apparently were repaired, but opened again either in the same or in the other places. Through these, the water finds its way into the concrete which allows it to percolate into the

rooms below. The places in which the ceiling leaked were pointed out to me, by the Officer Commanding and the Station Staff officers 8<sup>th</sup> Regiment A. S. but since then, heavy rains having fallen, I had an opportunity of examining them myself. I discovered that the water percolates not only through the places previously shown to me, which are all situated near the main walls, but also over the whole outer terrace, and in several other places in the Mess Room and the rooms adjoining it. The provisions made in the estimate forwarded under cover of my No.  $\frac{61}{37}$  of 1<sup>st</sup> March 1872 are therefore insufficient and the repairs proposed by you (sketch returned) would not meet these new requirements. Since these leaks have sprung up since the last monsoon, I am unable to state, but I imagine that Portland Cement expands and contracts to a greater extent than concrete, and as the variation of temperature must be considerable below

below the iron roofing, this may be the cause of the appearance of fresh cracks and consequent leaks.
