# MADRAS RECORD OFFICE

*Public Works* DEPARTMENT

No. 538. Read the following letter from Lieutenant-Colonel J. H. M. SHAW-STEWART, R.E., Consulting Engineer for Railways, to Major-General G. W. WALKER, R.E., Secretary to Government, Public Works Department, dated Madras, 18th December 1876, No. 624:—

*Collision at Tiruputty on 14th instant.*

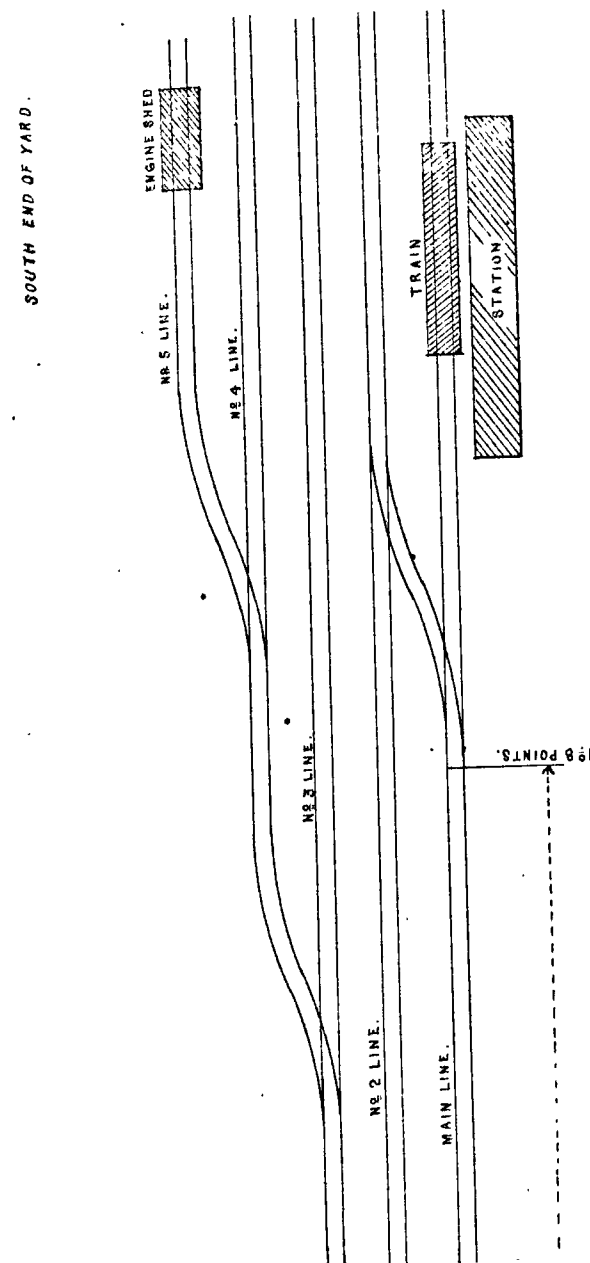
TIRUPUTTY STATION YARD

3. In order to make the circumstances clear I append a rough diagram of a portion of Tiruputty station-yard; the engine which brought the 4-45 P.M. special from Arconum to Tiruputty will be referred to as the incoming engine, and the engine which was to take the same train from Tiruputty to Cuddapah will be designated the outgoing engine.

9. The cause of the accident is, I think, quite clear. It appears to be customary for the incoming engine to back to the shed at No. 8 points, but as, on this occasion, the incoming engine was booked to take another train very shortly after his arrival, he wished to go to the north end of the shed instead of the south end as usual, to do which he had to back at the north points instead of at No. 8, and for this reason he asked No. 8 pointsman if the road was clear. But the north pointsman had made up his mind that the incoming engine would back at No. 8 points as usual and allowed the outgoing engine to pass him too soon, and neither pointsman was prepared to show such signals to each other as would provide with certainty for this slight change in the usual routine.

11. Damage caused—buffer beam of the outgoing engine destroyed, and the steam-chest cover and one valve-spindle broken by the blow of the drag-hook driven against it when the buffer beam gave way.

12. I propose to fine the driver of the outgoing engine half the cost of the damage, viz., Rupees 50, for his negligence, for had his head light been in the proper place according to rule the accident would probably not have happened.
