*Proceedings of the Madras Government, Public Works Department,  
16th February 1876.*

No. 289. Read the following letter from Lieutenant-Colonel J. H. M. SHAW-STEWART, R.E., Consulting Engineer for Railways, to Major-General G. W. WALKER, R.E., Secretary to Government, Public Works Department, dated Madras, 20th December 1875, No. 662 :—

ADVERTING to the Proceedings of Government, under date the 4th August 1875, No. 2,250, and to previous papers upon the subject of the Accident to the Inspection Train at the Paupugnee bridge upon the 16th June 1874, I have the honor to lay before Government a letter\* from the Agent of the Madras Railway giving cover to a

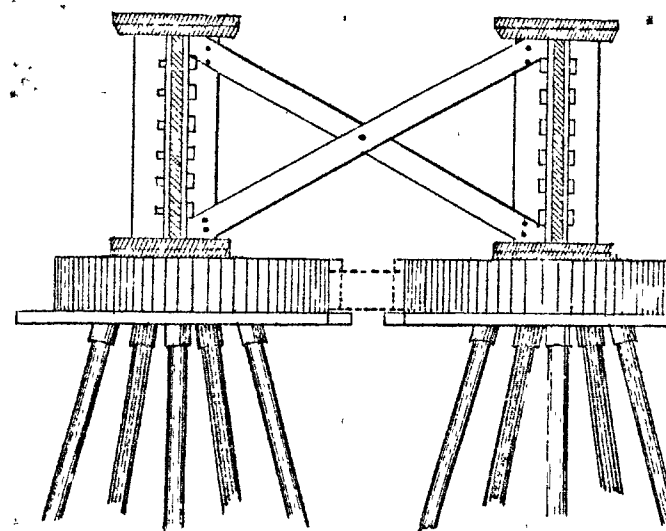
The bridge consisted of a series of longitudinal girders about 140 feet in length, each girder spanning two openings.

The girders rest on circular cast iron caps, each supported by five screw piles. The girders were connected transversely by diagonal braces slightly rivetted to the vertical angles or T irons, by two rivets in each end.

The circular caps of the piers on which the girders rested were intended to have been connected by cast iron struts, bolted to each, but which were never inserted, as pointed out by Sir J. Hawkshaw, leaving the adjacent piers wholly unconnected with each other. These are indicated by the dotted lines on sketch.

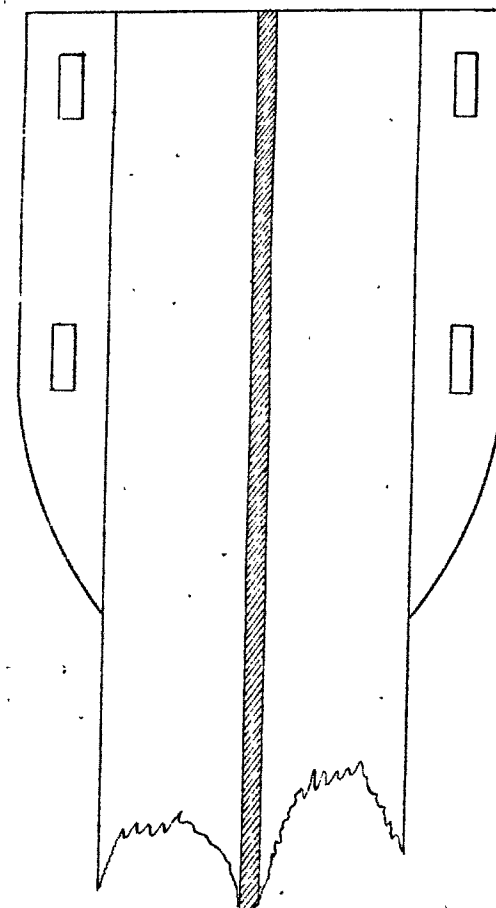
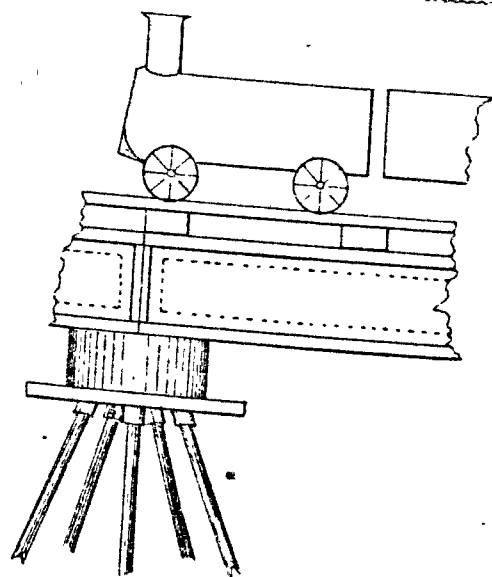
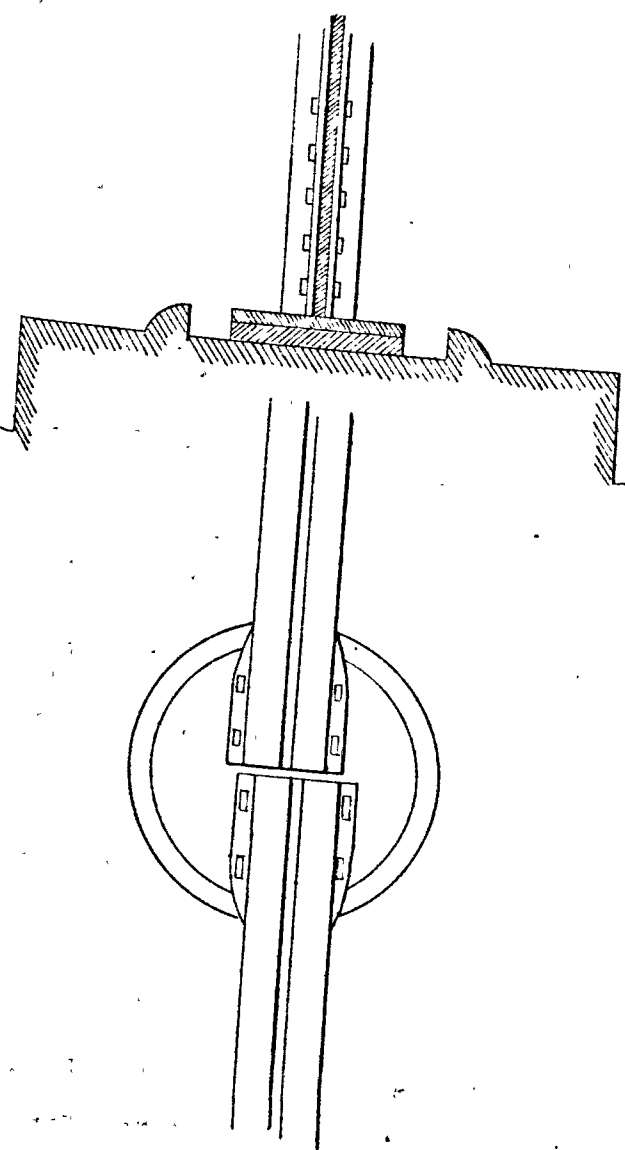
The result was that the bridge instead of being formed of one continuous framing, became a mere series of disjointed and unsecured girder frames held in place solely by their own weight, each except for its own weight free to be moved laterally or moved out of line on its own centre by any casual shock.

siderable to resist the shock of any oscillation of a rolling weight of 36 tons with the momentum due to a velocity of, say, 35 miles per hour, acting at the height of the rails.

I should state that the cast iron caps on which the girders rested had small ledges cast on, which were intended to confine the flanges of the girders, in fact to act as distance pieces, but as the girders did not fill the space between the ribs they were of no use to prevent slight movements.

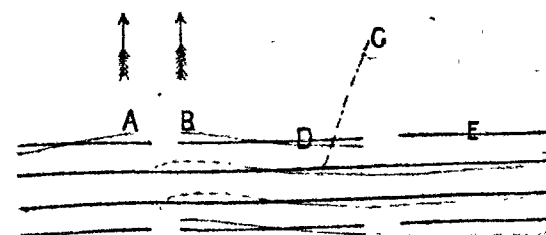
Now these girders being unsecured as I have described, if anything caused either the end of the last previous one, or the end of the one on which the accident occurred to be displaced laterally a very small amount, as at A B in the direction of the arrows, the rails would be pressed out of line, as shown in an exaggerated form by the red line in this figure, and thus cause the engine to oscillate and the engine wheels, with the momentum due to a velocity of 35 miles, to grind the rails.

with a severe pressure and alternately to mount and cross the rail probably at the moment when the oscillation of the engine and the action of the crank combined to momentarily relieve the wheel from part of its proper weight on the springs.

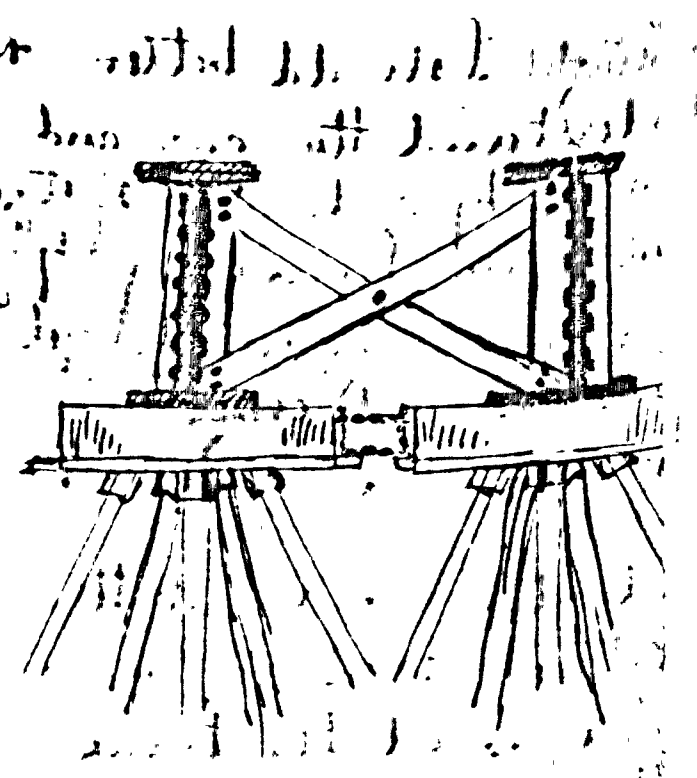
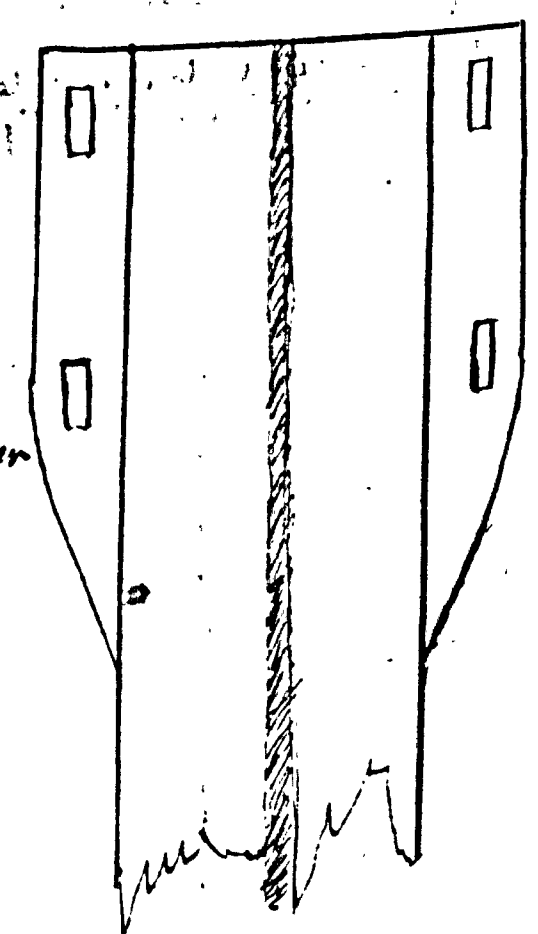
The bolts at the ends by securing adjoining ends of consecutive girders to one and the same casting would have kept the girders in line and

as pointed out by Mr. Handley leaving the adjacent piers wholly unconnected with each other -

enabled them to resist lateral shocks.

The holding down bolts, the size and number of which with arrangements to meet expansion were duly shown in the original drawings to which I referred, were altogether omitted in construction.

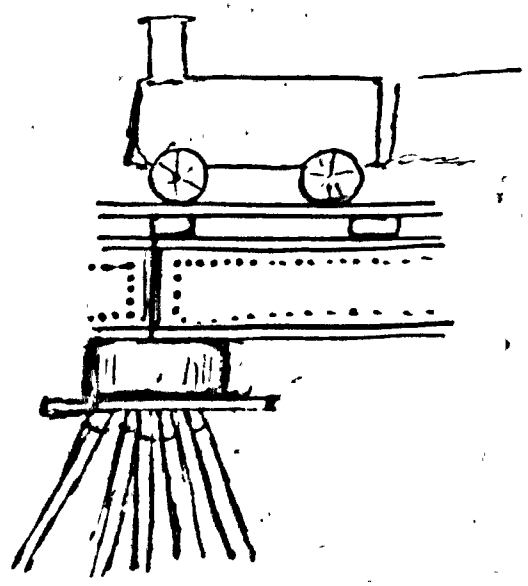
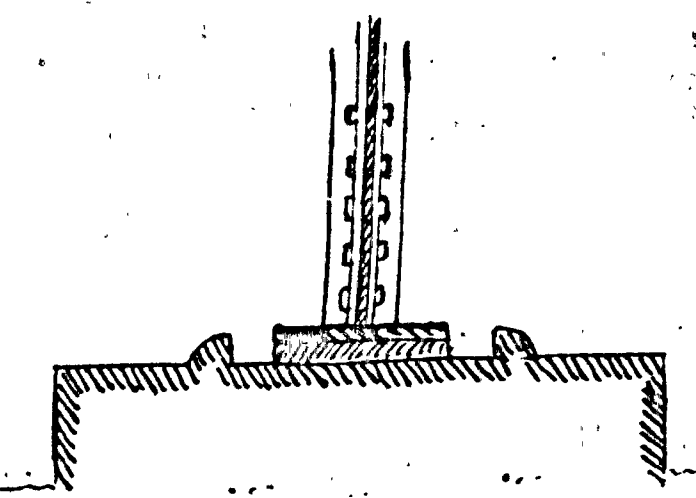
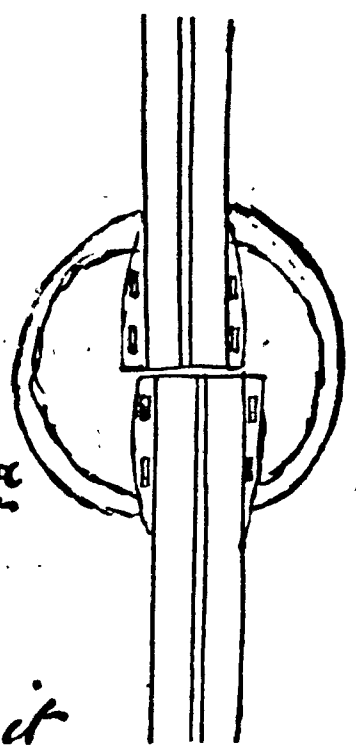
to resist the shock of any oscillation of a rolling weight of 36 <sup>with</sup> tons, the momentum due to a velocity of say 35 miles per hour, acting at the height of the rails, ~~leaving the point of contact~~ <sup>leaving the point of contact</sup> I should state that the cast iron caps on which the girders rested had small ledges - cast on which were intended ~~to confine~~ <sup>to confine</sup> the flanges of the girders - in fact to act as distance pieces - but as the girders did not fill the space between the rails they were of no use, to prevent slight movements.

With girders thus unsecured - it is obvious that any subsidence of a pier supporting an end of a girder <sup>would slacken the support</sup> ~~and~~ <sup>and</sup> would in effect leave the 2 girders resting on it balanced on the centres

ready to yield to any lateral thrust they might receive at either end.

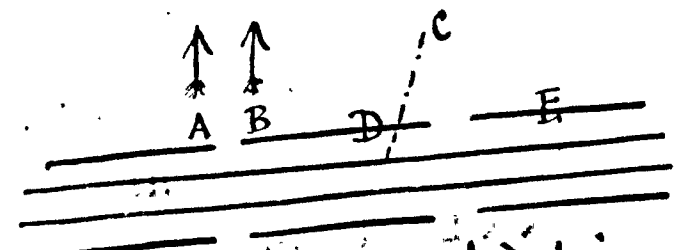
Now these girders being  
unsecured as I have described  
if anything ~~was~~ caused  
either the end of the last  
previous one or the end of  
the one on which the  
accident occurred to be  
displaced laterally a very  
small amount.

rails would be pressed out  
of line - as shown in an  
exaggerated form in this  
figure - and thus cause  
the engine wheels, with the  
high momentum, to grind  
the rail at C - with  
severe pressure and

\* as at A B in the direction  
of the arrows.  
the engine to oscillate and  
due to a velocity of 35 miles  
per hour - probably at the moment  
when the oscillation of the engine  
combined to momentarily elevate the wheel from its proper  
contact with the rails -
