# MADRAS RECORD OFFICE.

## SOUTH INDIAN RAILWAY.

## Adyar Bridge.

Six 65 feet lattice girder spans at 6 miles 50 chains.

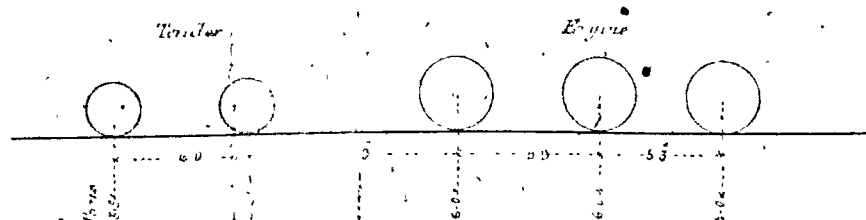
Statement showing the deflection and oscillation of the girders when subjected to the rolling load of two engines (Nos. 36 and 39, Neilson type, weights as given in the attached diagram) coupled front to front and moving at a speed of 25 miles an hour.
