GOVERNMENT OF MADRAS.  
PUBLIC WORKS DEPARTMENT.

11th August 1879, No. 2,104 W.

No. 77. From R. F. CHISHOLM, Esq., Consulting Architect to Government, to the Chief Engineer, Public Works Department, Buildings and Roads Branch, dated Chepauk, 2nd August 1879, No. 243.

Lawrence Asylum Buildings.—The Consulting Architect's annual report of inspection of the same, communicated to the Superintending Engineer, Fourth Circle, such inspections in future to be left to the local officers of the Public Works Department.

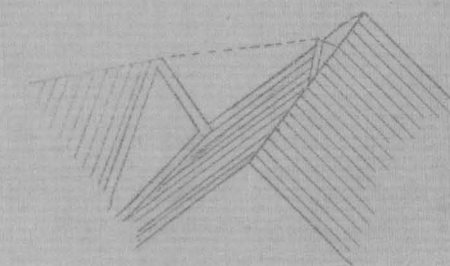
3. The tiling throughout appears to be satisfactory, but I am in doubt as to how long it will remain so. The tiles were laid by Colonel Farewell on continuous sheet iron; this so long as the iron lasts is perfect, but a leak in the school-room roof would indicate that the water has in some way got through the iron. There are one or two places in the roof wrongly constructed; these leak, and will, I fear, always leak until they are altered. I allude to a piece in the south-east corner and a piece over the Principal's residence, where the slope of one side of the roof drains against the gable wall.

These two places should be corrected by running the roof forward and draining by two angle gutters.

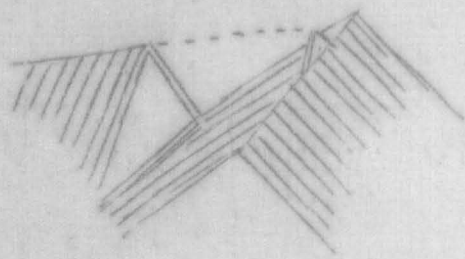
3 The tiling throughout appears to be satisfactory but I am in doubt as to how long it will remain so. The tiles were laid by Mr. Foxwell on continuous sheet iron this so long as the iron lasts is perfect, but a leak in the school room roof would indicate that the water has in some way got through the iron. There are one or two places in the roof wrongly constructed these leak and will I fear always leak until they are altered. I

allude to a piece in the South East corner and a piece over the Principal residence where the slope of one side of the roof drains against the gable wall

These two places should be corrected by running the roof forward and draining by two angle gutters
