GOVERNMENT OF MADRAS.

PUBLIC WORKS DEPARTMENT.

Extract from the Progress Report of Works in charge of Supervisor J. Mahony, in charge of Dumagudem Sub-division, Godavari Eastern Division, from 21st to 31st May 1883.

Extract from the Notes of Inspection of J. C. LARMINIE, Esq., Executive Engineer, Eastern Division of Upper Godavari Works.

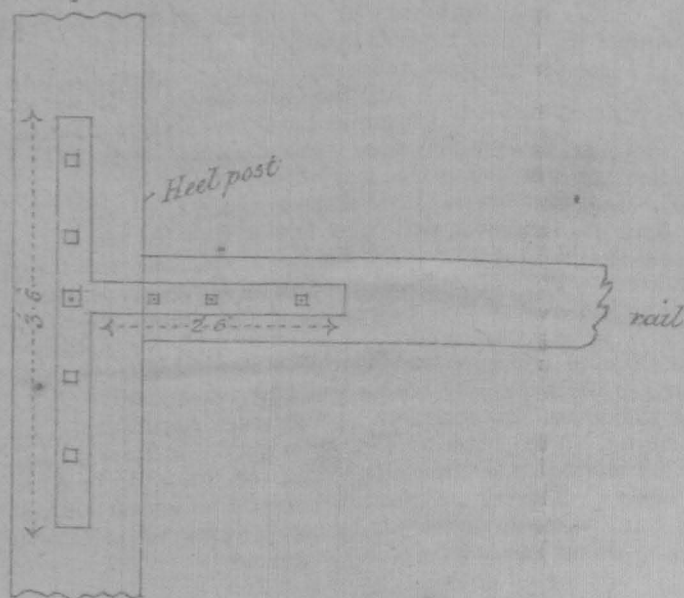
There is no indication whatever of decay in the heel posts where they enter the pintle sockets (nor elsewhere), and it is not understood how such a report ever originated. The only part at all decayed is the heel-post tender of the second rail (from sill) of the right leaf; this has opened a little from the heel, and the corner of the heel has cracked away; the part is probably still strong and sound enough, but, as a precaution, two — straps are to be bolted through to rail and heel post as per sketch.

Straps to be countersunk to be  $3\frac{1}{2}$ " broad  $\times$   $\frac{3}{4}$ " thick and bolted through each other by 8 bolts and nuts,  $\frac{3}{4}$ " diameter would do, but the Overseer has only  $\frac{1}{2}$ " and 1", so the bolts can be 1" diameter. The gates are to be thoroughly cleaned before being tarred; all crevices and cracks to be well cleaned and filled in with tar, with tar and dammer where cracks are wide enough to take it. The crack in left heel post, alluded to by Superintending Engineer to be so treated, valve shutter bearings to be looked to.

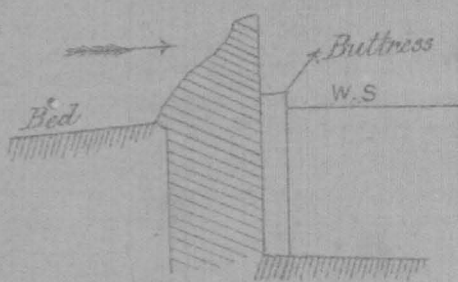
natural pool below the anicut, from 10 to 15' deep. The lascar sent in to examine the anicut rear face reported a hole  $36' \times 4' \times 8'$  deep into the body of the anicut; to make certain of this a small boat was launched in the pool and, after a careful examination, I conclude that the hole is not more than 2' deep, and that it does not extend for any length. There is a tradition

said to be in the rear face of the anicut; of these, one  $21' \times 4' - 6' \times 12'-0$  is said to be under the

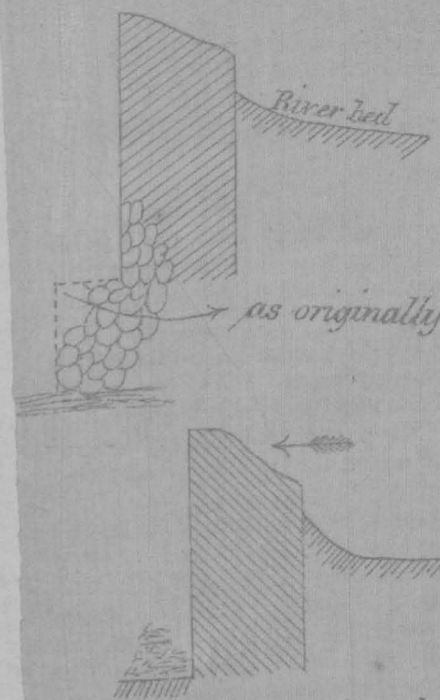
The other four places supposed to require repairs were pointed out by the lascar, who with Overseer Venkataswamy measured them; but only in one place, after most careful search in rear of Section No. 4, could anything resembling a hole be discovered, and it (this hole) was only in the basement of the anicut. Repairs to this basement as per Venkataswamy's estimate are to be done. At present the basement is somewhat, as per sketch, a good deal broken down in places; there is no immediate danger, but the action of the water when there is but little going over the anicut will loosen more of the small rubble of which the basement is composed. Rear face of anicut to be pointed where required as shown, pebble concrete grouting being used where the spaces are large enough to take it.
