Copy of letter from Dr. Jopp, Engineer, Procurement Engineer, Panama, to the Superintg. Engineer  
 VI Circle No 1465 dated 19<sup>th</sup> June 1889

17/9 I have the honor to submit the report on the Light House at Pambou as requested in your letter No: 1067. J. & of 26<sup>th</sup> February 1889.

Lighthouse at Pamban.

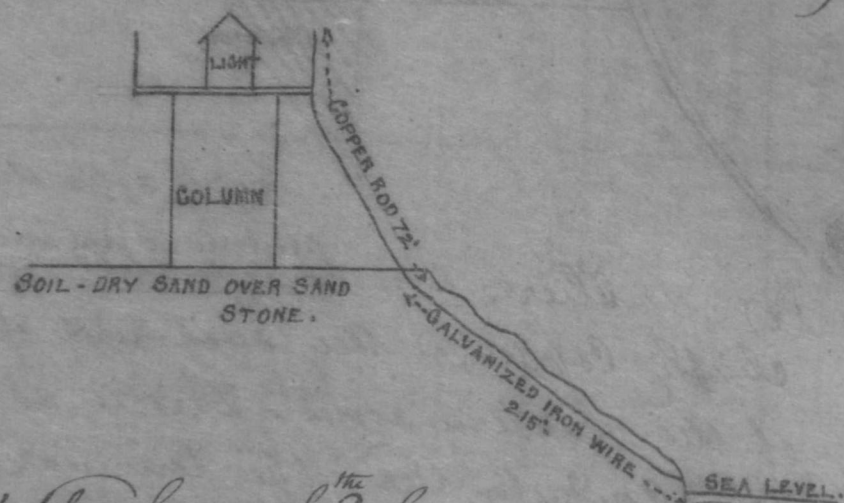
4. (a). The Conductor consists of a Copper rod 76 feet in length from its upper terminal to ground level; at this point it is joined to a galvanised iron wire, which is buried about 1 foot below the surface of the ground and terminates near the sea in permanently moist earth at a distance of 215 feet from its junction with the Copper rod (as shown in the sketch)

The soil at the base of the Column and throughout the length of the iron wire is pure sand and quite dry.

(b). The diameter of the Copper rod is a little less than  $\frac{1}{2}$  an inch which may be considered sufficient but the diameter of the iron wire is only  $\frac{1}{3}$  of an inch and as it passes for 215 feet through an almost non conducting medium of dry sand, its diameter should be at least  $\frac{1}{2}$  inch.

(c). Again the junction between the Copper rod and iron wire is electrically inefficient.

The iron wire is merely twisted tightly several times round the Copper rod and as the wire is also considerably rusted, the junction cannot be said to be electrically a safe one.

1<sup>st</sup> To replace the iron wire by a Copper rod of  $\frac{1}{2}$ " diameter.

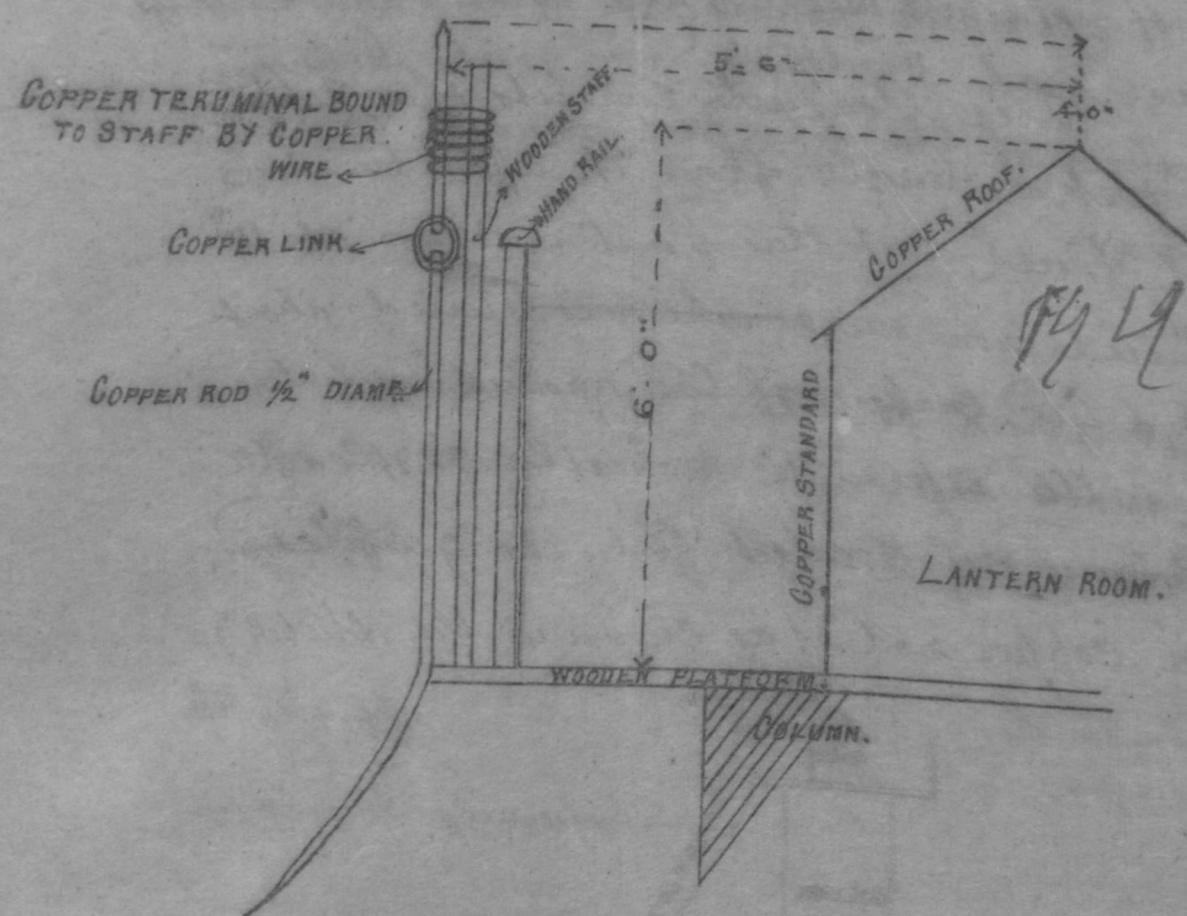
(d). The upper terminal is not jointed and soldered to the Copper rod but is merely connected to it by a copper link as shown in the

the sketch.

(e). There is a considerable mass of metal, chiefly Copper, in the roof and frame work of the lantern room. This is not connected with the Conductor; the upper terminal of which is not more than 4 feet higher than the top of roof and at a horizontal distance of about 5'-6" from it.

(f). There is no metal plate at the lower terminal of the Conductor.

2<sup>nd</sup> To properly joint and solder the Conductor to its upper terminal.

3<sup>rd</sup> To connect all metal of the roof and frame work of the lantern room to the Conductor.

4<sup>th</sup> To provide a metal plate of sufficient size at the lower terminal.
