Public Works Department.

The Estimate under  
review amounting  
to Rs. 1064 provided  
for remodeling the  
lightning conductor  
of No. 1 Magazine  
attached to the  
Arsenal at Tollymore

# Section and Tests of Lightning Rods made by the undersigned on the 6<sup>th</sup> July 1888.

Report to accompany estimate  
for remodelling Lightning Rods of  
Magazine No 1 Bellary Fort.

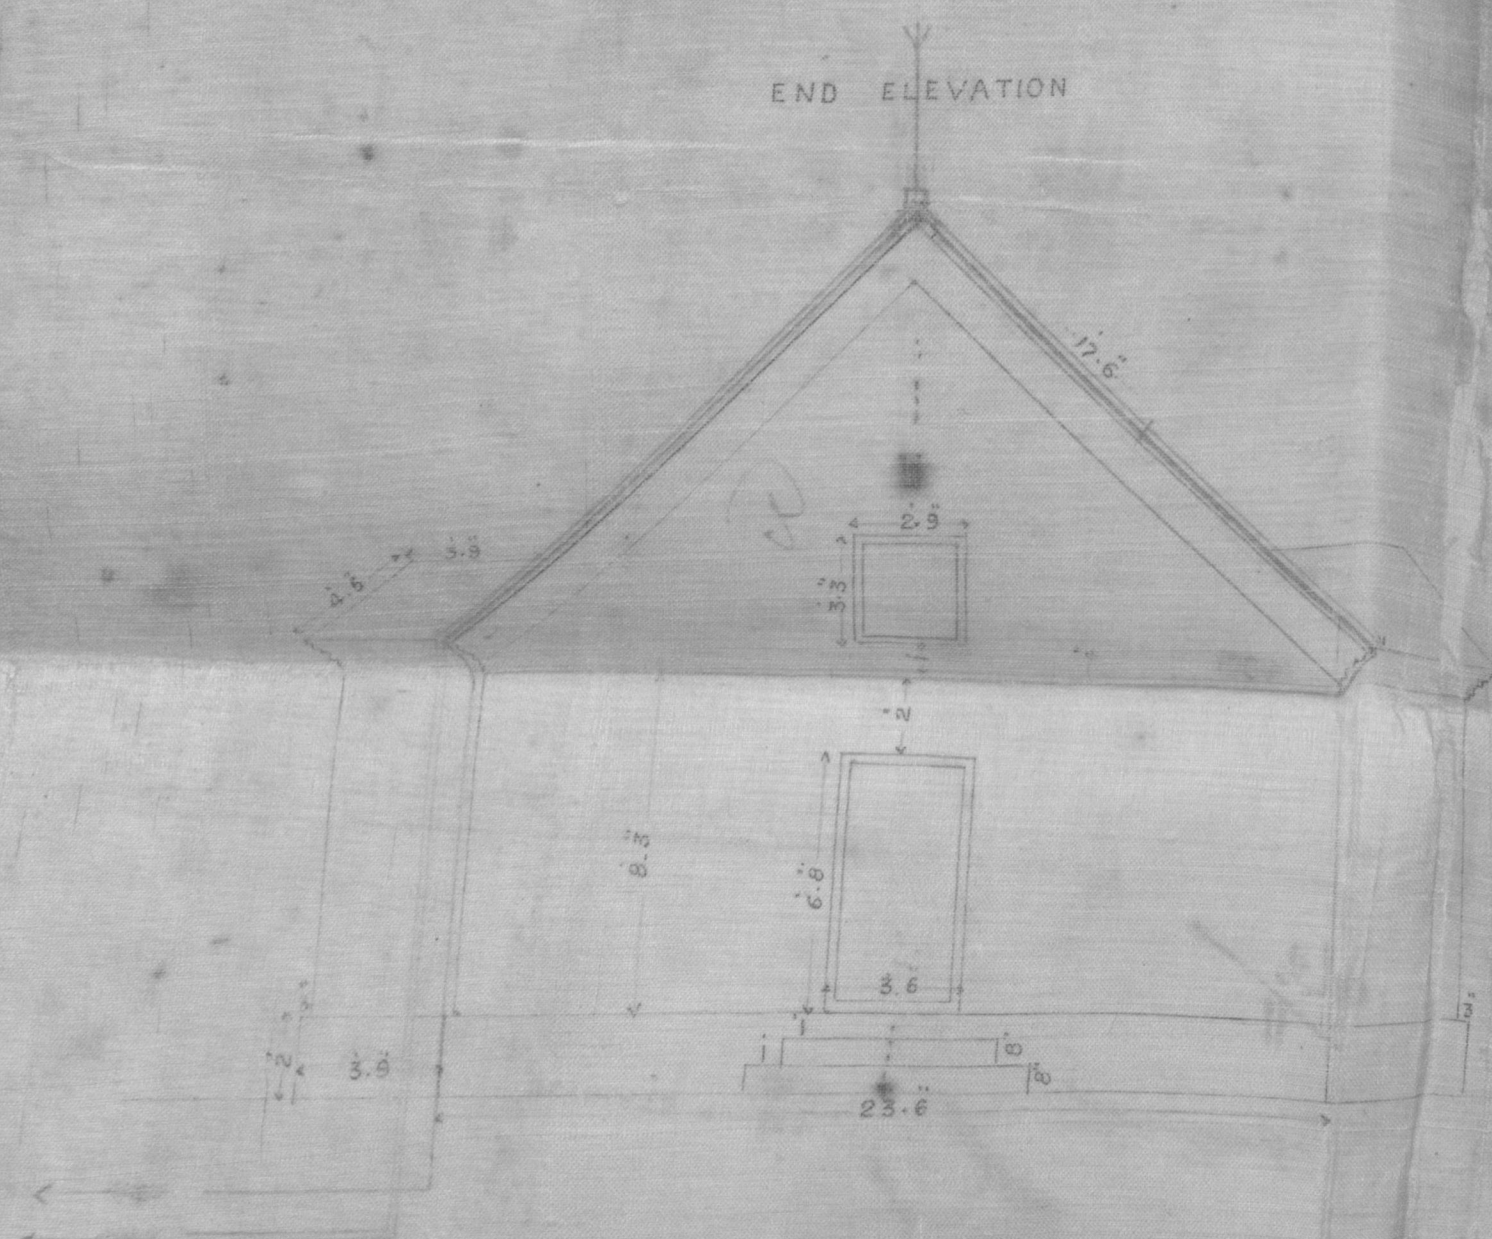
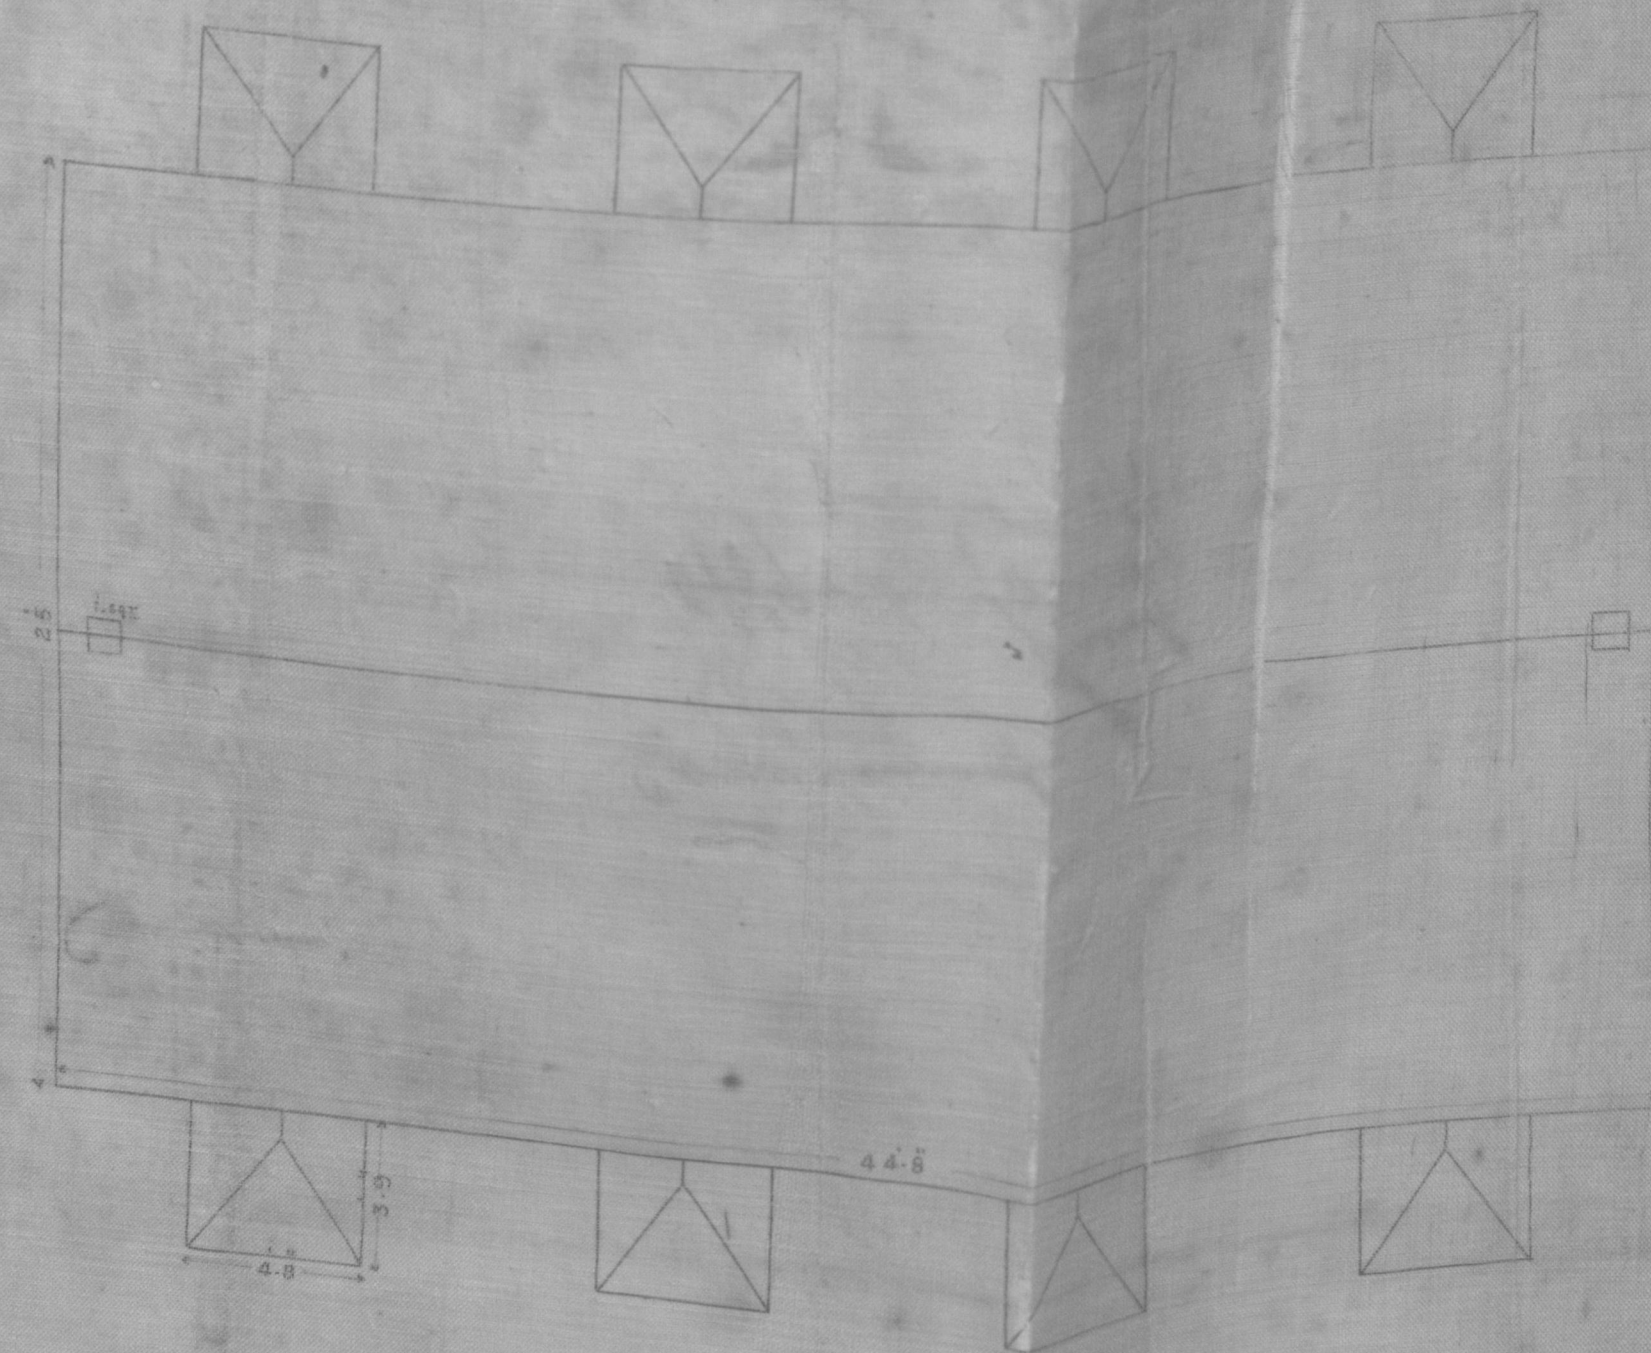
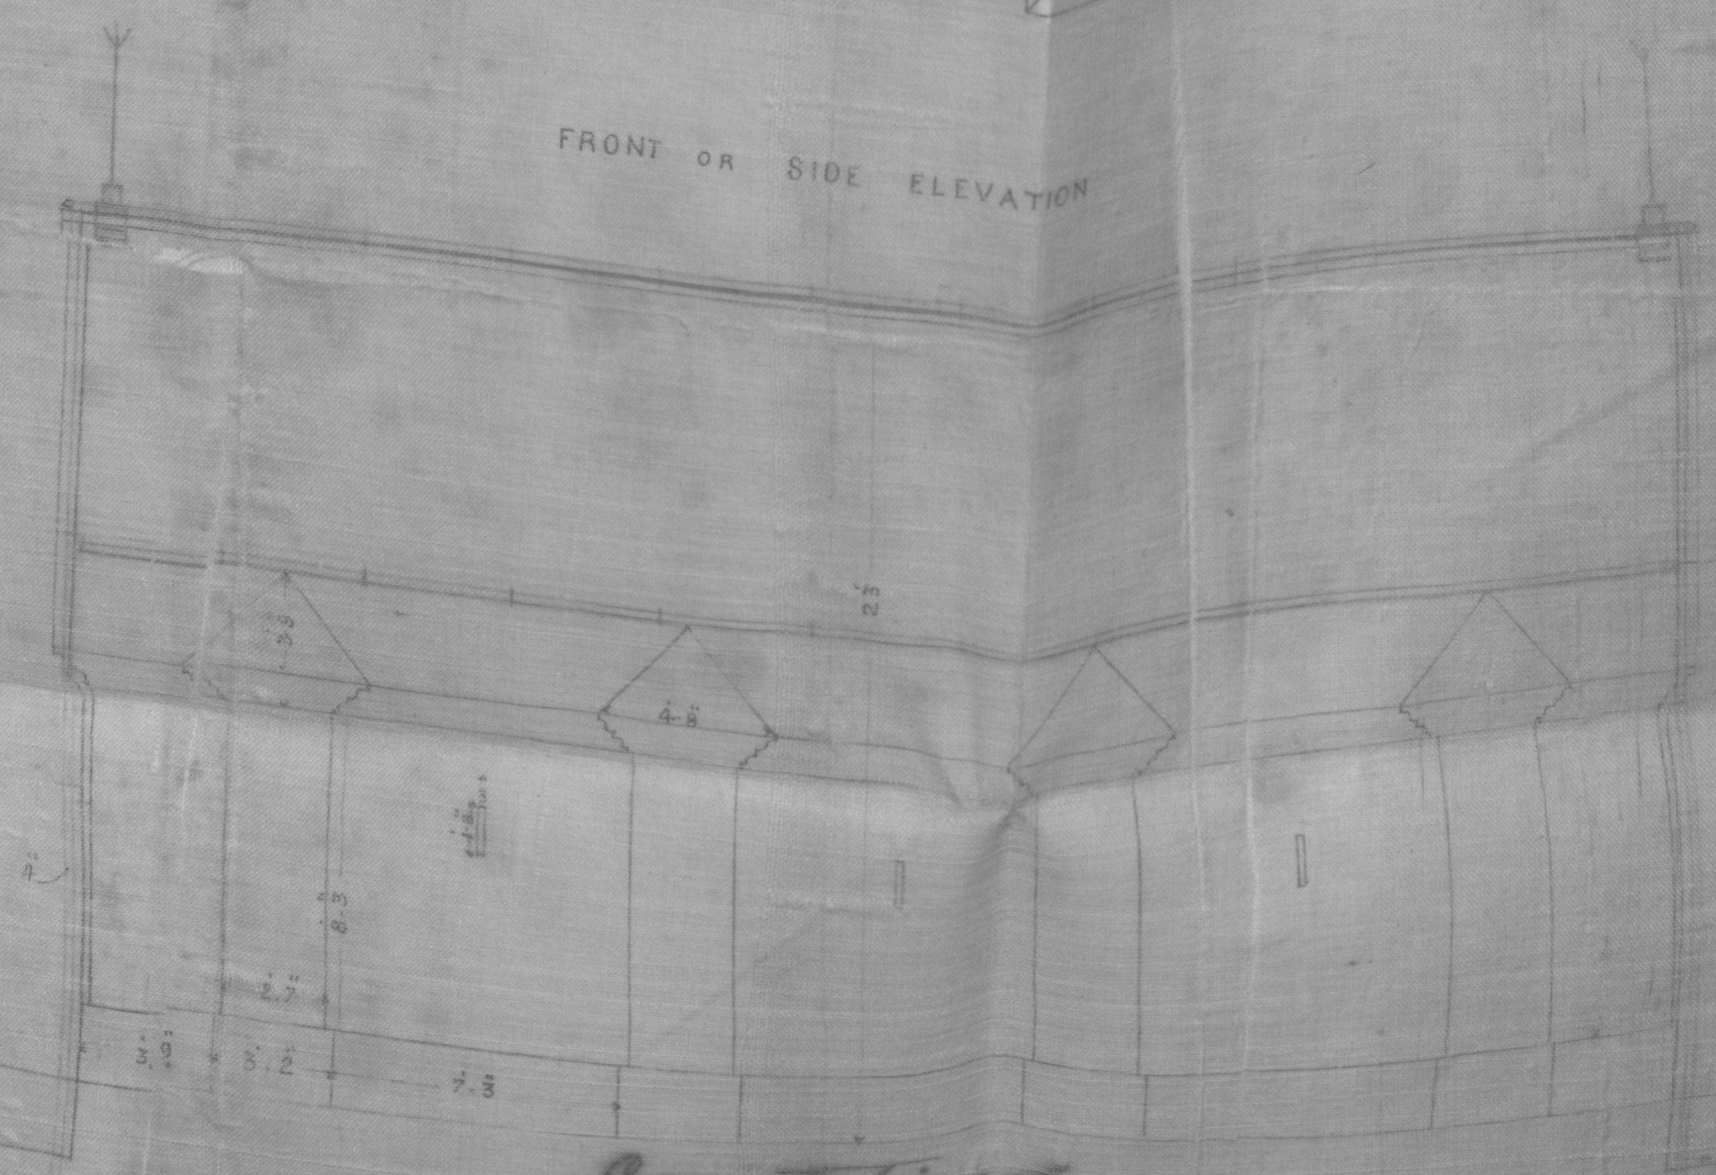
Nº 1  
**MAGAZINE**

| Locality and name of building | When last tested | Description of condition, material, height, shape, position, or any other and number of upper to lower conductors and the nature of earth connection. | Electrical Resistance from top of rod to ground, in ohms. | Remarks including suggestions for improvement if necessary. |
|---|---|---|---|---|
| 1 Battery Ford Magazine No. 1 | | The shape of the roof is that of an ordinary gabled end building, there are two terminal rods at the point of each gable. Copper tape runs along the ridge also along each eave a little way up the roof, the ends of these tapes are connected at the gables by two other tapes, run | <p>9 1/2</p> <p>14 1/2</p> <p>2 1/2</p> | <p>all was under 1000 ohms</p> <p>less than 1000 ohms</p> <p>N.E. corner = good</p> <p>N.E. — d<sub>2</sub> — fair</p> <p>S.E. d<sub>2</sub> good</p> <p>This magazine is used for small arms ammunition and</p> |
| Description | | ing from one to point of gable, under the pole and down to the other corner. At the four corners of the building a copper tape descends into the ground (1 deficient see below) where they are connected and run into 2 pits outside the front of the magazine. One of the four tapes passing from the corner to ground viz that at the N.E. corner is deficient and there are no signs of it at all. | | <p>perhaps requires no conductor.</p> <p>(G. O. K. 845 H dated 14 March 1888 rule III)</p> <p>should it be decided to retain the conductor the deficient tape should be replaced and petty repairs to loose pieces of tape be carried out.</p> |

Although No 1 Magazine is  
only used for small-arm ammu-  
-nition made up in cartridges, it  
is considered it should be provided  
with a lightning rod. The present  
rod is according to latest principle  
but there are many joints in the  
upper tape and they are not well  
soldered and might fail at the  
critical moment and they cannot  
easily be repaired. The earth con-  
-nections are doubtful. It is there-  
-fore considered desirable to replace  
the present lightning rod with an  
entirely new one of continuous copper  
tape and with earth coils bedded in  
a mass of old iron. the old copper  
will doubtless fetch a good price.

The new lightning rod will con-  
-sist of 2 upper terminals 4 high one  
over each gable, form according to

specification, and connected with continuous copper tape which will also pass down the hips and round the eaves and down the opposite angles of the magazine to the ground where it will be led off in trenches one 120 long towards the West end the other 60 long towards the South. At these points pits will be sunk and the tapes will be brought into the end coiled round wooden frames. As the ground is very dry and rocky a mass of old iron will be buried at the foot of the earth coils and coke will be bedded around them as also round the copper tape in the trenches. Copper hold-fasts 4" apart will be fixed along the ridge, hips and eaves of the roof of the magazine and on the walls to keep the lightning rod in place.

2. It does not seem  
necessary to incur the  
expense of providing an  
entirely new arrangement  
of lightning conductors  
for this magazine. The  
Supdy: Engr. should have  
the earth connections  
examined, and the whole  
system then tested.  
It is probable that  
a small sum spent in  
repairs would make  
the existing conductors  
quite efficient.
