தமிழ்நாடு அரசு

அரசாணை எண். 581 W அச்சகம்  
 மு. கோப்புத் தாள் எண். பலவகை

Your No 44 dated January 9<sup>th</sup>  
respecting Bellary Aramal.

Bellary Arsenal Workshops

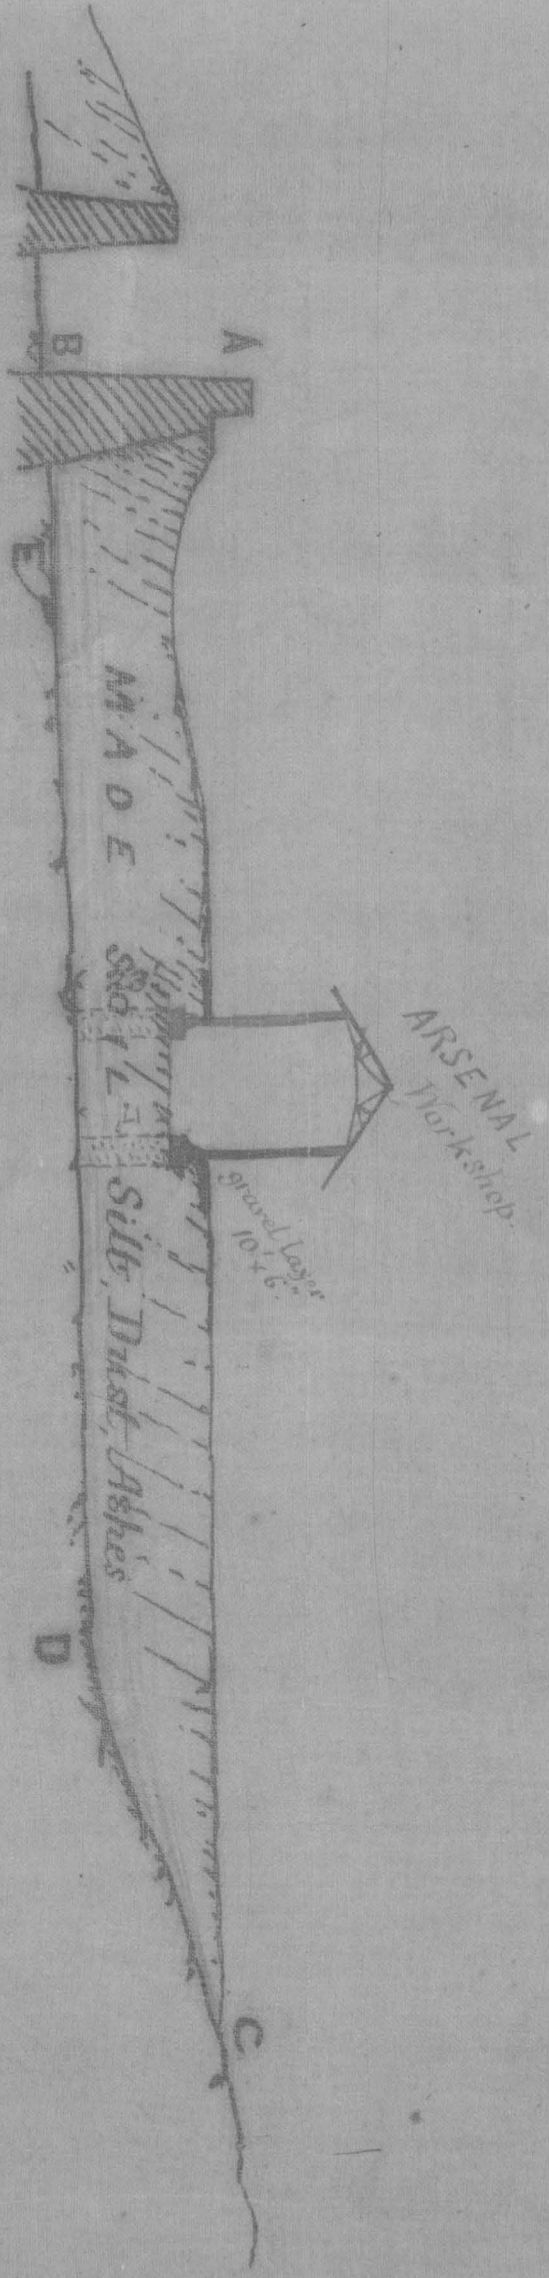
# BELLARY ARSENAL, Presumed Section of Ground

8. I give a presumed section of the ground, but which although only presumed, I do not think can be far from the truth, to illustrate this.

Not merely would there be a percolation through the weak soil but there would

also be a creep of water along C.D.E. the drainage from the high ground beyond, the water entering at the junction of the mass soil with maiden earth, probably rock or gravel and comparatively impervious.

The pressure of this water caused the partial failure of the rampart and the consequent cracking of the mass earth as remarked by Mr. Russell. And this assumption will be borne out if the ground in the pit excavation was found damper as the excavation was carried downwards. How could a gravel platform have prevented or even modified this?

A.B. Rampart, Dry Stone, pointed

45/17  
be carried down to the hard, underpinned in fact, but not necessarily the whole length. I would suggest concrete pillars 6' x 6' x 18' and 10 ft apart centre to centre, the concrete to be made with very fresh lime. Such concrete should be carried out departmentally at 15R per 100 ft. Allowing the length of exterior walls to be 400 ft - this would be  $400 \times 6 \times 6 \times 18 = 25920$  <sup>cu ft</sup> or Rs 3367 for concrete. The excavation for each pillar, might be estimated at Rs 30 so that approximately a sum of Rs 5000 should <sup>then</sup> underpin all the exterior walls, which would be practically supported on concrete piles. That completed, the earth from the interior might be removed and as suggested by the Superintending Engineer, an underground store room might very easily be contrived. Considering how convenient the site is and the time it will take to construct another workshop, I do hope that an attempt will be made to utilize the present building.
