2223  
1  
17TH AUGUST 1891, No. 2223 W., PUBLIC WORKS.

GOVERNMENT OF MADRAS.  
PUBLIC WORKS DEPARTMENT.

Police Station-house at Jagannadharajapuram, Vizagapatam District

Orders regarding the failure of the — built under the supervision of Mr. Sub-Engineer T. T. Raghavachariyar.

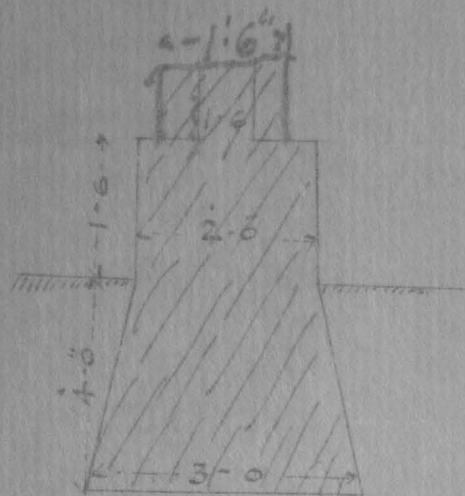
I examined the buildings of the Lunatic Asylum. The walls of almost all of them are cracked, and in several instances very badly so. I attribute this to defective drainage, insufficient width of foundations, and to the fact of the foundations

being built entirely of rough stone in mortar.

2 The buildings are on sidelong ground of a porous sandy description and the variations from wet to dry must be frequent and extreme. The form of foundation for the main walls is given in the sketch. The verandah and other smaller foundations are 2'-9" wide and 3' deep, as the main walls are 16' high and 1'-6" thick of rough stone in Chumam it is evident that these foundations are very small compared with those of the standard police station where the foundations are 4' wide 4' deep, and carry walls 10'-6" high

1'-3" thick and of brick.

3 The foundations too being built entirely of rough stone, probably from the first never had a full bearing on the ground. The rubble work here I have noticed is generally very bad and the interiors of the walls are full of open spaces. Drainage water intercepted by the foundations, and finding its way through any cracks that may have formed would be conducted down to the ground under the foundations and go far to encourage unequal settlement.

4 This cracking of these walls has not ceased but is still in progress

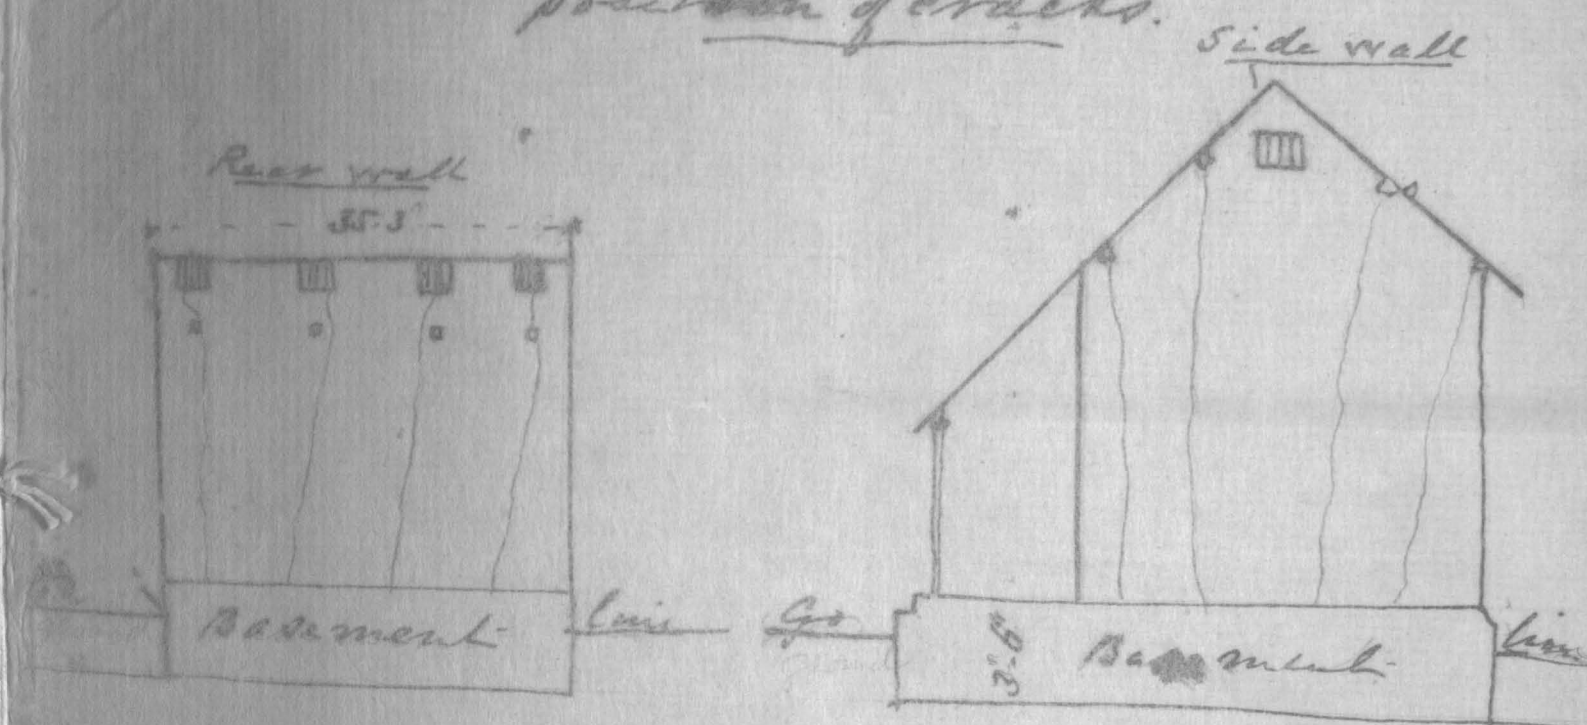
Police Station at Kuaupau  
Rough Elevations showing  
position of cracks.

This is on the same design as above but has four light  
cracks on the rear wall and four more but very slight on  
the south side wall (gabled) as shown in the rough elevation  
annexed.

The cracks on the rear wall are visible both inside and  
outside but are so slight as not to be considered serious.  
On examining the foundations none of the cracks appear  
to have extended below the top of basement which  
together with the foundations consist of rough stone  
in chunam while the superstructure is of Brick in  
Chunam. The walls are plumb, workmanship as  
fair

fair as can be expected in an out of the way agency station and bricks fairly good. The mortar used seems indifferent and to this I attribute the cracks on the rear wall. The reflecting on purlins being nailed on there could not be much lateral thrust and if the mortar used had been made of fresh lime would have set properly and the cracks could not have been formed.

The cracks in the outside wall are not visible inside they start in each case from a purlin and are due to the absence of stones under the purlins to distribute equal pressure also bad mortar.

Besides the above cracks there is one on the crown of the segmental arch of the entrance door and another by its side, but not serious, these are due to the settlement of the arch and must have appeared soon after the completion of the building.

It is reported that all the cracks above described have been in existence there last three years and have not shown any signs of enlargement. I consider them to have properly settled and require but to be raked out and filled in with Chinaman grout.
