24TH OCTOBER 1891, No. 2800 W., PUBLIC WORKS.

### Central Jail at Trichinopoly

Note by the Chief Engineer, Public Works Department, regarding repairs and improvements carried out in the —, recorded.

Central Jail at  
Trichinopoly — Reports  
on the complaints made  
as to the bad workman-  
ship in repair and  
improvements to the —

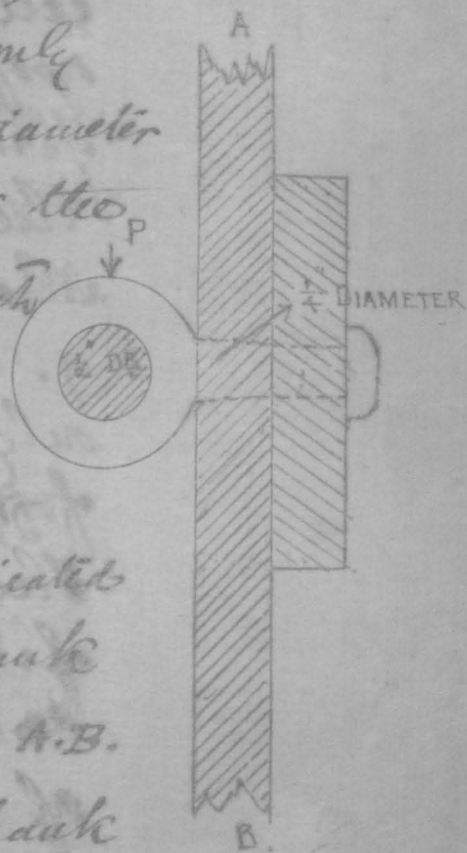
10. Lastly with regards to the iron doors, as regards the locking arrangements, the complaint refers to only seventeen doors. At present the bolt for fastening each of these doors runs through two eyes one on each side of the lock, and then into a hole, protected with an iron plate, in the wooden frame. Each eye has only one shank a quarter of an inch diameter by means of which it is rivetted to the door (really gate) ~~as shown by sketch~~.

What occurred is, that the prisoner put his hand through the bars of door (gate) and hit the eye from above as indicated by the arrow P, and broke the shank at the connection with the plate A.B. A man could not break the shank without using a stone or a hammer, but with a stone or hammer it is very easy to break it. All the doors except the seventeen just referred to, are provided with a "dec" on each side of the lock through which the bolt runs each "dec" being provided

48  
provided with two shanks for rivetting to the bar A.B. already mentioned. each shank being 3/8 inch diameter. These "decs" appear strong enough and the superintendent has informed me that he is satisfied with them.

12. Iron plates as shown in the ac-  
companying plan are now being  
attached to each door to prevent the  
prisoners having free access to the  
locking arrangements, under the  
estimate sanctioned in the G. O.  
under reference, and the fastening  
on the seventeen doors already re-  
ferred to will be made the  
same as in the case of all the  
other doors, and then I do not  
think there will be any ground  
for complaint.

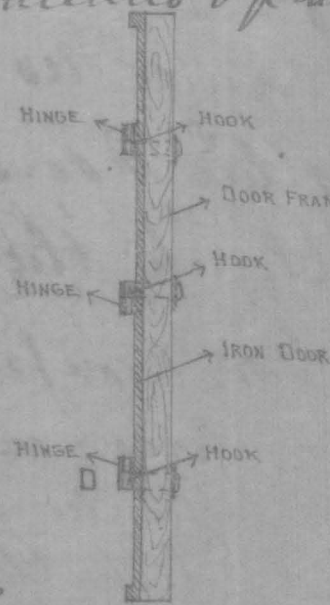
11. Regarding the bending up of the door referred to in G. O. dated 19<sup>th</sup> Aug. No: 1206. Judicial embodied with the G. O. under reference only one door has given way. Each door is attached to the wooden frame by means of three hooks as per sketch supposed to be properly secured at the back. what occurred is this.

The hook at D was not properly made so it was not properly hooked in the frame and when the door was pulled out at the bottom the hook came out which allowed the door to be bent up. The hook should, of course, have been properly secured behind but when a large number of doors are being made and fixed it is difficult to

to prevent workmen not making mis-  
takes or omissions.
