Accidents. Report from the S.E. II Circle  
of two blasting — which occurred on the  
29<sup>th</sup> March and 1<sup>st</sup> April 1897 in the 1<sup>st</sup> mile  
of Illunigera main channel, Kistna  
Northern D<sup>o</sup> recorded.

Report from the Superintending Engineer, II Circle, of two blasting — which occurred on the 29th March and 1st April 1897 in the 1st mile of Muniyeru main channel, Kistna Northern division, recorded.

Irrigation.  
Establishment.

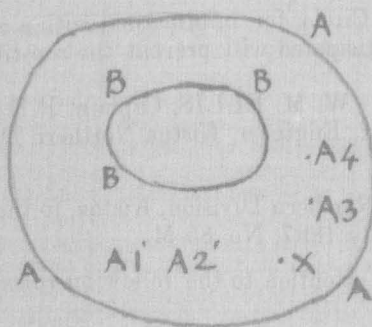
When I saw the place soon after the second accident, the position of the bore-holes were as noted in the sketch at the margin.

The rock within the boundary line BBB was cleared to a depth of 2 feet from top, and that between the lines AAA and BBB to 1 foot deep from top on the 1st instant. Bore-holes were ordered to be made at points A<sub>1</sub>, A<sub>2</sub>, A<sub>3</sub> and A<sub>4</sub> in a ring at about the same distance about 9 inches from the face line BBB. The explosion was from the bore-hole X which was out of the line of A<sub>1</sub>, A<sub>2</sub>, A<sub>3</sub> and A<sub>4</sub>. As no new bore-holes were made outside of the line A<sub>1</sub>, A<sub>2</sub>, A<sub>3</sub> and A<sub>4</sub>, and as all bore-holes made and blasted the previous day should be along the line BBB, it is concluded that the bore-hole

X should have been charged some two months back when bore-holes were made all over the top of the rock and the top layer only blasted. Such old bore-holes are seen now all over the rock. This practice of making bore-holes indiscriminately has been discontinued long ago.

The coolies were ordered to make bore-holes at A<sub>1</sub>, A<sub>2</sub>, A<sub>3</sub> and A<sub>4</sub> and they finished A<sub>1</sub>, A<sub>2</sub> and A<sub>4</sub>; when they laid on only a few strokes pretty hard at A<sub>3</sub> (the man with his jumper sitting over X which was not seen previously); the explosion took place from bore hole X. The man that was sitting over this with a stone for his seat, is the worst injured. He was thrown away from the place to a distance of 15 feet from the spot. The explosion took away a layer of 6 inches at top of the rock and the bore-hole, after this piece was removed, was 9 inches deep.

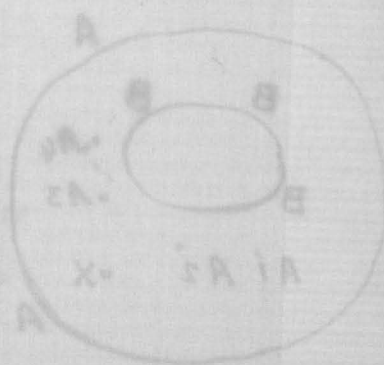
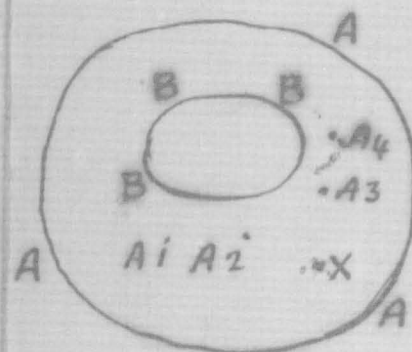
With reference to your Nos  
82 m dated 1-5-97 I have the honour  
88 m dated 4-5-97  
to forward herewith the report of the  
Engineer Student on the two accidents.  
Soon after the accidents took place, I also  
went to the spot and found that the  
first accident took place purely out of  
the carelessness of the coolies in not  
obeying the orders of the maistry.  
When I saw the place soon after the  
second accident, the position of the bore  
holes were as noted in the sketch at the  
margin

The rock within the boundary line  
B. B. B was cleared to a depth of 2 ft  
from top and that between the lines  
A. A. A and B. B. B to 1 ft deep from  
top

top on the 1<sup>st</sup> instant. Bore holes were ordered to be made at points  $A_1, A_2, A_3$  and  $A_4$  in a ring at about the same distance about 9" from the face line B. B. B. The explosion was from the bore-hole  $x$ , which was out of the line of  $A_1, A_2, A_3$  and  $A_4$ .

As no new bore holes were made outside of the line  $A_1, A_2, A_3$  and  $A_4$  and as all boreholes made and blasted the previous day, should be along the line B. B. it is concluded that the bore hole  $x$  should have been charged some 2 months back when boreholes were made all over the top of the rock and the top layer only blasted. Such old bore holes are seen now all over the rock. This practice of making boreholes indiscriminately has been discontinued long ago.

88P  
The coolies were ordered to make bore holes at  $A_1, A_2, A_3$  and  $A_4$  and they finished  $A_1, A_3$  and  $A_4$ ; when they laid on only a few strokes pretty hard at  $A_2$  (the man with his jumper sitting over  $x$  which was not seen previously); the explosion took place from bore hole  $x$ . The man that was sitting over this with a stone for his seat, is the worst injured. He was thrown away from the place to a distance of 15 ft from the spot. The explosion took away a layer of 6" at top of the rock and the bore hole after this piece was removed was 9" deep.
