Tower of the Convent = Library at Madras.  
 Forwarding copy of P.O.: showing the  
 actual condition found to exist during the demo-  
 lition of the tower of the —

I submit, herewith, a report from the Consulting Architect of the actual conditions found to exist during the demolition of the tower of the Connemara Library.

Submitting a full report  
describing the conditions  
found to exist during  
the demolition of the  
tower of the Court  
Library &c  
building

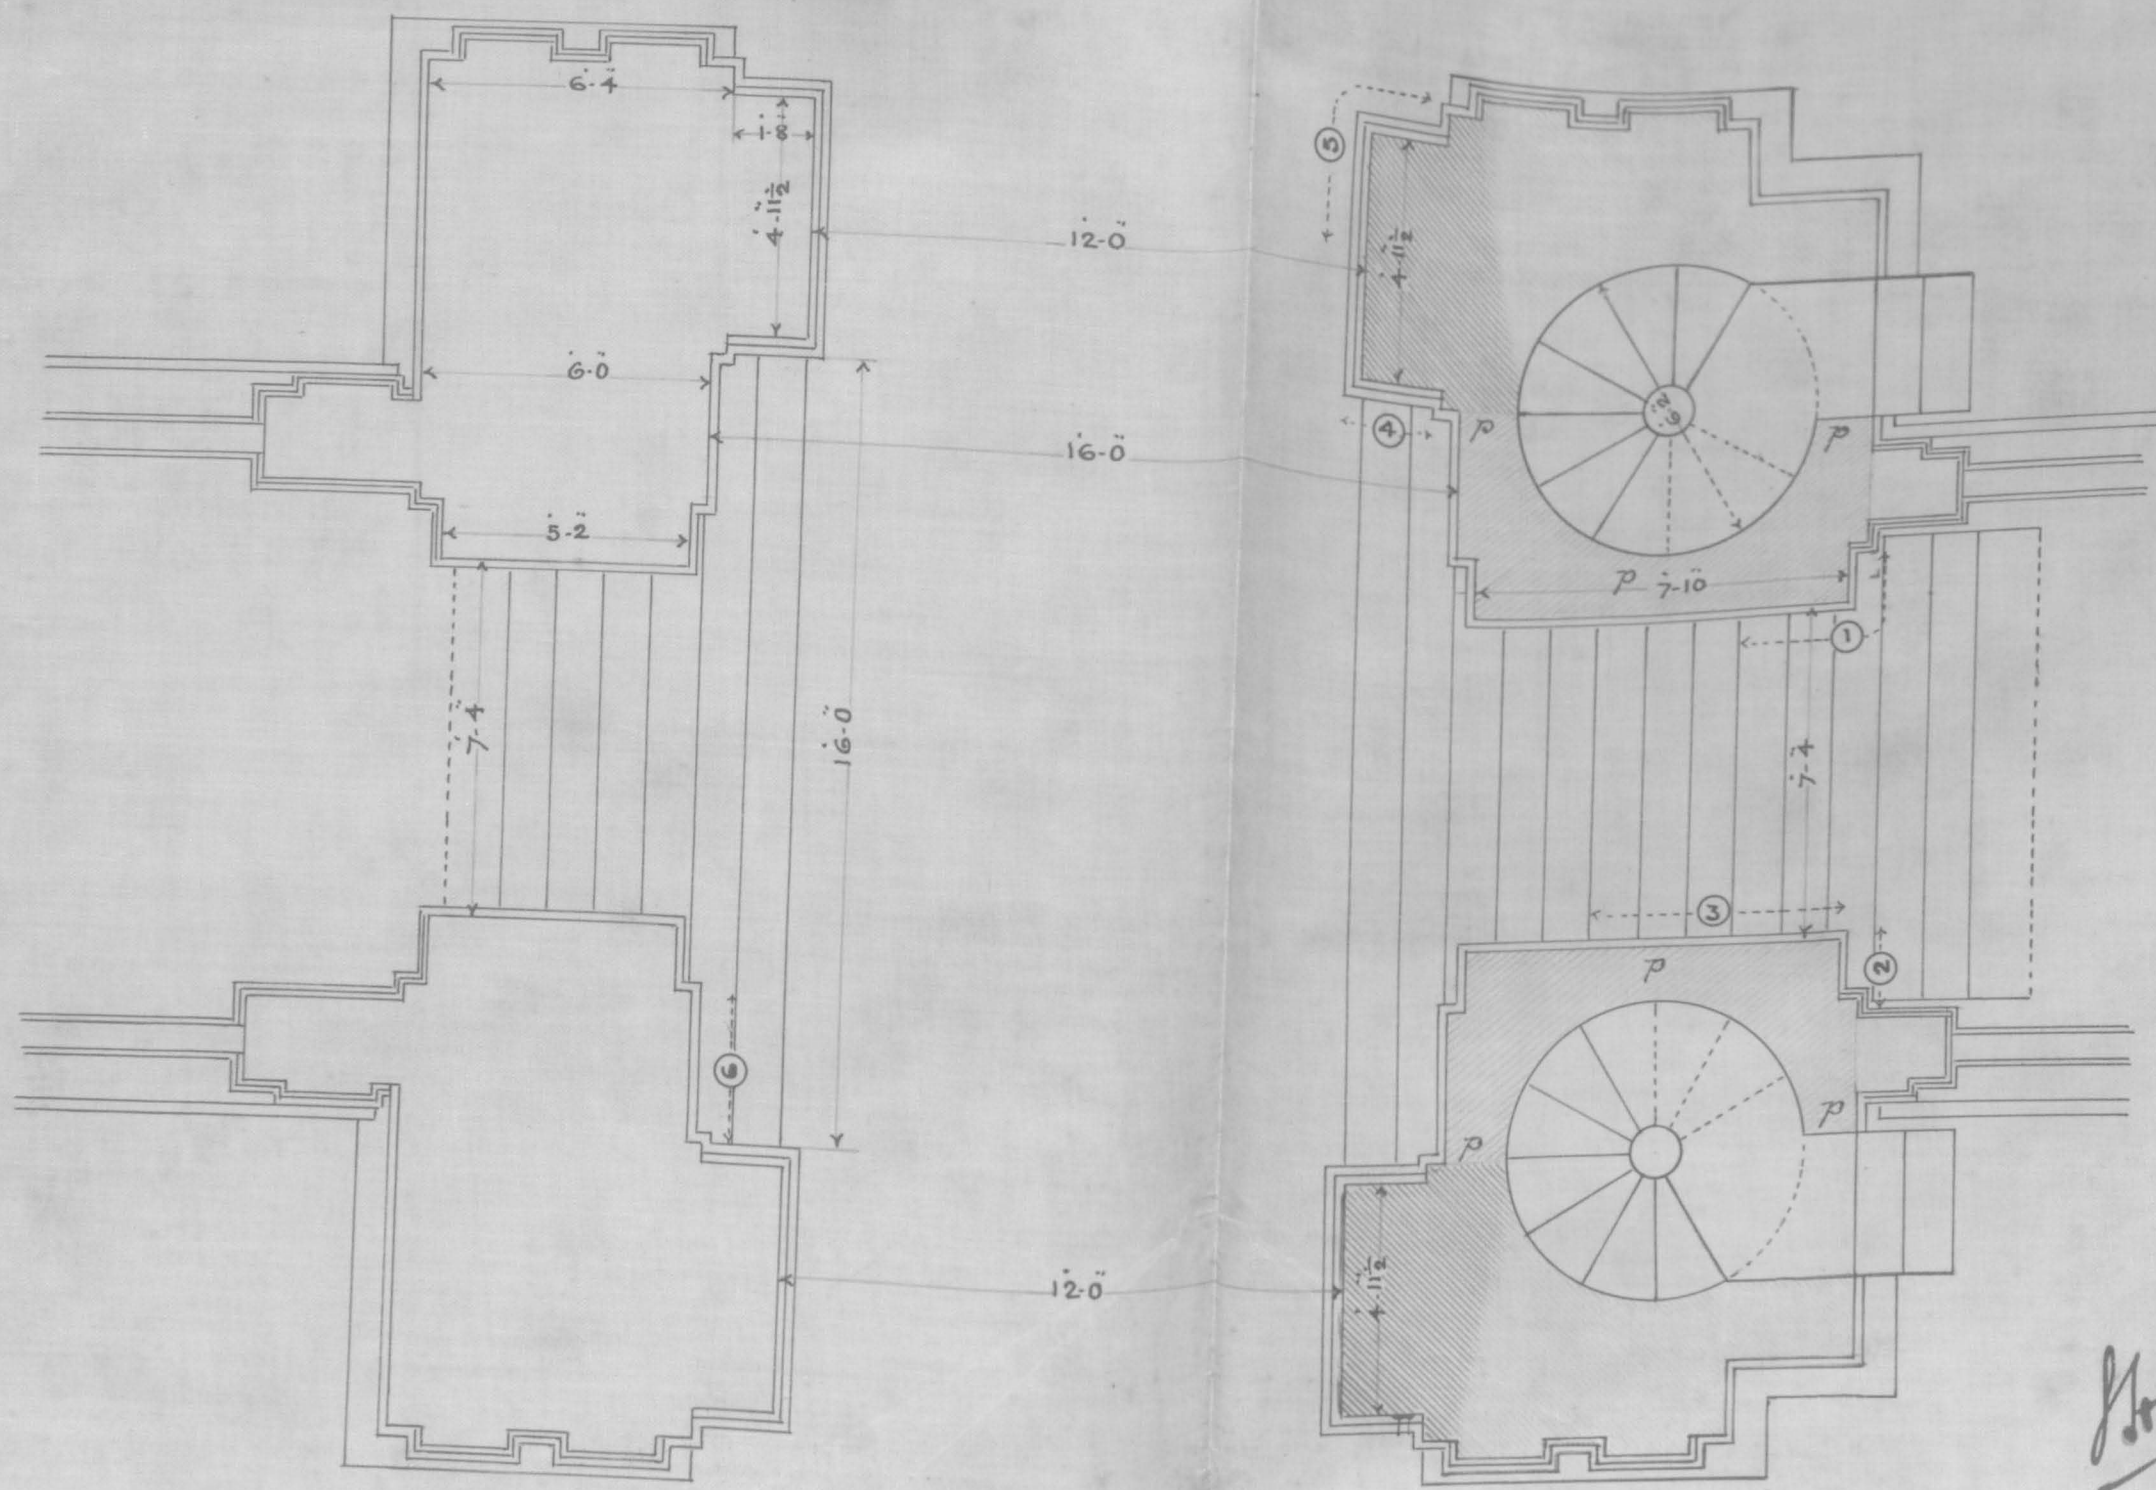
PLAN TO ACCOMPANY CONSULTING ARCHITECT  
 LETTER N<sup>o</sup> DATED APRIL 1898.

3. The brickwork showed, as a matter of course, the greatest signs of failure immediately beneath the porch arches; these arches I had carefully removed and I then examined the brickwork on to which they were turned. The work in that portion hatched in blue\* was shattered, hardly a whole brick was taken out, many were crushed, the mortar was dust, and it was easy to pick the work to pieces by the hand: that portion hatched in red was in a very similar condition, but not quite so bad. Every tread of the staircase was broken.

- (1) Bricks of all sizes and shapes were used.
- (2) Mortar joints were of all thicknesses.
- (3) At the point of greatest pressure, marked blue in plan, nearly every brick was cracked or shattered, and all the mortar was crushed to powder.

2. His Excellency the Governor in Council observes that from the present report it appears that not only were the materials bad but the design also, inasmuch as the section of the staircase piers was entirely inadequate to withstand the heavy pressure to which it was exposed. For passing this faulty design, the superior officers of the department concerned cannot escape responsibility and blame.

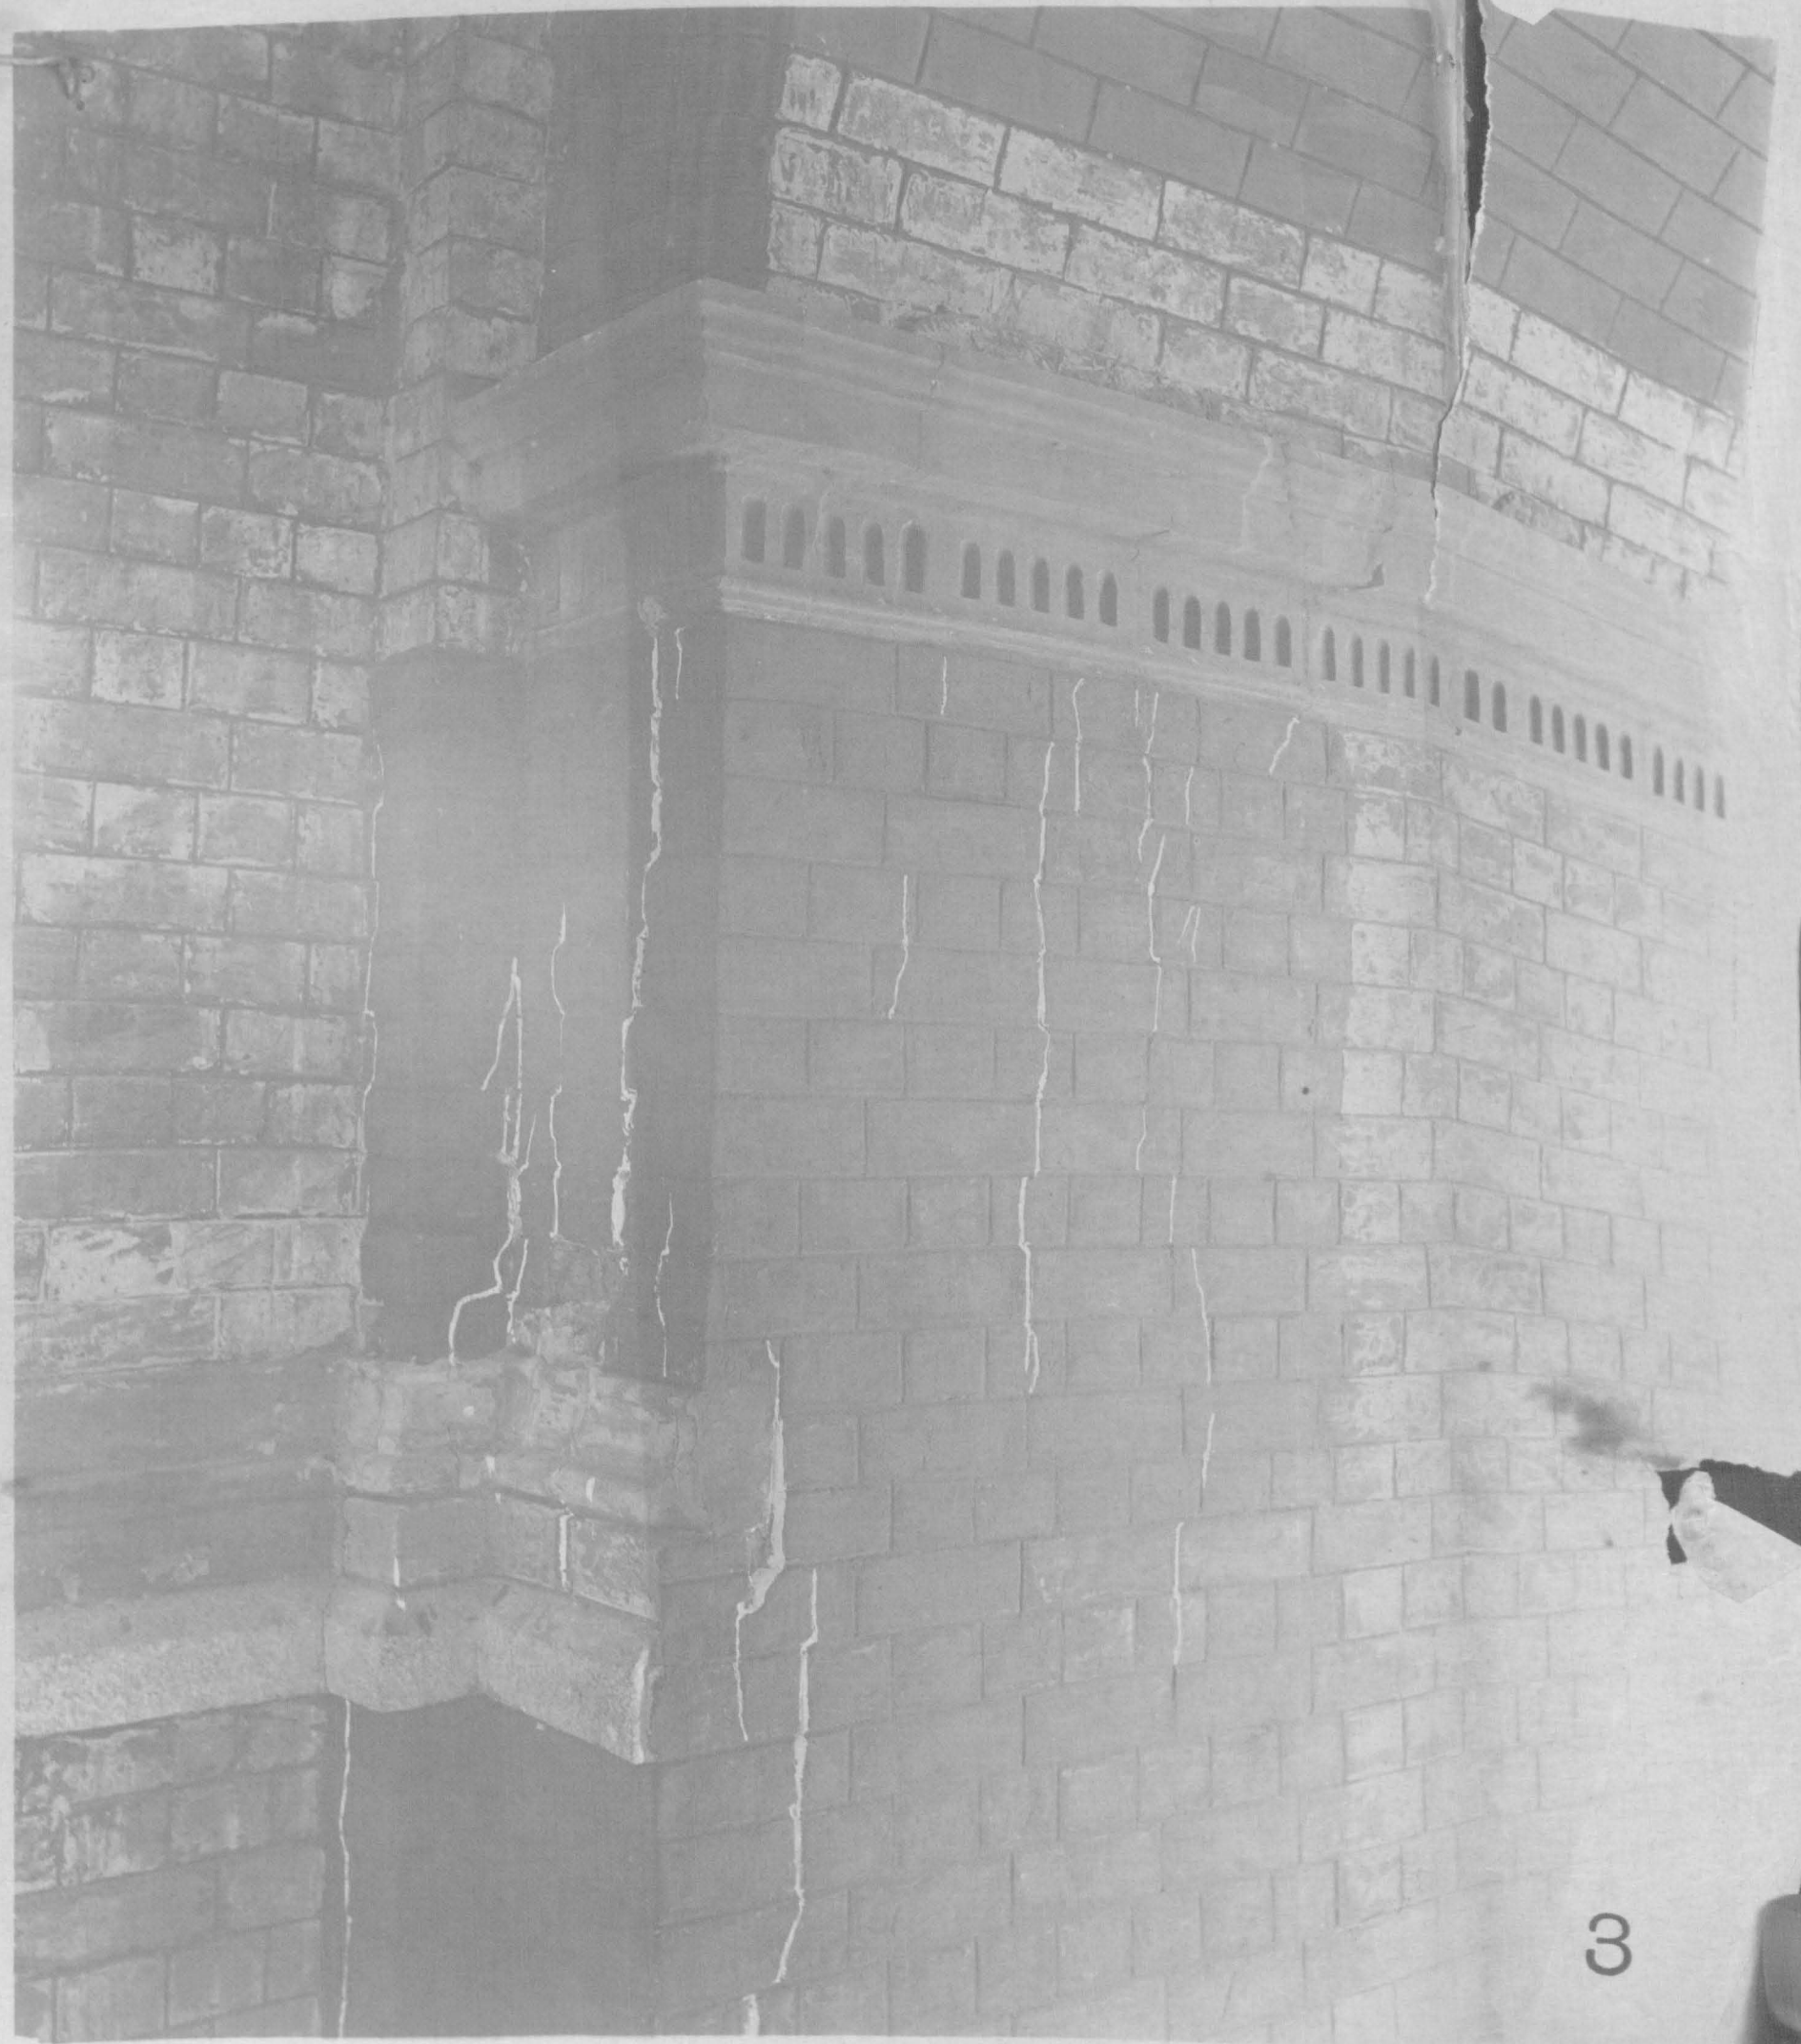
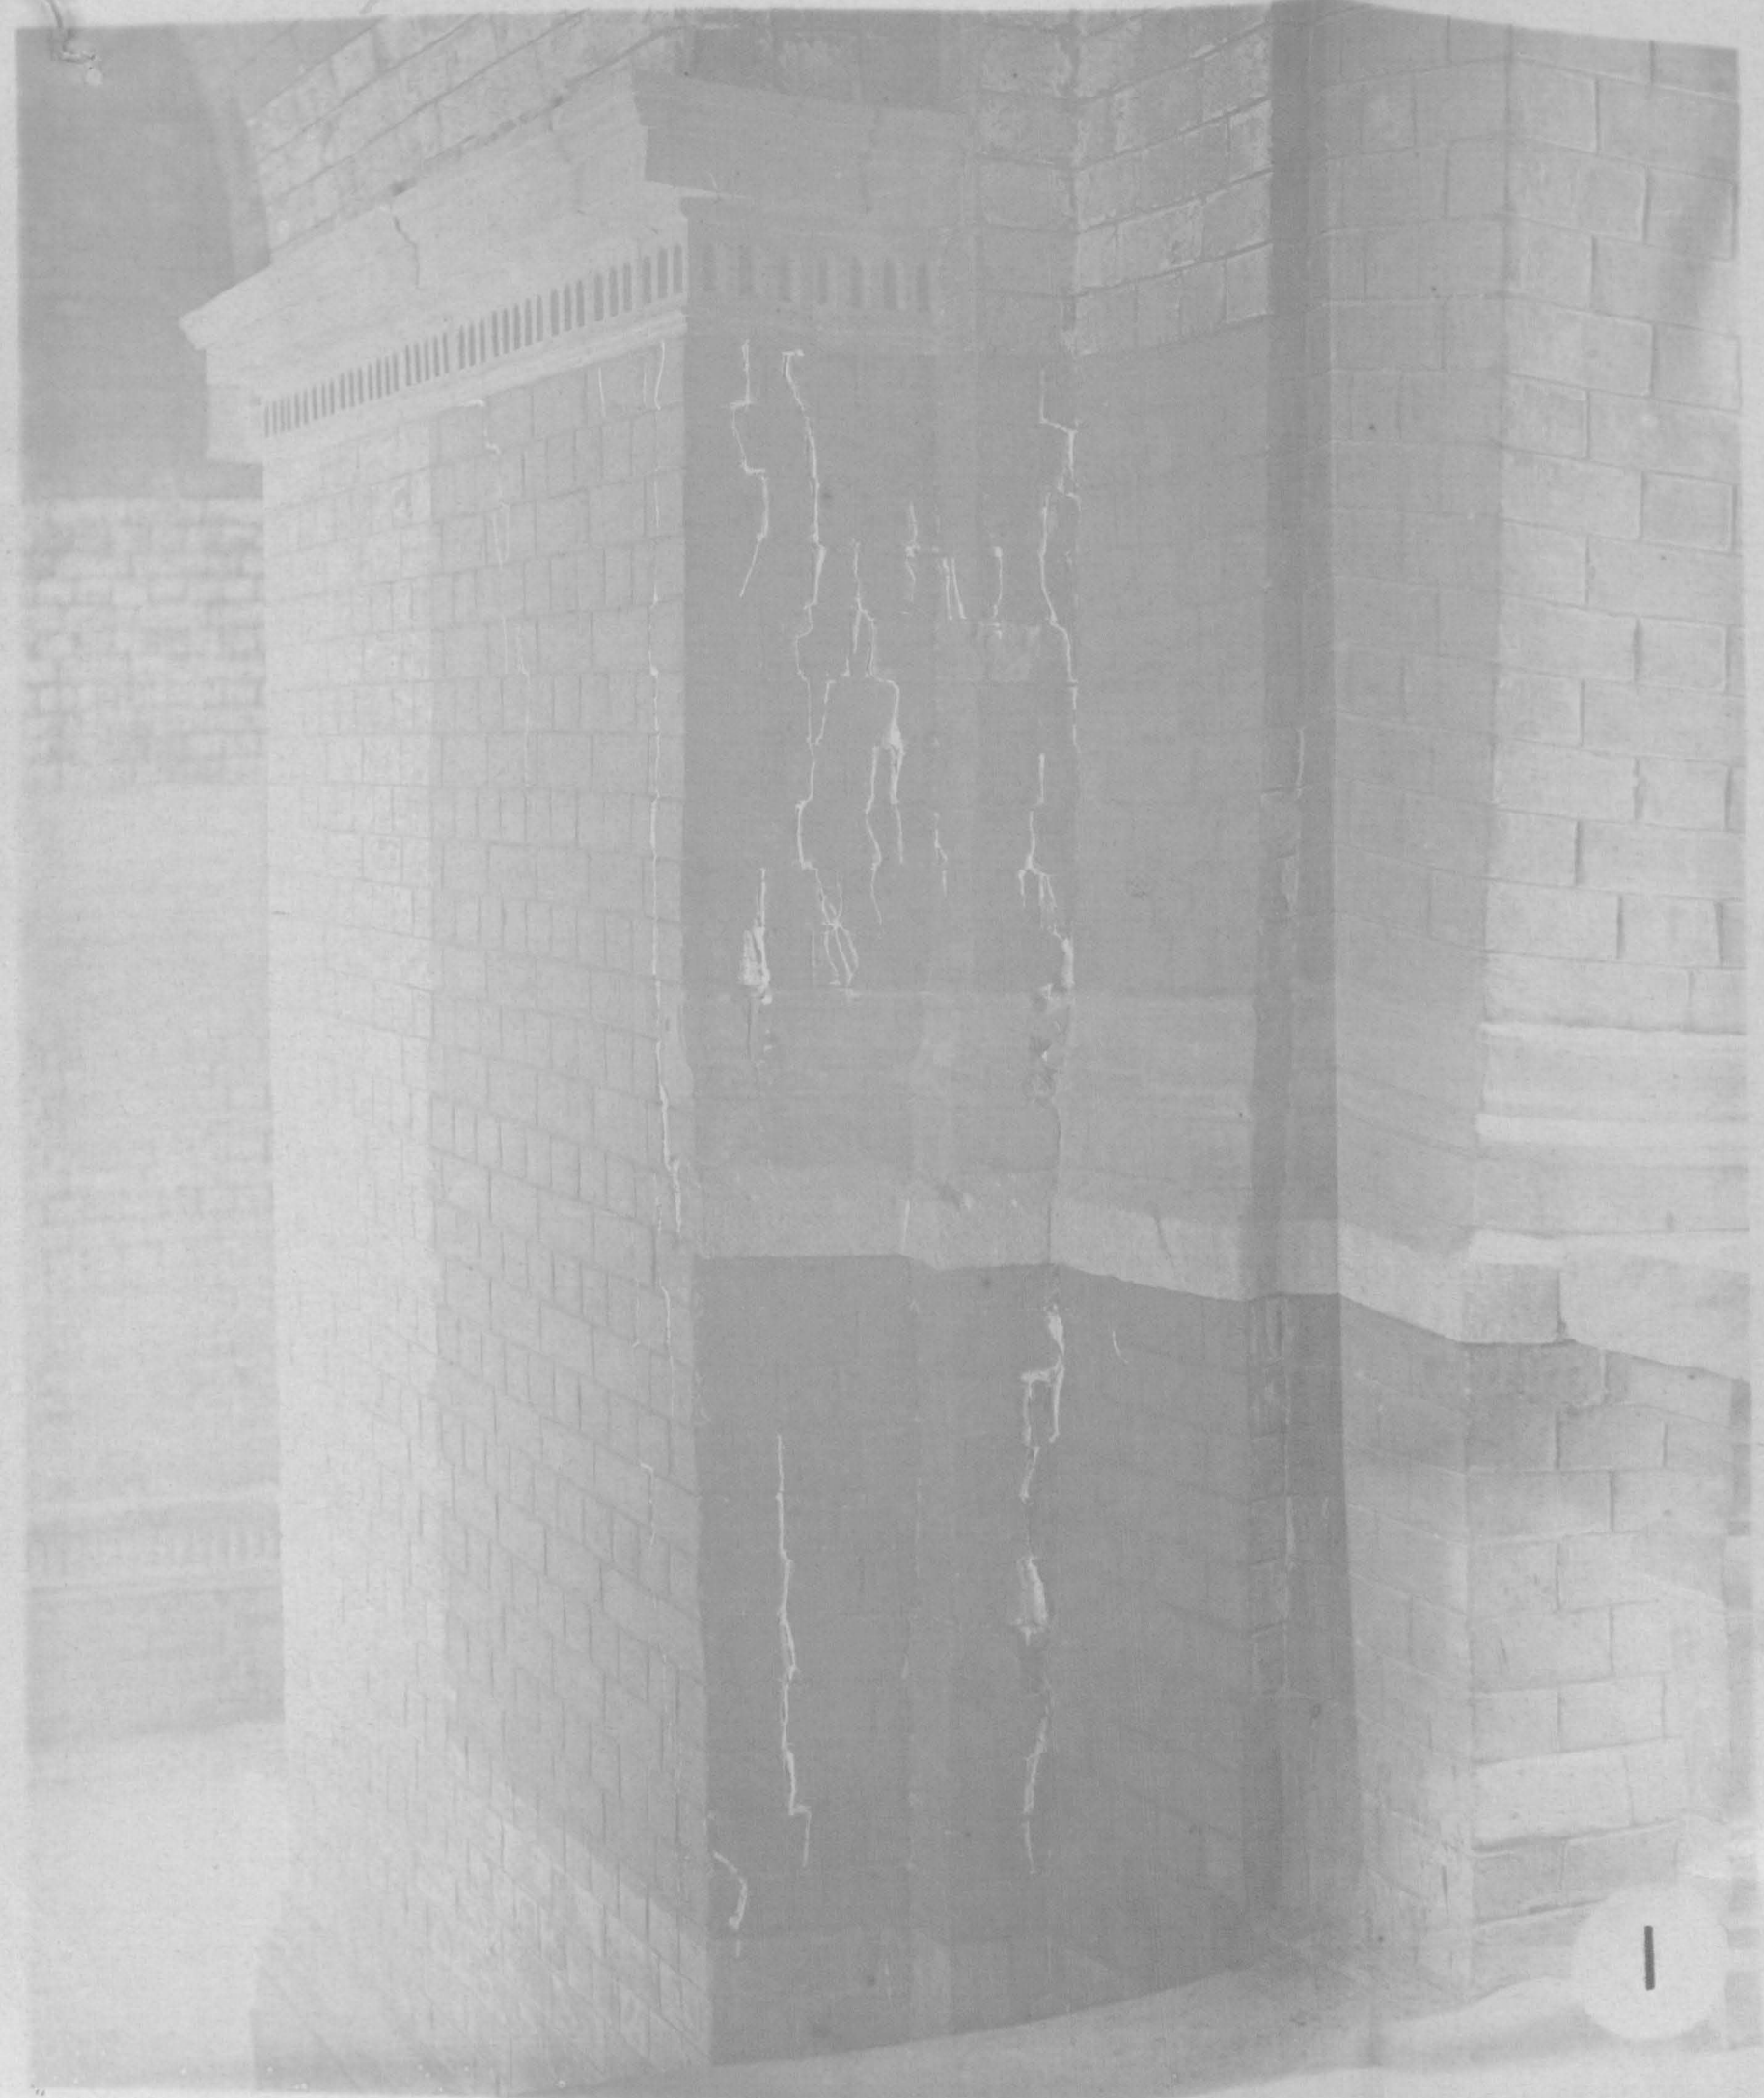
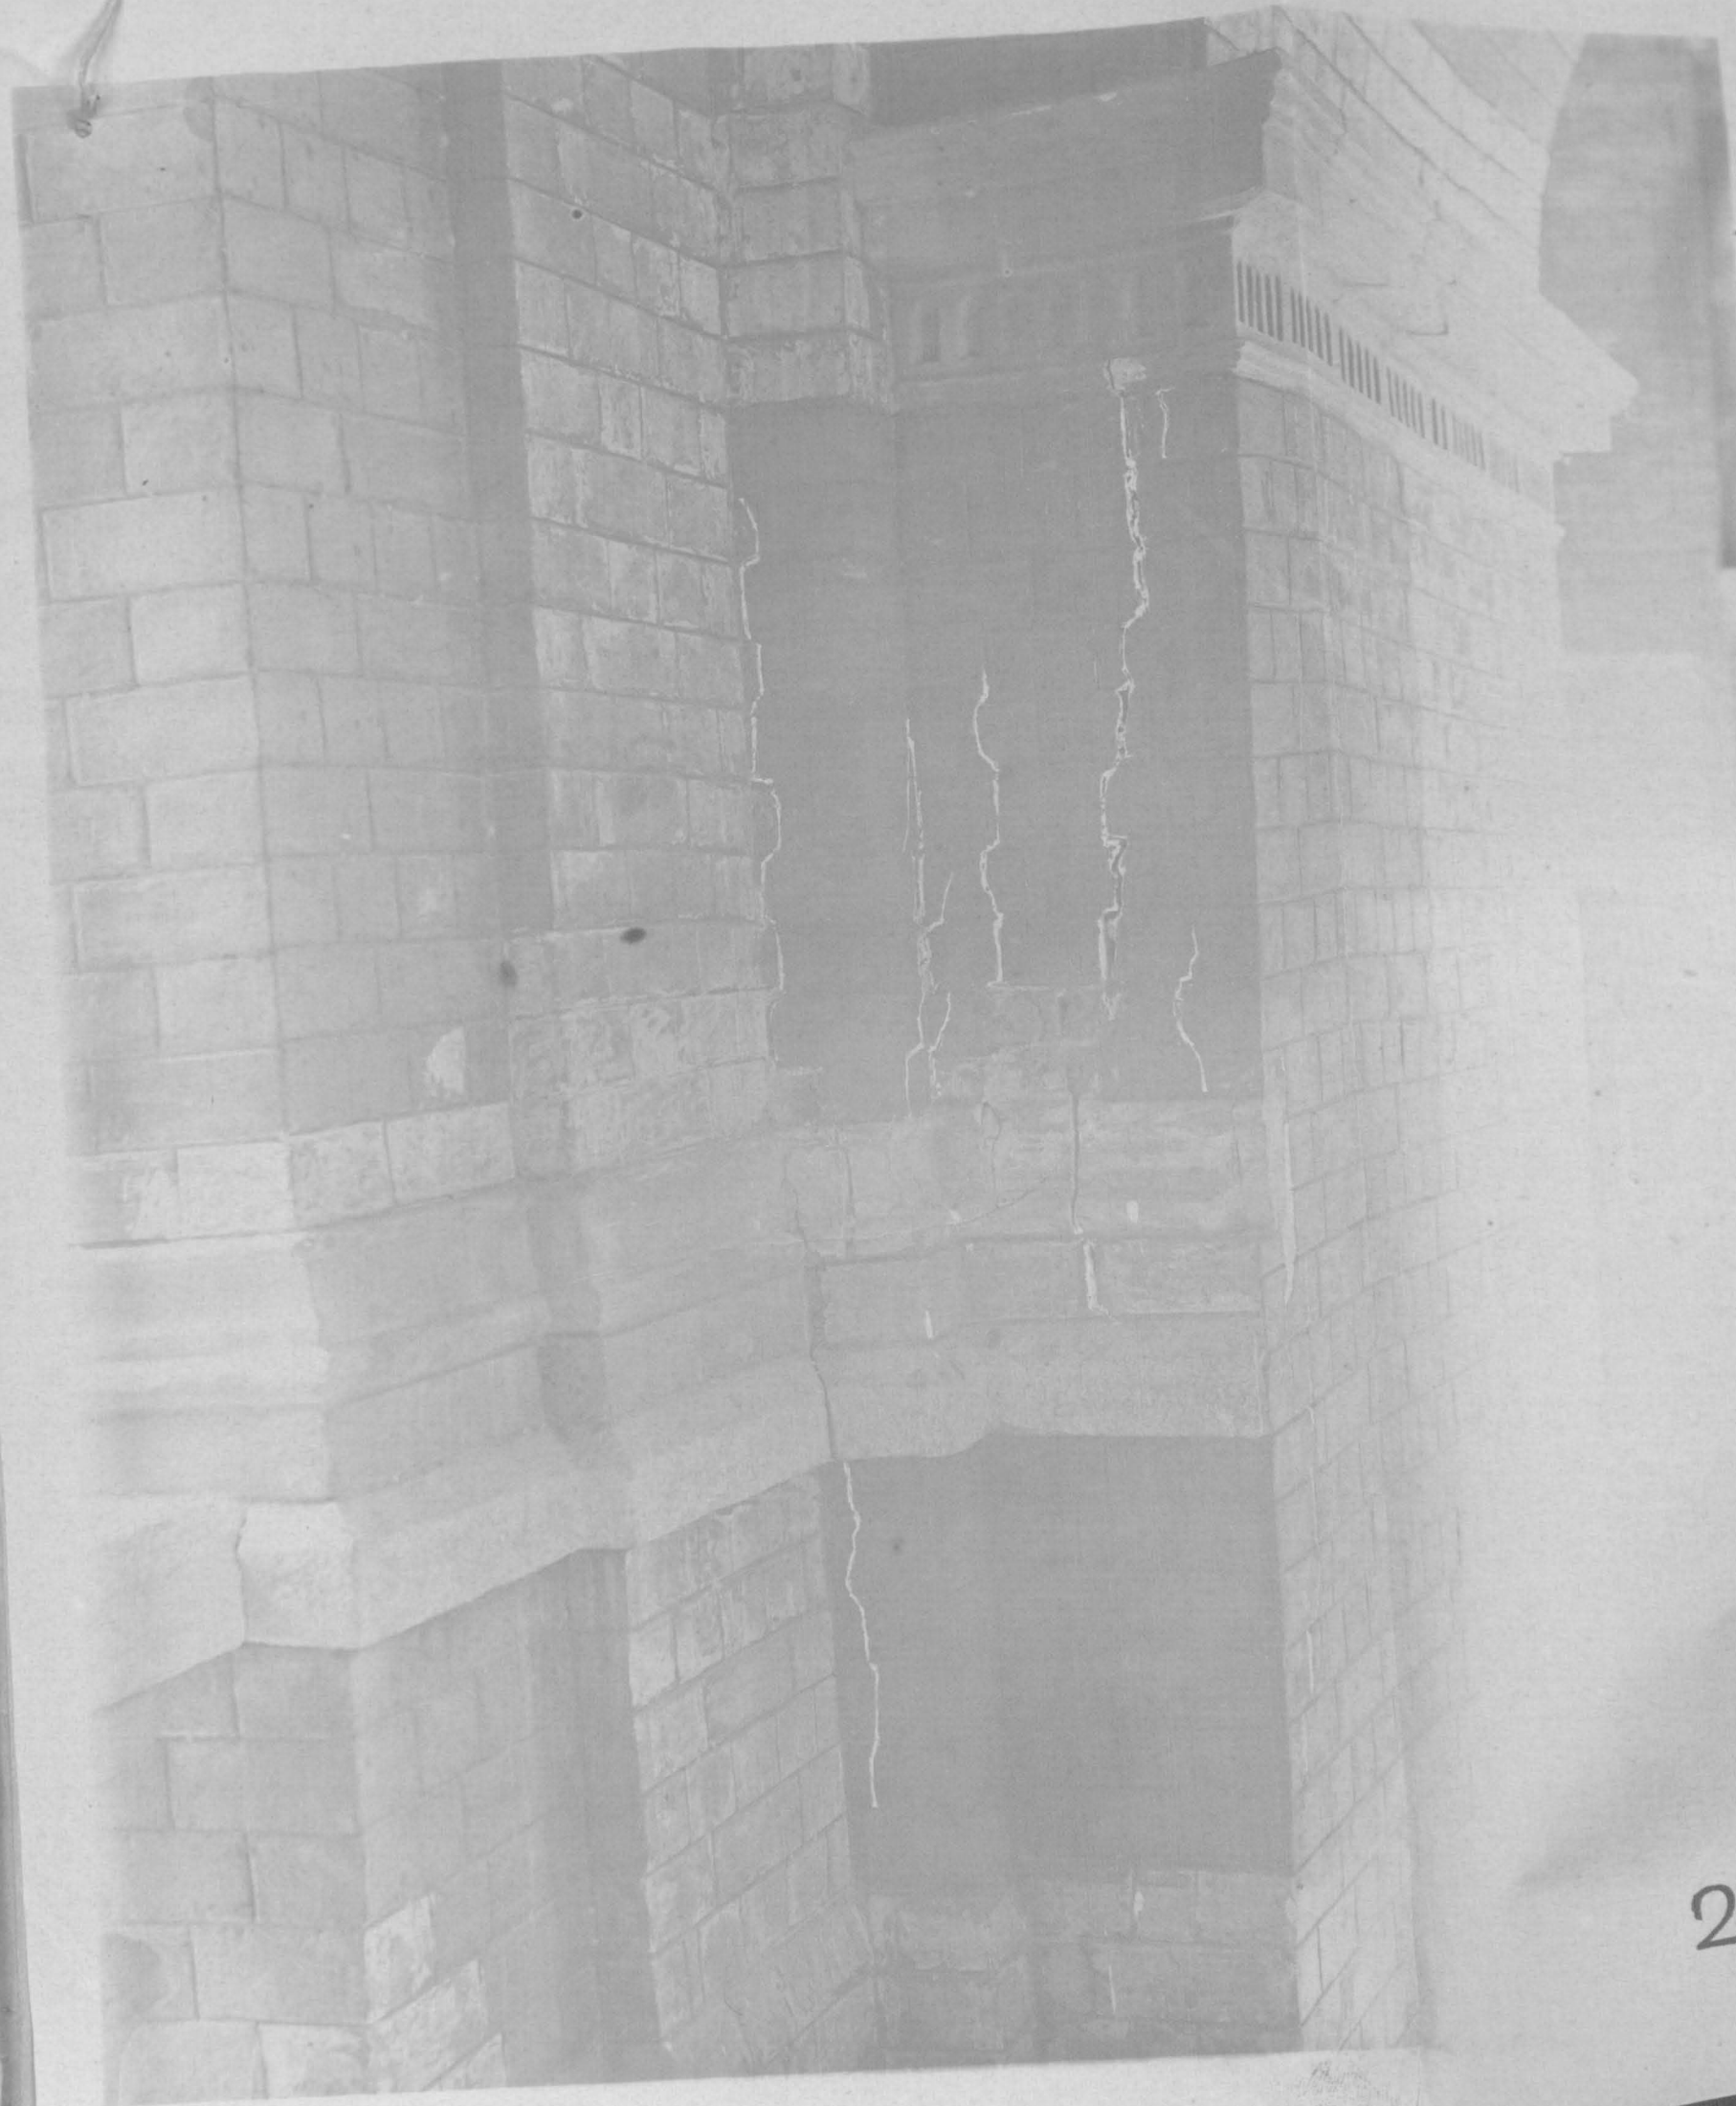
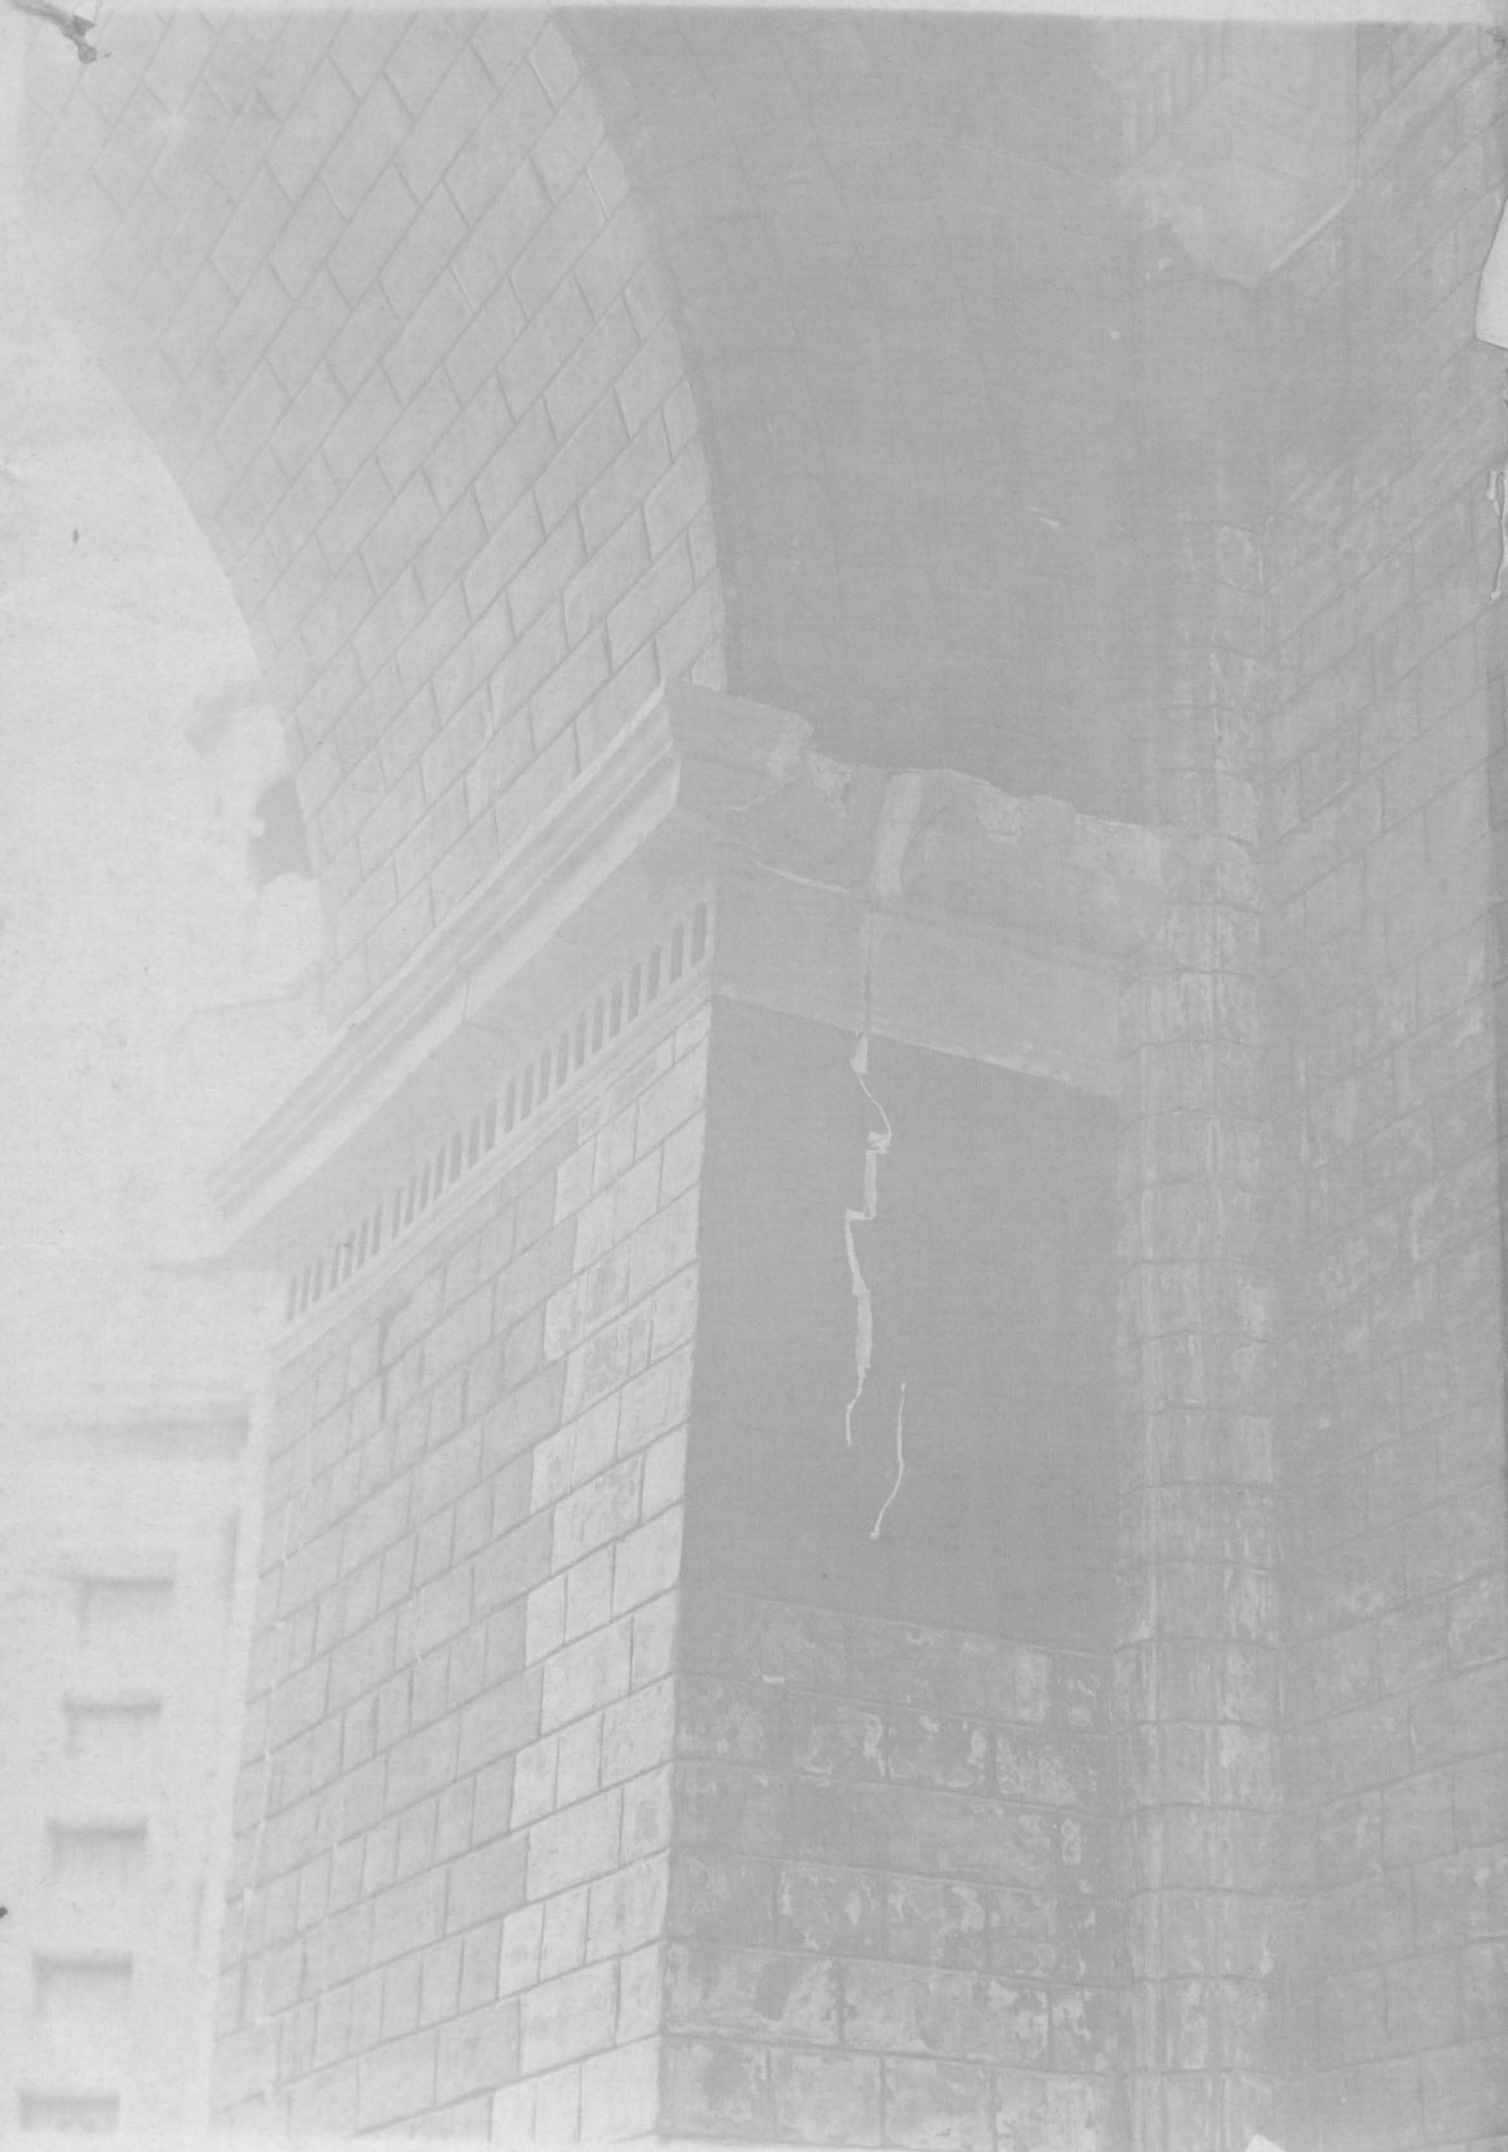
5. Not only was the brickwork in a shattered state in the several layers, but in three places cracks had occurred downwards and through portions of the brickwork under the cornice; this can be seen in photographs Nos. 1, 2, 3 and 4.

5. Not only was the brickwork in a shattered state in the several layers, but in 3 places cracks had occurred downwards and through portions of the brickwork under the cornice, this can be seen in photographs numbers 1. 2. 3. 4.
