Vizalapatam Waterworks: Inspection notes by the  
As. Chief Engineer regarding the records.

Inspection Notes

the Acting Chief Engineer.

22nd February 1898.Vizagapatam Water Works.

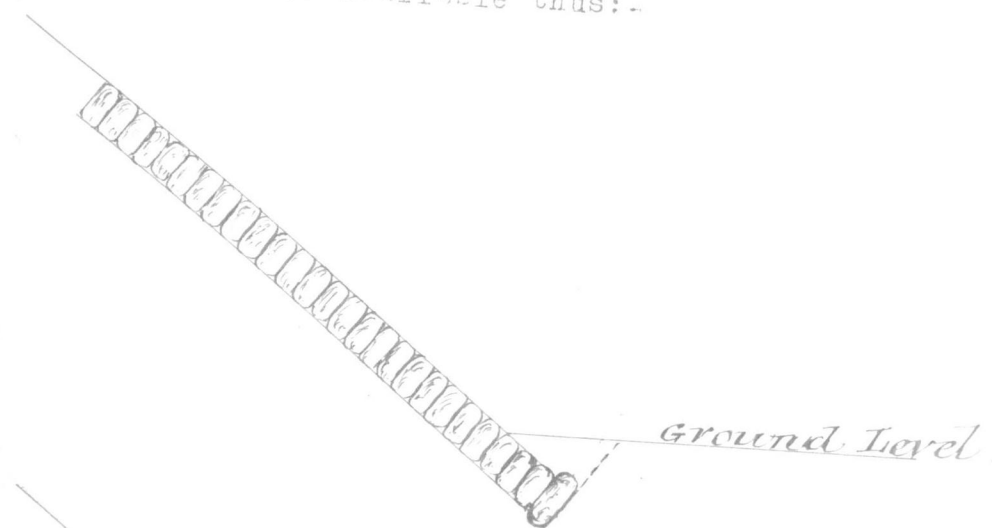
3. Revetment. Stone is under collection for this, and is fairly suitable. The stones should be laid all as headers, i.e. with their greatest length perpendicular to the slope and the toe should

should be also perpendicular to the slope and laid with the largest stones available thus:-

The revetment should be backed with gravel or chips or small broken stone.

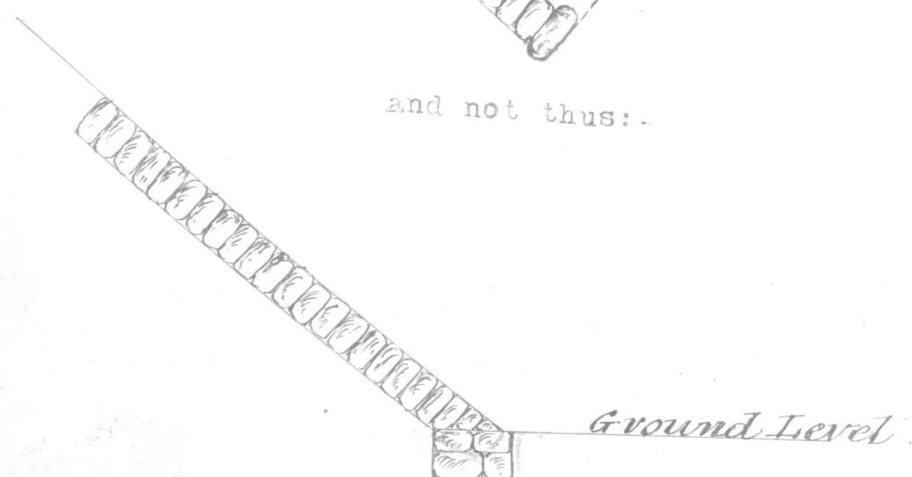
and not thus:-
