Public Works (1890) Department.

# INDIAN RAILWAYS.

ABSTRACT RETURNS OF ACCIDENTS FOR THE QUARTER  
ENDING 30TH SEPTEMBER 1889,

REPORTS OF THE INSPECTING OFFICERS UPON A CERTAIN ACCIDENT WHICH  
WAS INQUIRED INTO.

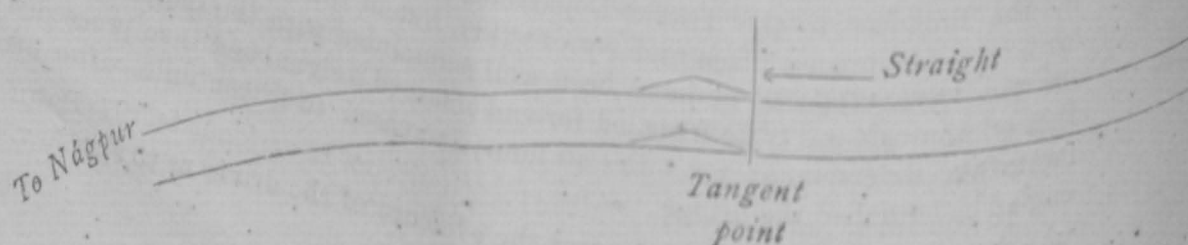
it had been produced by a most apparent "kink" at the tangent point (h) on accompanying diagram.

14. The above sketch in which the red lines indicate the "kink" does not greatly exaggerate what we, or to be more reserved, what I saw. In my own mind there is not the slightest doubt that the one single jolt which we felt occurred at the tangent point.

31. The first sign of a vehicle having got off was discovered by the middle of a rail on the left or outer side of the curve where the gauge was found  $2\frac{1}{2}$ " wide.

From this point backwards the widening of gauge gradually decreased, until at a distance from it of *about* 30 feet (*i.e.*, up to 437 from abutment of bridge, see diagram) the gauge was found correct.

38. There can be no doubt that the immediate cause of the accident was the widening of gauge due to the comparatively weak pine sleepers yielding to the pressure exerted by passing trains against the outer rail of the curve and to the bending of the spikes securing the chairs to them, and probably, but I will not say undoubtedly, to insufficiency of super-elevation of outer rail.
