**Accident at Mallur Bridge, Southern Mahratta Railway**

## DESCRIPTION, SUMMARY OF EVIDENCE AND FINDING OF JOINT ENQUIRY INTO ACCIDENT TO No. 70 DOWN, AT MALLUR BRIDGE, MILE 246/12, MYSORE STATE RAILWAY, ON 23RD SEPTEMBER 1897.

# NOTES MADE AT THE SITE OF THE MALUR BRIDGE ACCIDENT BY THE SENIOR GOVERNMENT INSPECTOR ON THE 27TH OCTOBER 1897.

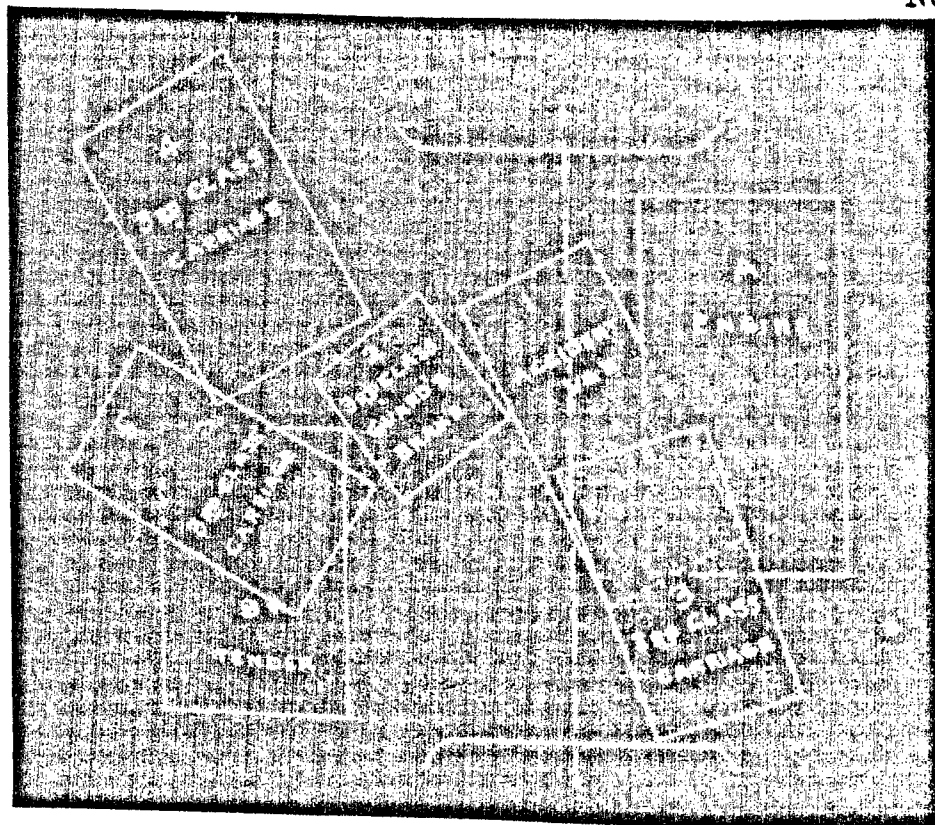
BROKEN PIER.  
No. 5.

The 5th pier, 5 feet wide, has fallen sideways into the span. Half of the 6th, an abutment pier 8 feet wide, has fallen lengthways upstream, indicating the overturning of wells by a scour in the 6th span.

The fall of the 5th and 6th piers brought down the arches of 5th, 6th and 7th spans.

The engine, tender, accident van, third-class brake and three third-class carriages fell into the gap of the 4th span. While the following second-class carriage hung over the side of pier No. 4, the lower end being partly submerged in the water, the succeeding double first-class hung a little over the gap. The roof and portion of one side of one third-class carriage was found on a sandy island covered with brushwood 1/4 of a mile down stream. A rough sketch of the position of the vehicles in the gap is as follows:—

- A. Engine, funnel uppermost and tail down.
- B. Tender, on side.
1. Accident van, submerged.
2. Third-class guard's brake, end on.
3. Third-class carriage, on its side on top of No. 1 and A.
4. " " on its wheels with shutters closed on down stream side.
5. " " wheels uppermost and lying on B.
