*Interlocking Arrangements at  
Peralam Station.*

Interlocking arrangements  
at Peralam station

Report of Inspection of the South Indian Railway System

## INSPECTION REPORT FOR THE HALF-YEAR ENDED 30TH JUNE 1898.

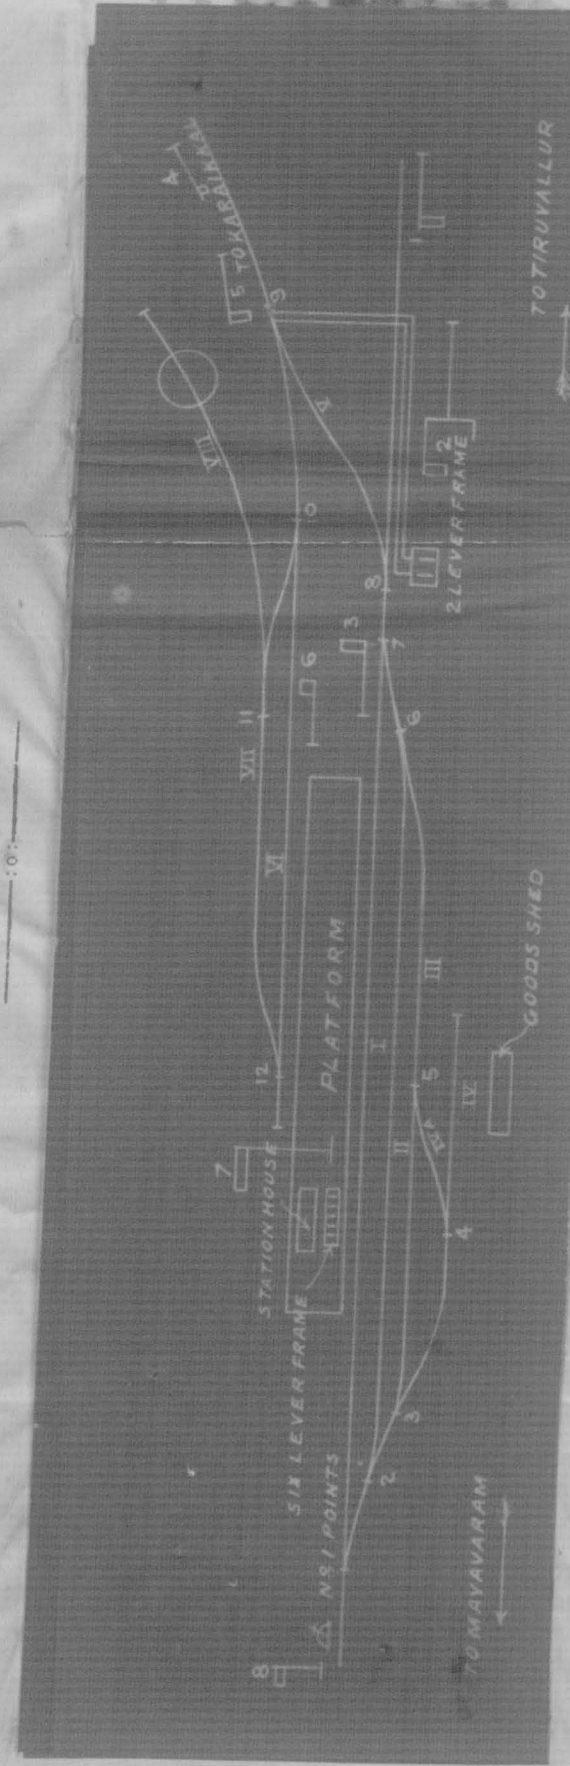
1. Above is a sketch of the Peralam station and when reporting accidents &c, the lines, points, signals and sidings as herein shewn must be quoted.

5. Cross over road No. V can only be worked by the levers at No. 7 Points. When it is required to use the Cross over, the key, which must invariably be kept on the six lever frame at the station, must be inserted in the lock on the lever frame of Points No. 7, 8.

When this Cross over road is used, all the signals 1 to 6, both inclusive, are locked at danger and hand signals must be used for engines or trains requiring to pass over it.

The points for the Cross over road are interlocked with the signals, but all other points are independent of them.
