GOVERNMENT OF MADRAS.

PUBLIC WORKS DEPARTMENT.

22nd September 1877, No. 766 W.

Veyarpanay Tank, Presidency Dis-  
trict.—The explanation of the District  
Engineer regarding the breach of —  
communicated with remarks to the Re-  
venue Department.

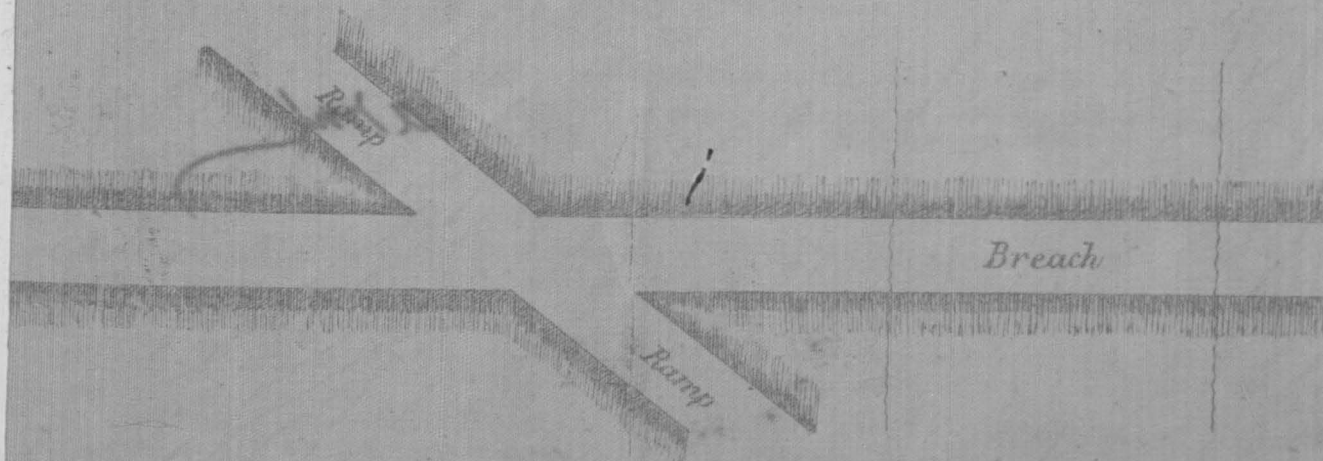
Reply to question c.—The breach occurred just on the west side of the ramp that is used for allowing cattle to pass over the bund; please see rough sketch.

The bund on each side of breach and top of ramp is in good order, and there is nothing to show that the bund at the breach had been worn down by being used as a pathway.

1st.—The faulty construction of the tank bund; there is little or no foundation to the revetment, no puddle wall in rear of the revetment, the revetment is built nearly perpendicular instead of having a slope of  $1\frac{1}{2}$  or  $1\frac{1}{2}$  to 1. The sectional area of the bund is very inadequate considering the bad nature of the soil it is made with; the soil is of a salty and spongy nature. Cross section of breach forwarded.

2nd.—I beg to point out that I consider the ramp on the inner side of the bund was one of the chief causes of tank breaching in that particular place, as the ramp acted as a groyne during the time the high westerly winds prevailed.

The breach must be repaired and the bund brought up to its original section. Two feet thickness of clay puddling should be put in behind the revetment.—R. T.  
28th May 1877.
