Public Works (1896) Department.

G.O., Nos. 1049, 1050 I., 12th December 1896.

Floods in the Trichinopoly District

Forwarding Proceedings communicating, with remarks, to officers concerned note by the Chief Engineer for Irrigation reviewing the reports on the Cauvery and Coleroon — at the end of July and beginning of August last.

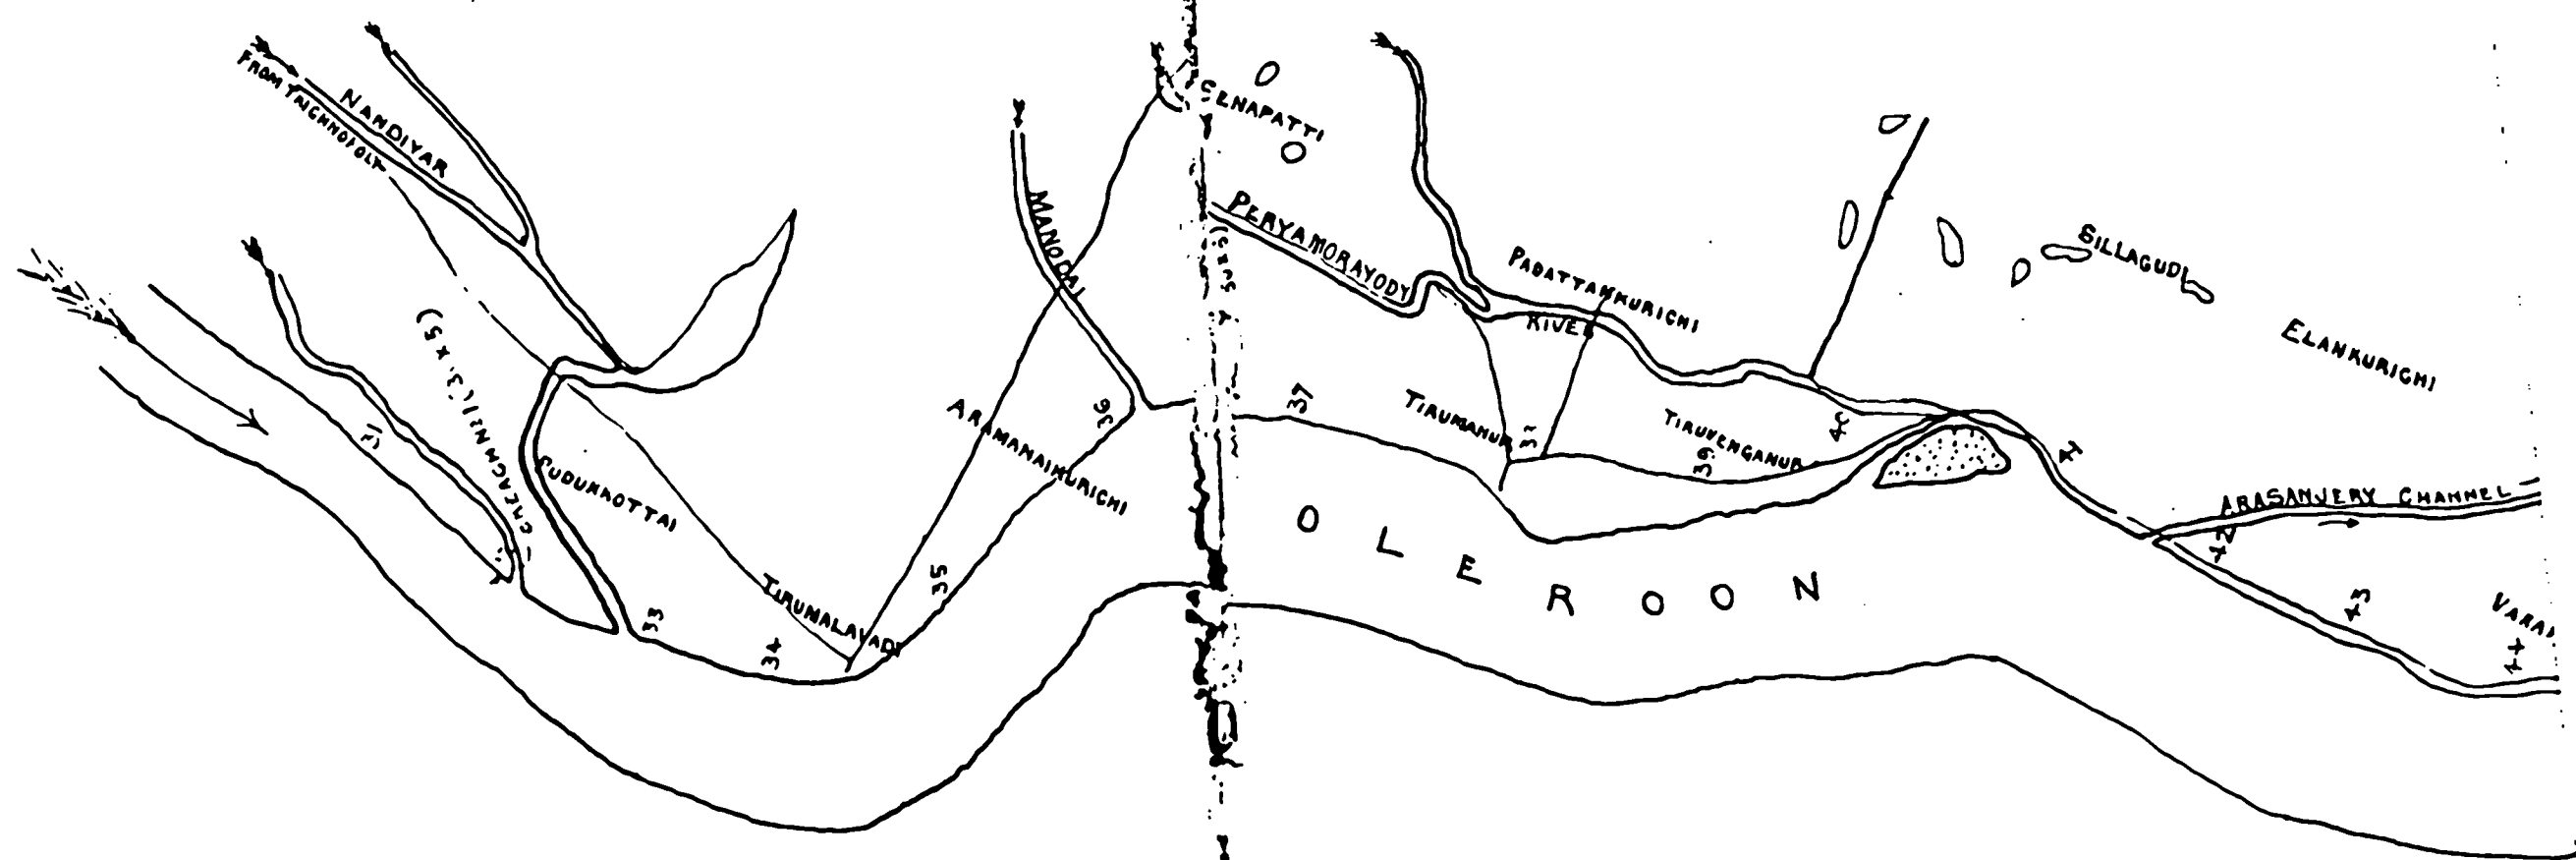
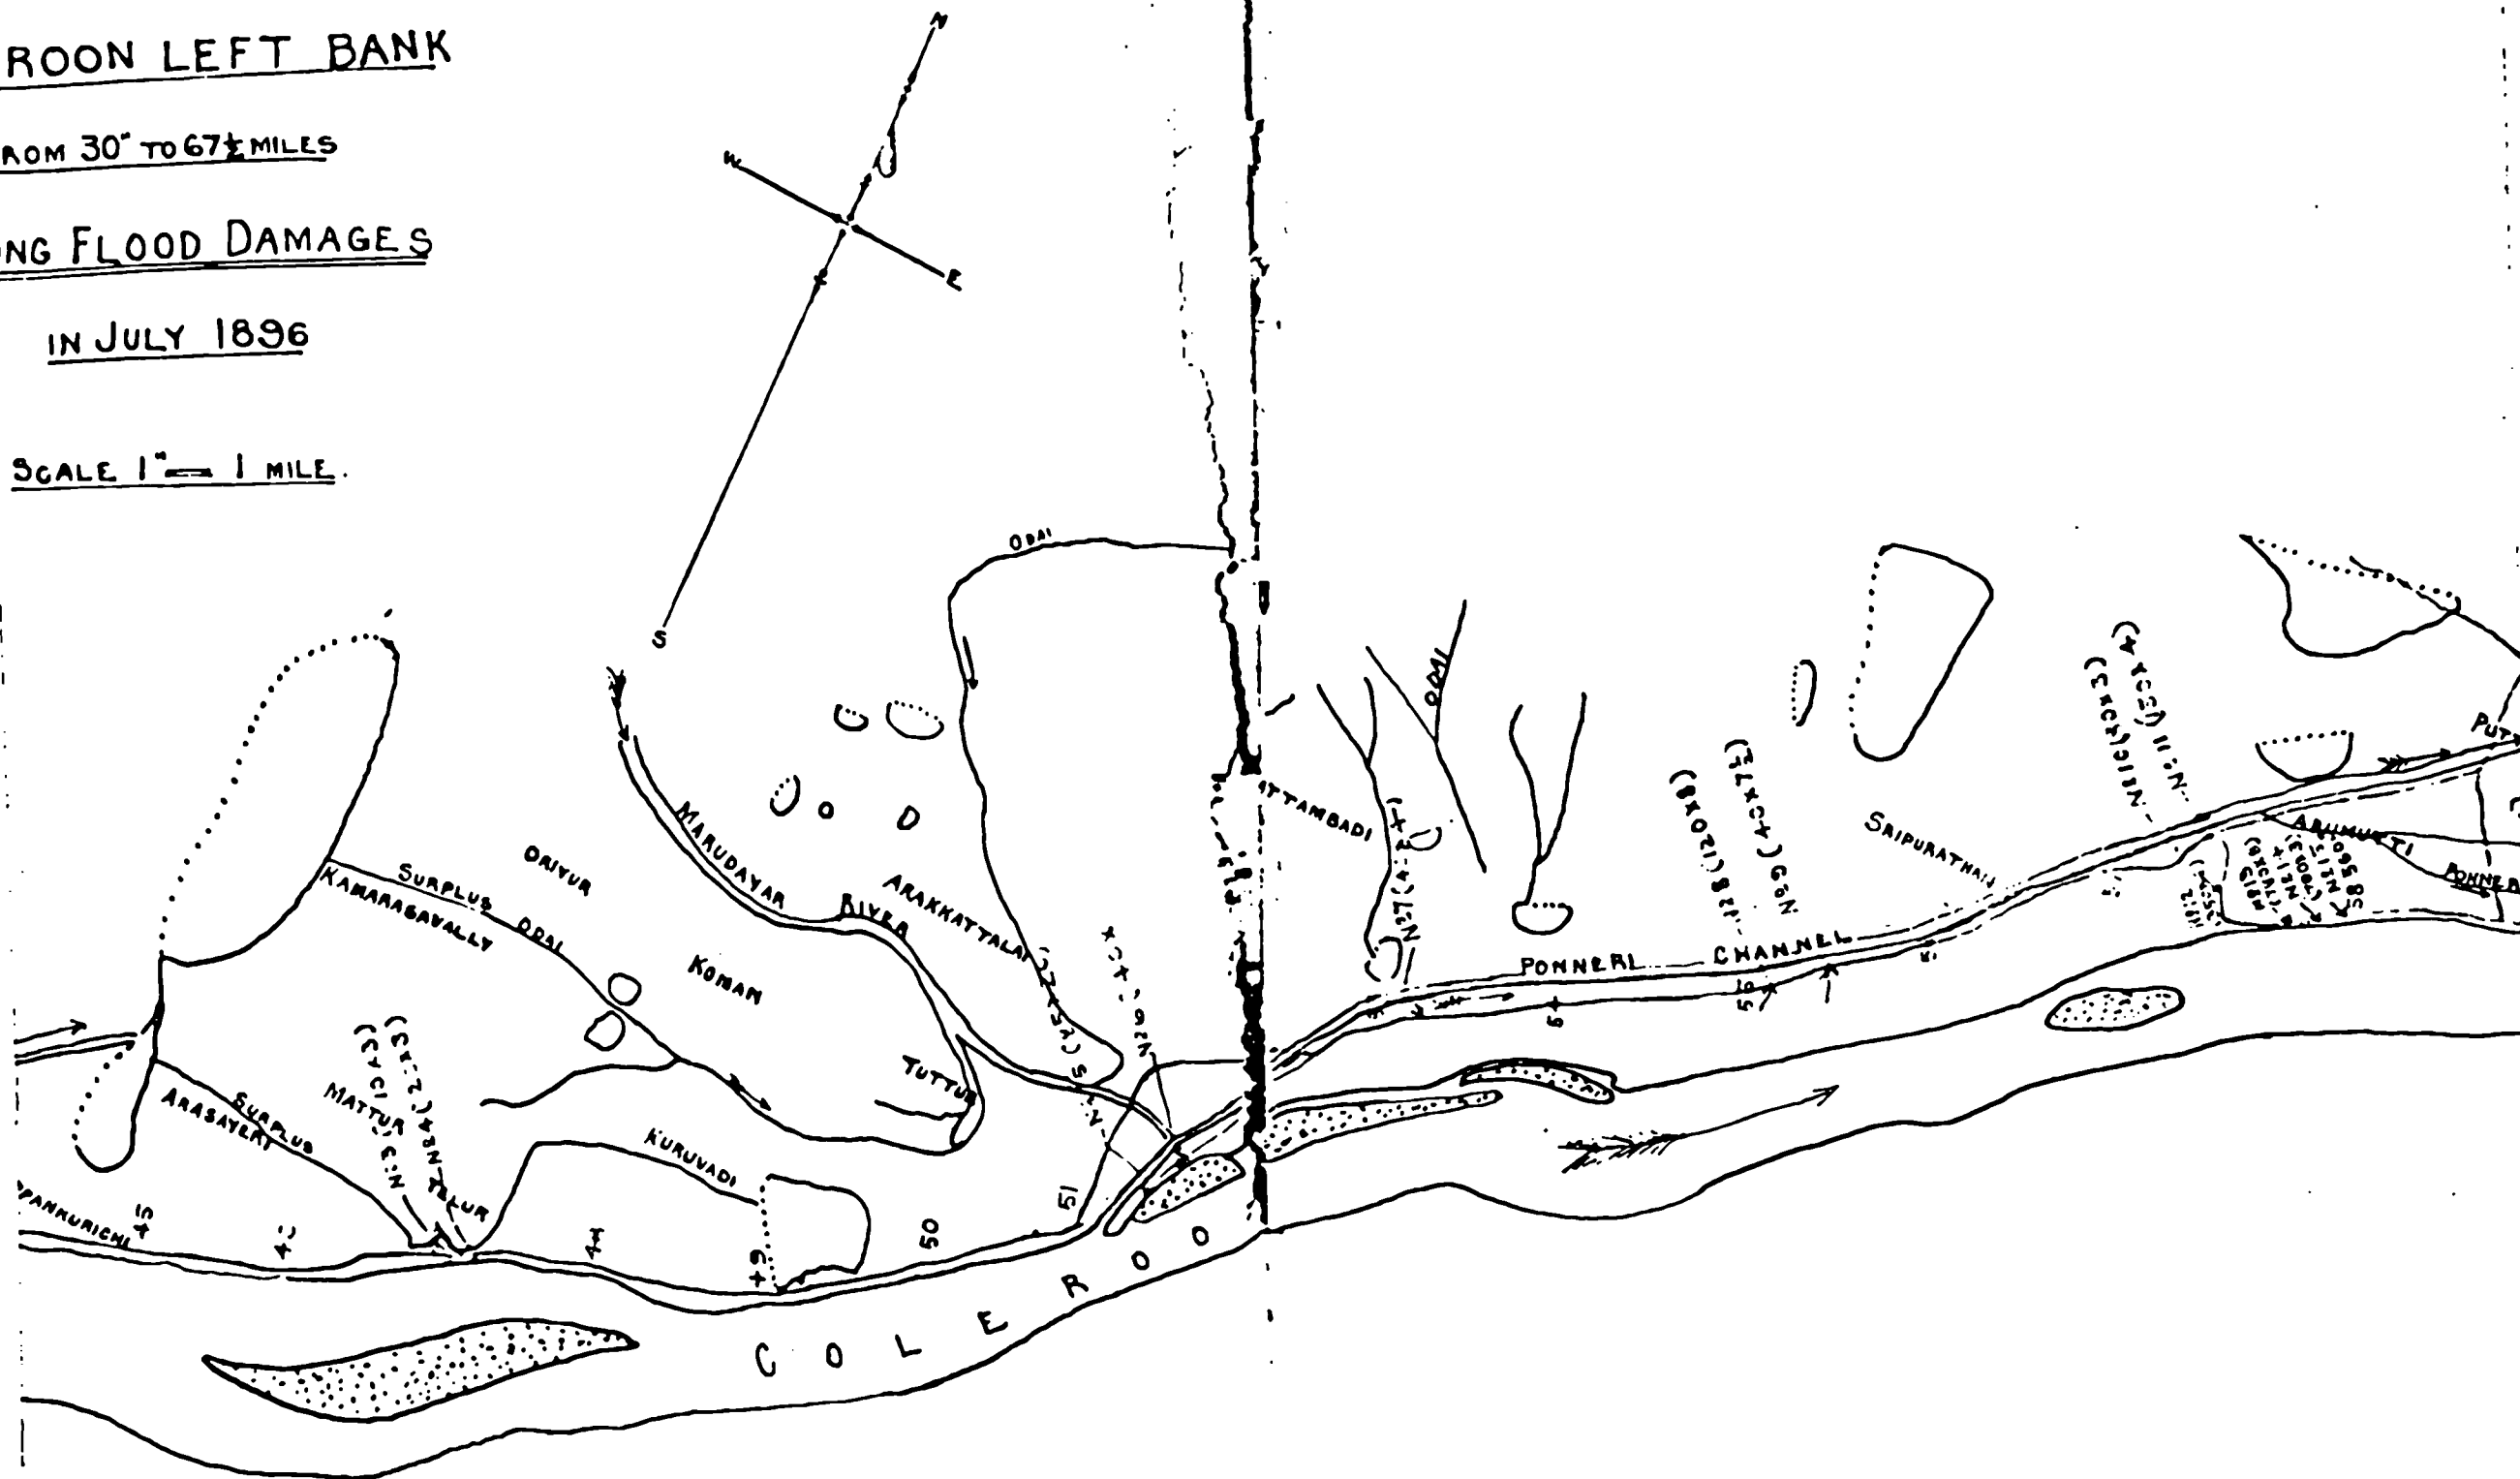
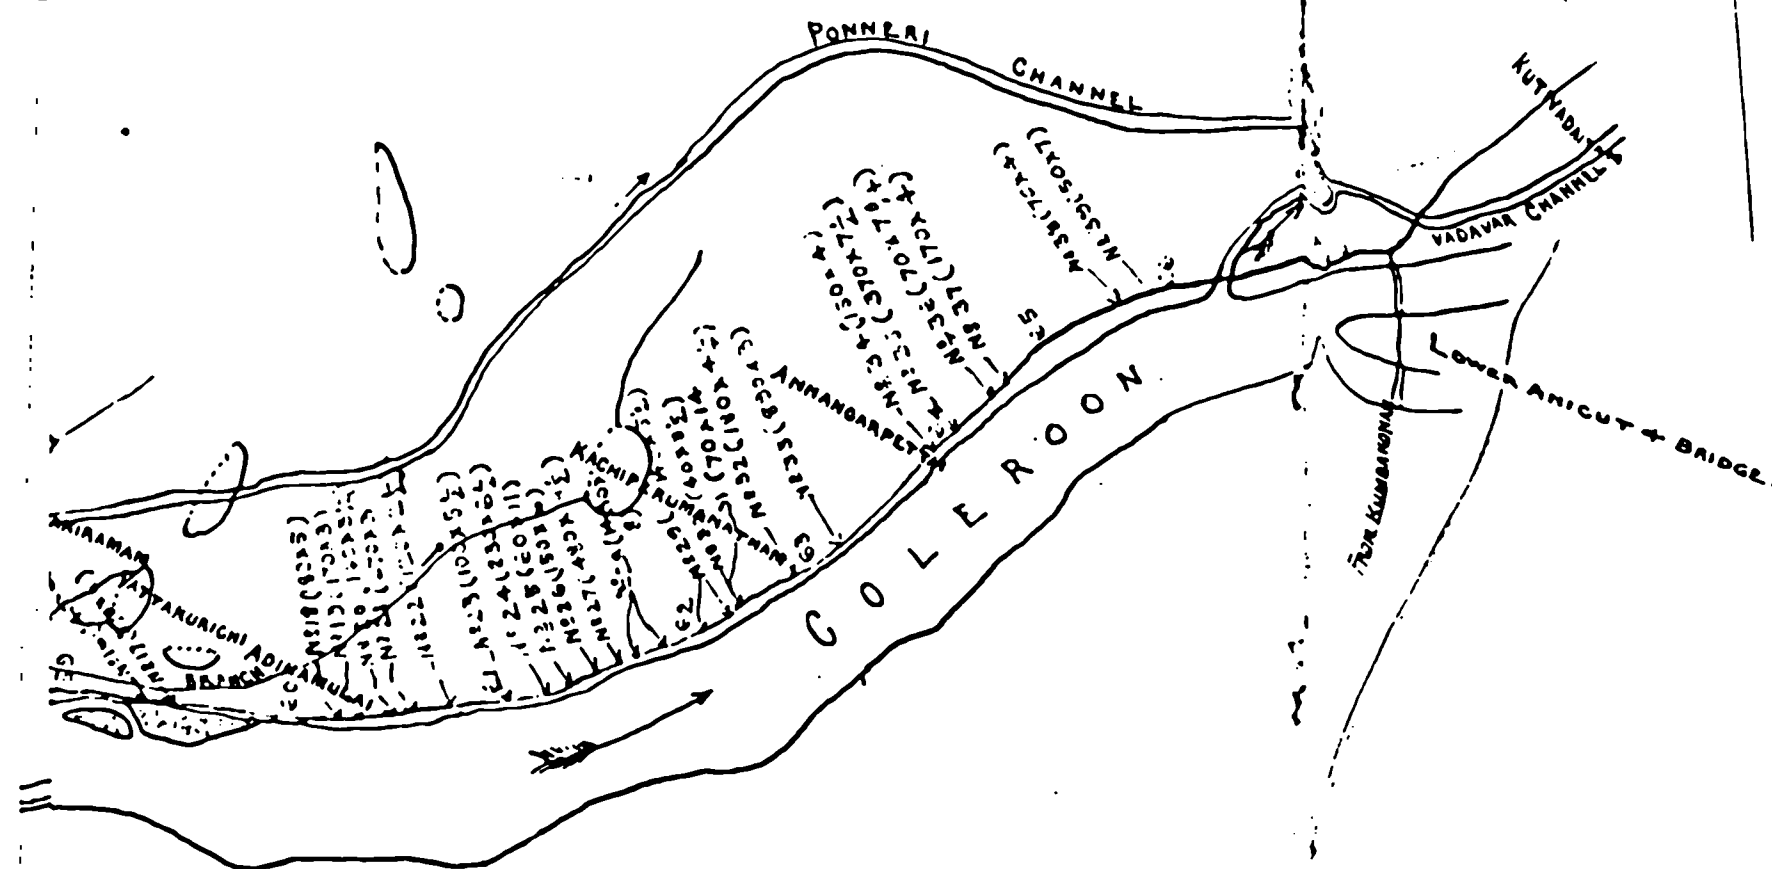
ERON LEFT BANK

FROM 30° TO 67½ MILES

ING FLOOD DAMAGES

IN JULY 1896

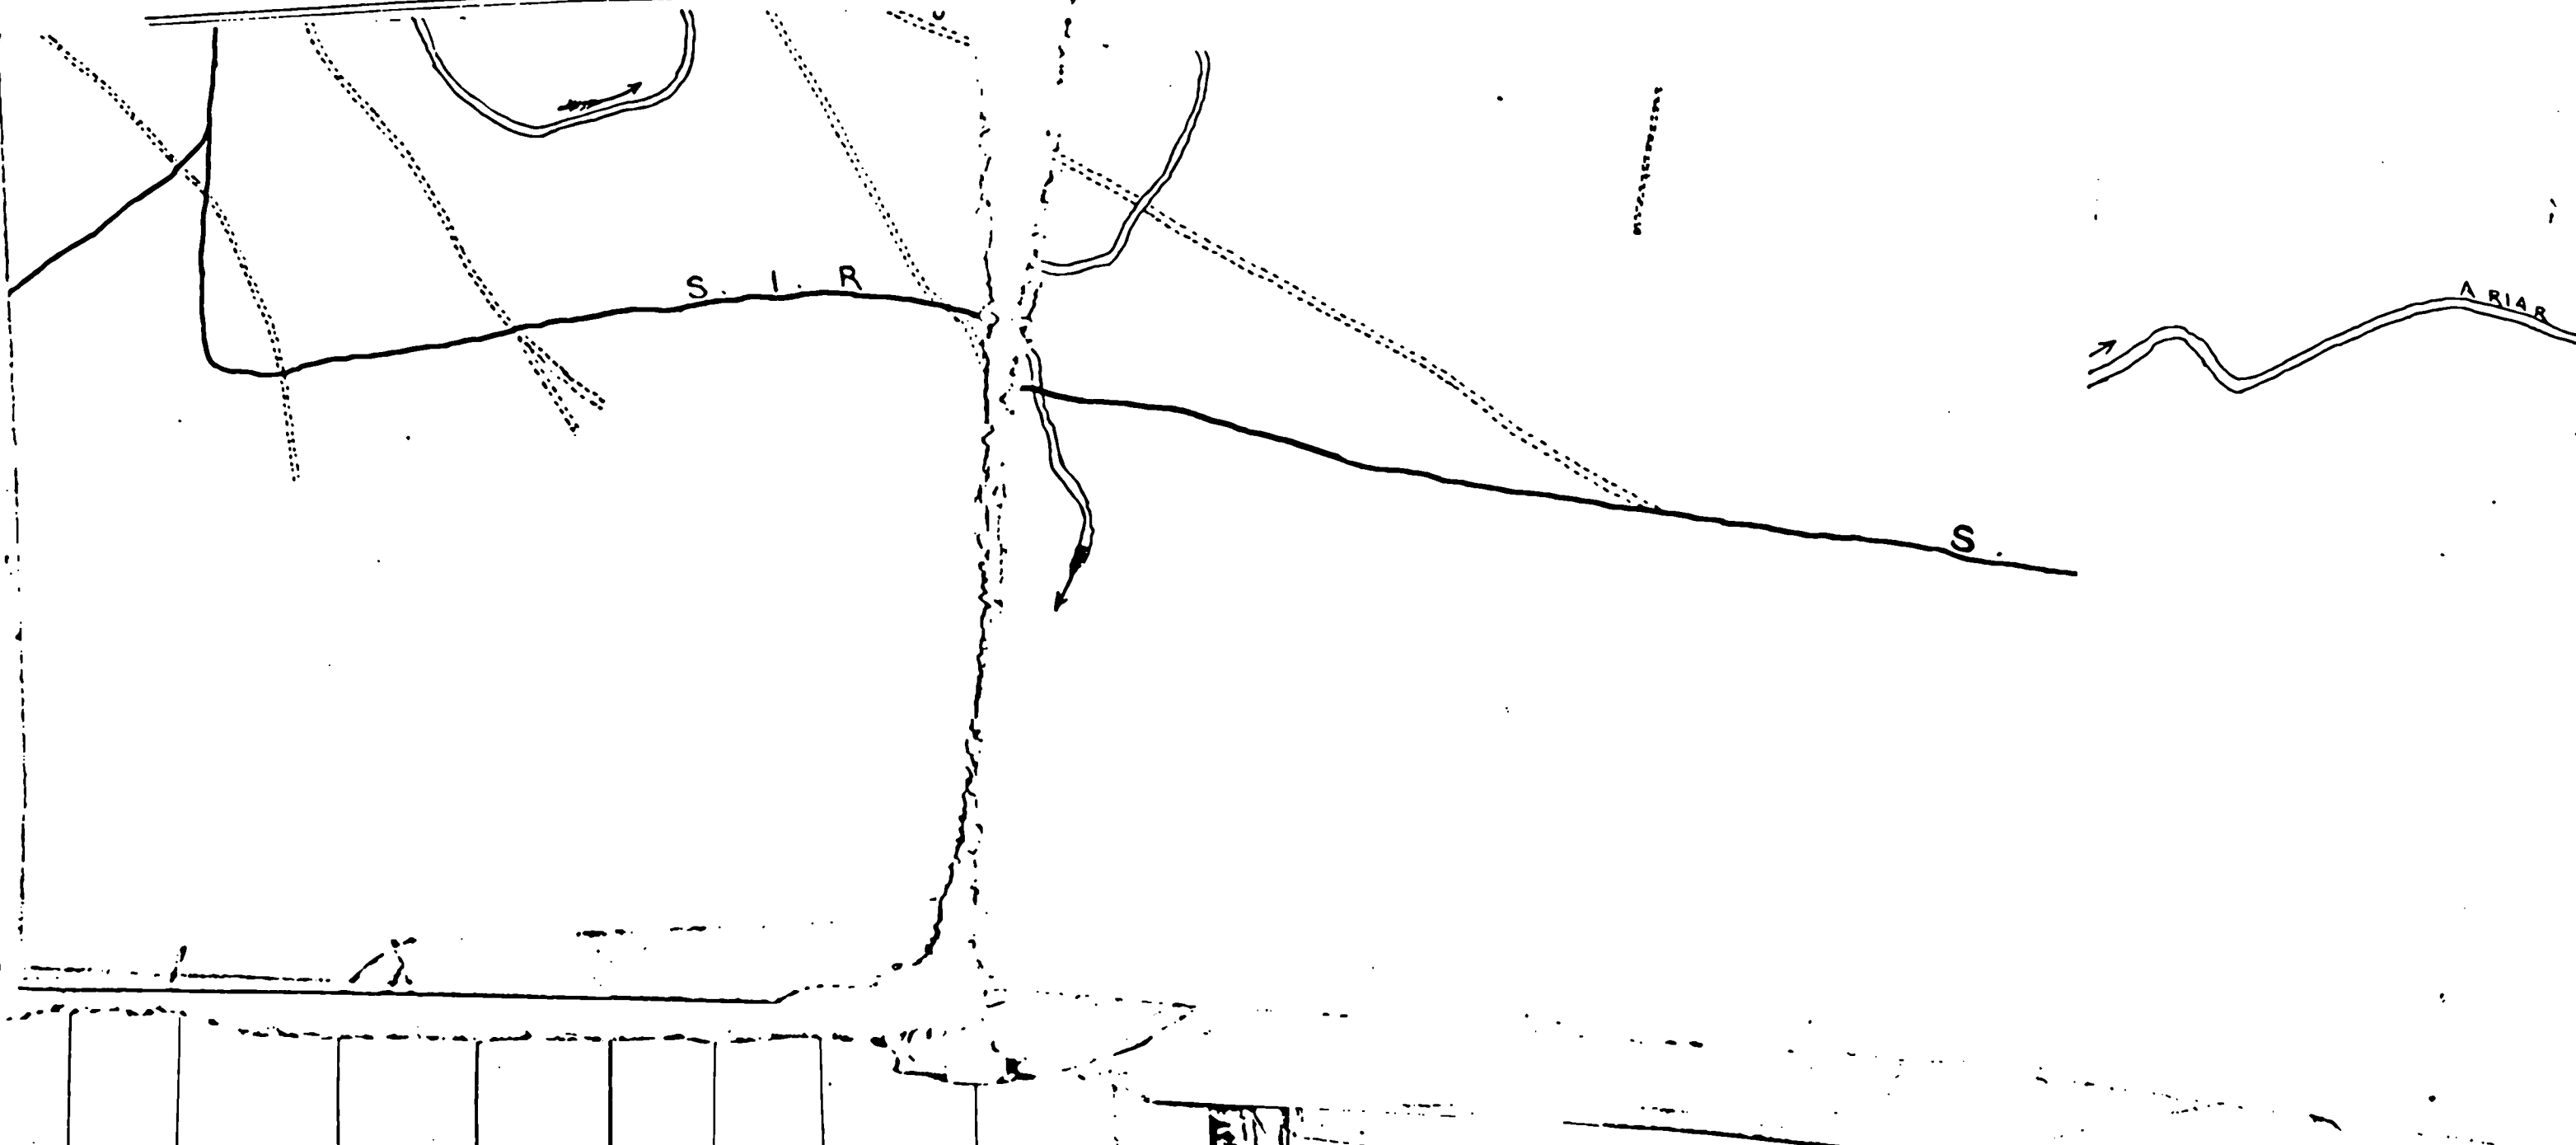
TRICHINOPOLY TALUG

TO ACCOMPANY FLOOD REPORT No. DA.
