Stating that, as the best opinions obtainable on the whole question of protection of light houses from lightning will be sought, it does not seem advisable to make a reference to Messrs Chance Brothers regarding the lightning conductor of the light house at Point Divi.

1895-  
Public Works Department.

Lightning Conductor of  
the Light House at  
Point Dui:-

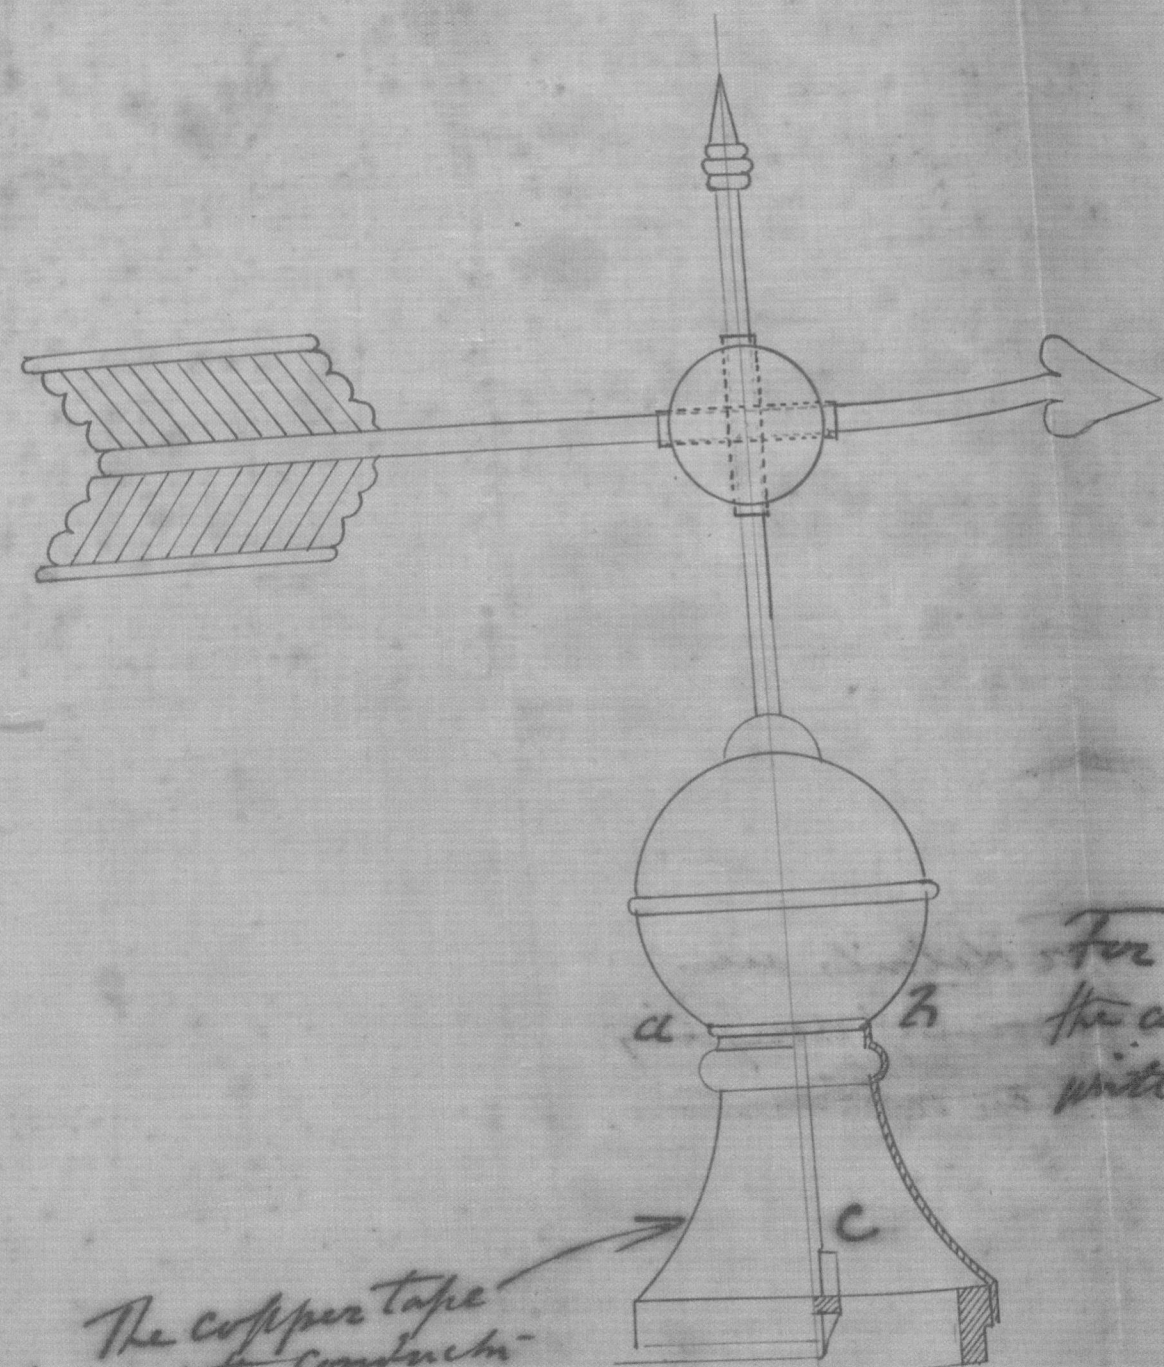
Sketch of Wind vane.  
 Point Pine light house.  
 — " —

The copper tape  
 forming the construction  
 is attached to the  
 lower part of the frame  
 of the wind vane.

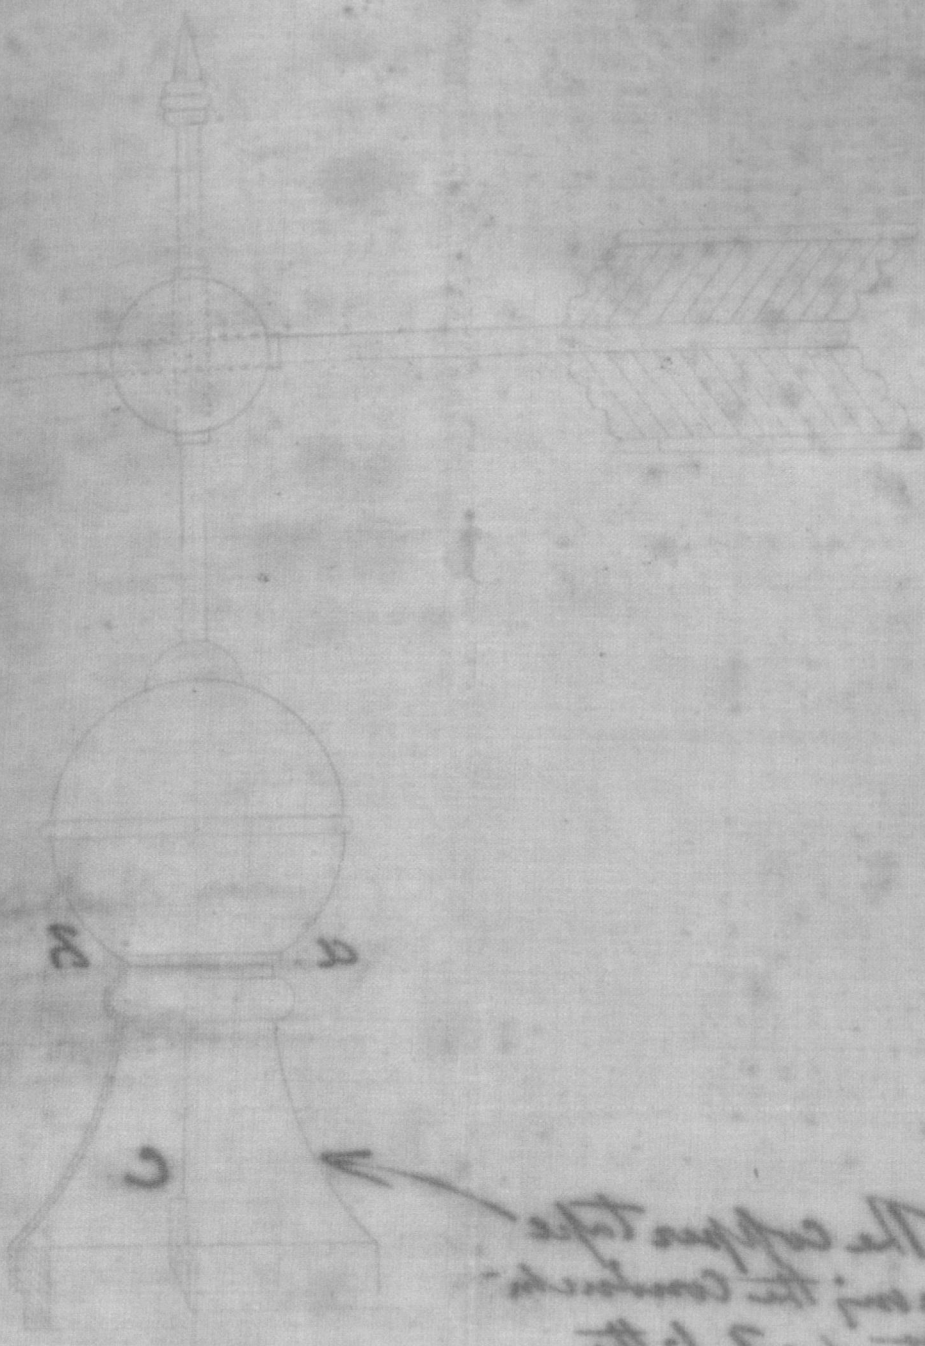
Sketch of Wind Vane of Point Ledge Lighthouse.

The copper tape is attached to the lower part of the frame and the spindle.

The whole length of spindle copper ball revolve. The spindle pivotted at c. The frame of the vane below the line ab is attached to the dome of the lighthouse. There is no difficulty in making electrical connection between part of the frame and the hanging conductor tape.

It is found however in practice that the remainder of the wire is not in electric contact with the conductor, the reason is apparently that the contact at c is not sufficient for electrical purposes. What is required is some simple method of joining the spindle and the copper ball above ab, in electric contact with the lower part of the frame as before stated the difficulty in making an electrical connection between the lower part of the frame and the hanging conductor tape.
