### Public Works DEPARTMENT.

No. 19. Read the following letter from Major E. LAWFORD, Superintending Engineer Southern Circle, in charge of the Central Office of Public Works; to W. H. BAYLEY, Esq., Acting Secretary to Government, dated 7th June 1858, No. 912.

Memorandum to accompany Mr. FRASER'S Estimate for the repairing and ventilation of Ootacamund Church.

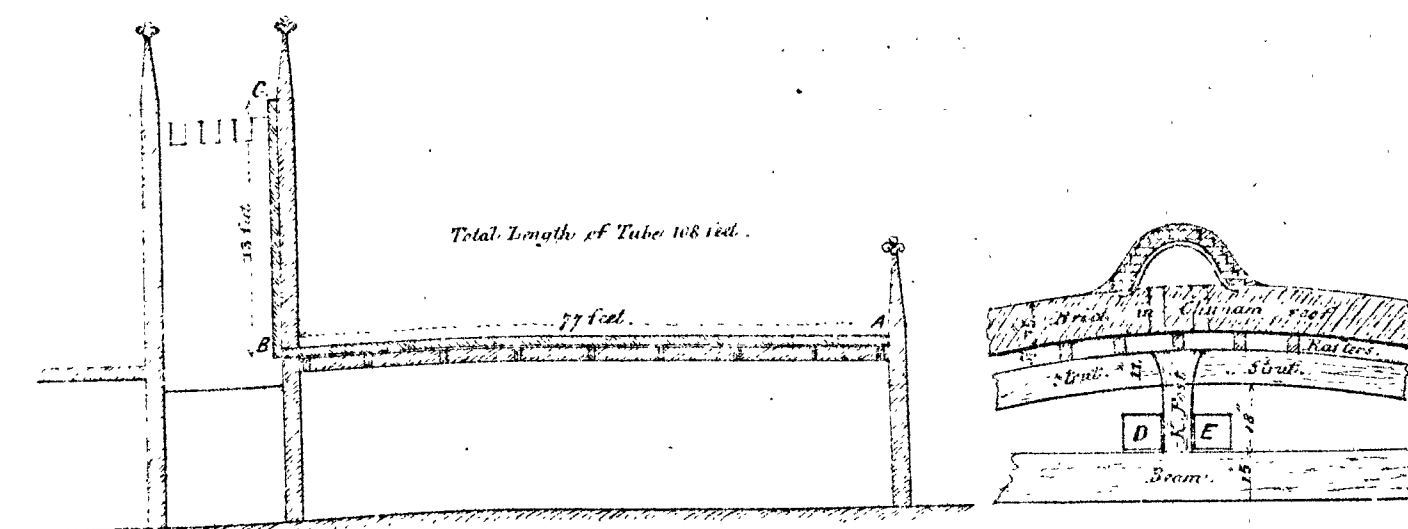
The following Sketches will illustrate the Plan proposed.

It is proposed to lay along the centre of the roof, an air trunk or tube A. B. C., from the west end of the Church to the Tower; turning up inside, and opening to the atmosphere at the top of the Tower.

Apertures at intervals of a few feet, and alternately on each side of the ridge pole, pierced through the roof, for the purpose of conveying the vitiated air from the body of church into the tube.

It is presumed that the difference in weight between the heated column of air B. C., and surrounding atmosphere, will cause such a draught through the tube, as will thoroughly ventilate the space below—but should this not be the case, any required intensity of draught can be produced, by placing, during the time of Divine Service, a vessel of lighted charcoal in the tube B—upon the top of the tube a cowl should be placed, to prevent, during the high winds, regurgitation of the foul air.

The cross section will show how the sheet iron forming the tube, is proposed to be placed upon the roof: it must be protected by some substance which is a bad conductor of heat, and chunamed over, to throw off the rain—for were the rain allowed to fall upon the iron and evaporate from its surface, its temperature and that of the air inside might be so much lowered as to cause the latter to fall again into the body of the Church and descend to the level of congregation.

The area of the tube is proposed to be  $1\frac{1}{2}$  square feet; which is about the result of a calculation made on the supposition, that the greatest number of people in the Church at any one time is 400, and that each person will require 5 cubic feet of fresh air per minute. I do not deem it necessary to go further into this part of the question, as it is one which hardly admits of calculation—for, according to the best authorities, the quantity of fresh air required for each individual, ranges from 3 to 10 cubic feet per minute—besides by having a fire and a damper at point B. the draught can be regulated to suit any required degree of ventilation.

Instead of constructing one sheet iron tube upon the roof,—two smaller tubes of tin or copper, one on each side of the ridge post, might be laid upon the beams under the roof as shown at letters D. E., on the cross section: they—after passing through the wall at the back of the Gable—could be connected with a single up-cast shaft of sheet iron in the Tower, as already proposed—this would avoid any interference whatever with the roof, and as the tubes could be made of timber would be a cheaper plan, than that already described:—it is however objected to, as supposed the tubes would disfigure the appearance of the Church.
