Cochin Experimental Boring.

# COCHIN EXPERIMENTAL BORING

## SKETCH SHEWING SUPPOSED POSITION OF BORING ROD

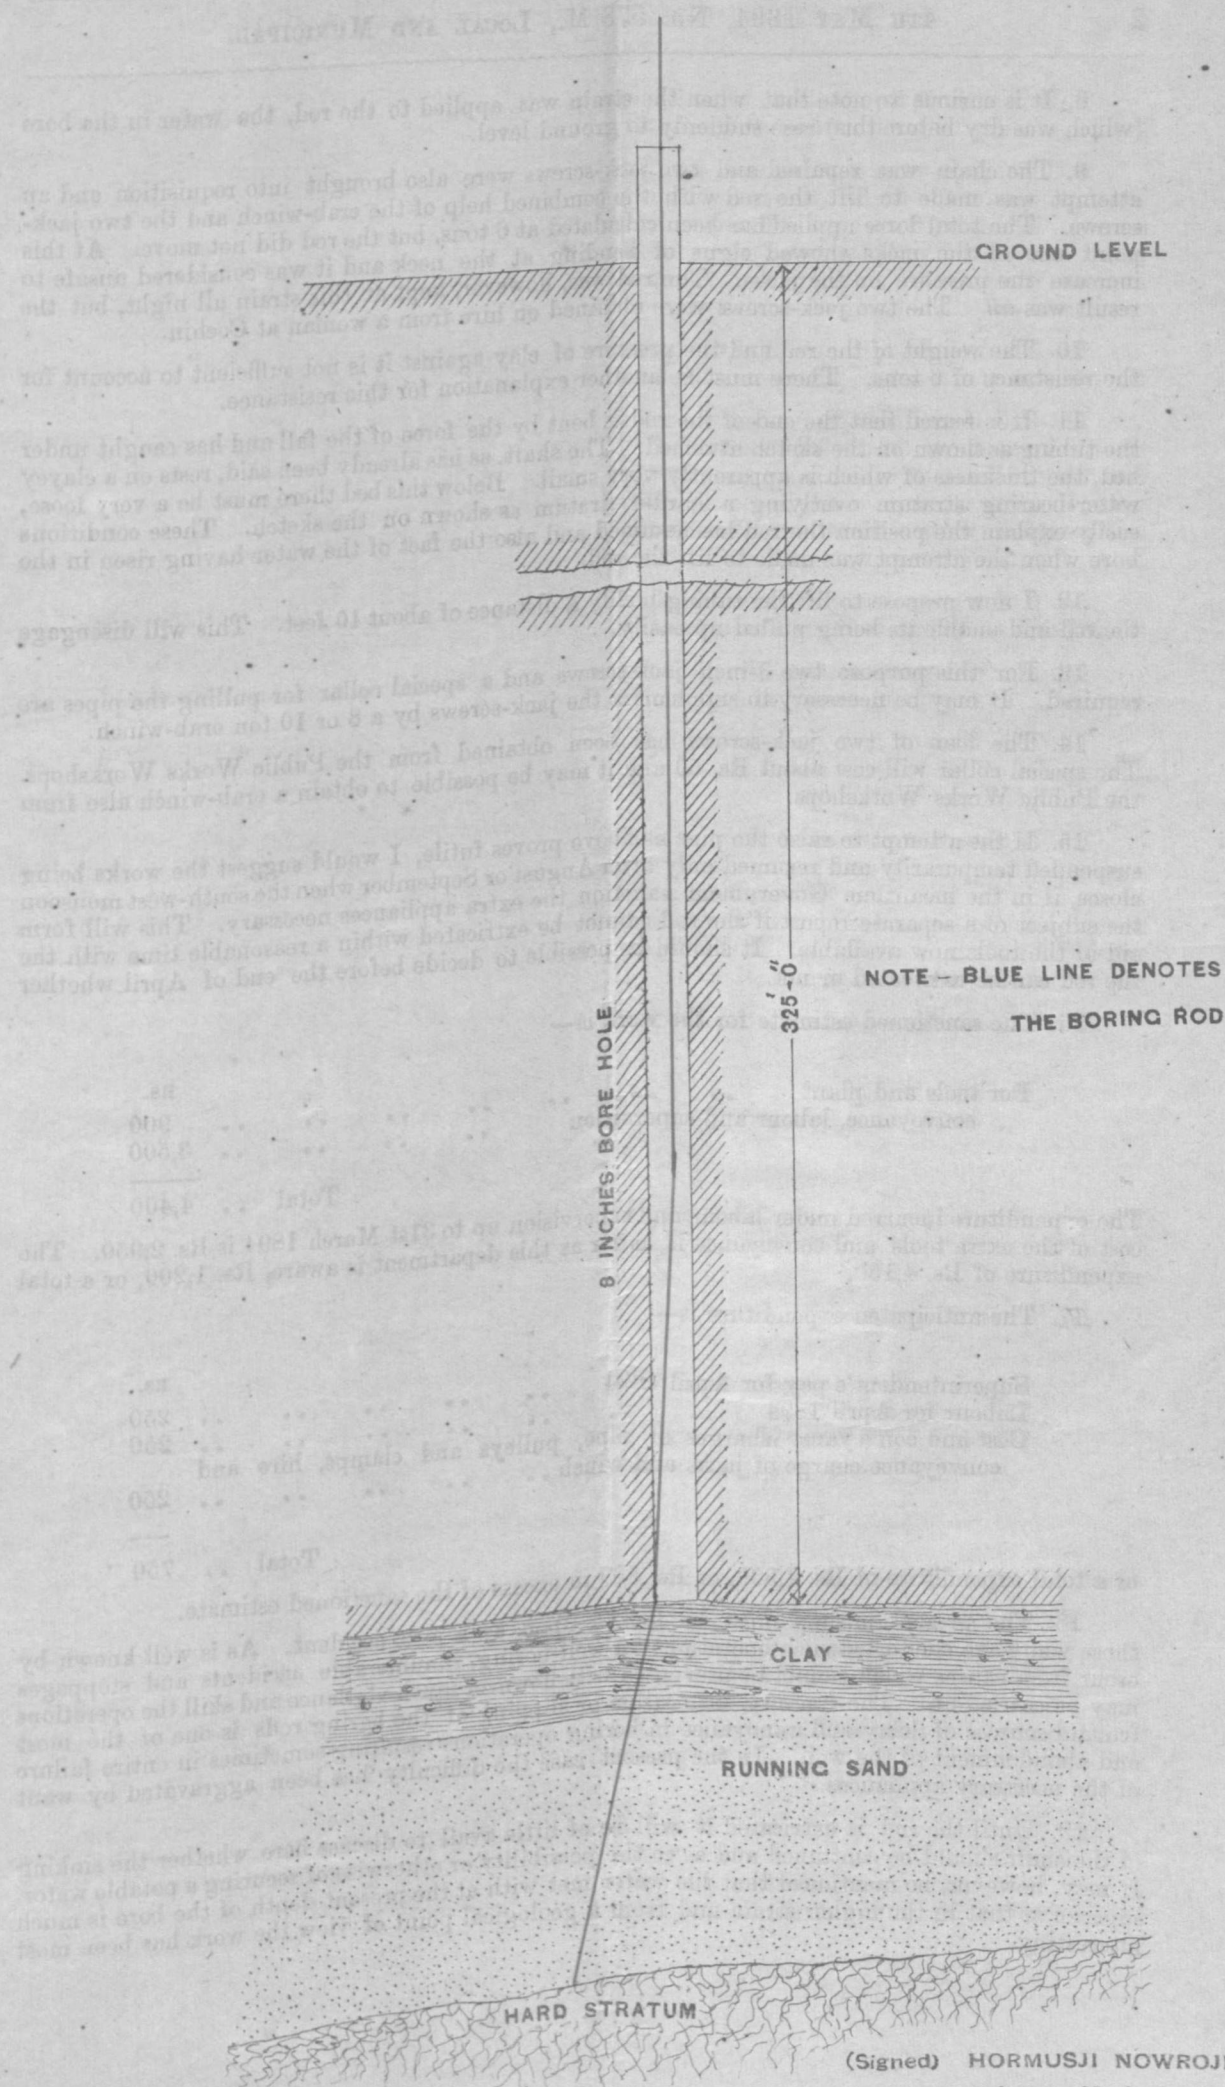
10. The weight of the rod and the pressure of clay against it is not sufficient to account for the resistance of 6 tons. There must be another explanation for this resistance.

11. It is feared that the end of the rod is bent by the force of the fall and has caught under the tubing as shown on the sketch attached. The shaft, as has already been said, rests on a clayey bed, the thickness of which is apparently very small. Below this bed there must be a very loose, water-bearing stratum overlying a harder stratum as shown on the sketch. These conditions easily explain the position the rod has assumed and also the fact of the water having risen in the bore when the attempt was made to lift the rod.

4. On the 13th the shaft was pumped dry. On the following day on attempting to lower the boring rod to resume sinking operations it slipped from the holding dog and fell to the bottom of the bore. The length of the rod when it fell was  $281\frac{1}{2}$  feet including the cutting chisel and weighed about 1.3 tons. The rod fell through a height of about 70 feet and the force of the fall drove it clean through the clayey bed which, in the light of the circumstances that will be presently explained, is, it is presumed, of a very small depth. The rod, it is calculated, has sunk some 10 feet below the shaft. The shaft being 325 feet and the rod only  $281\frac{1}{2}$  feet, about 10 feet of which has sunk below the bottom of the shaft, the top of the rod was  $325 - (281\frac{1}{2} - 10) = 53\frac{1}{2}$  feet below the top of the shaft.

12. I now propose to lift the tubing bodily a distance of about 10 feet. This will disengage the rod and enable its being pulled up easily.

13. For this purpose two 3-inch jack-screws and a special collar for pulling the pipes are required. It may be necessary to supplement the jack-screws by a 8 or 10 ton crab-winch.
