## EXCAVATIONS AT AMARAVATI.

PREHISTORIC REMAINS AT  
PERAMBUR.

## CONSERVATION IN MADRAS.

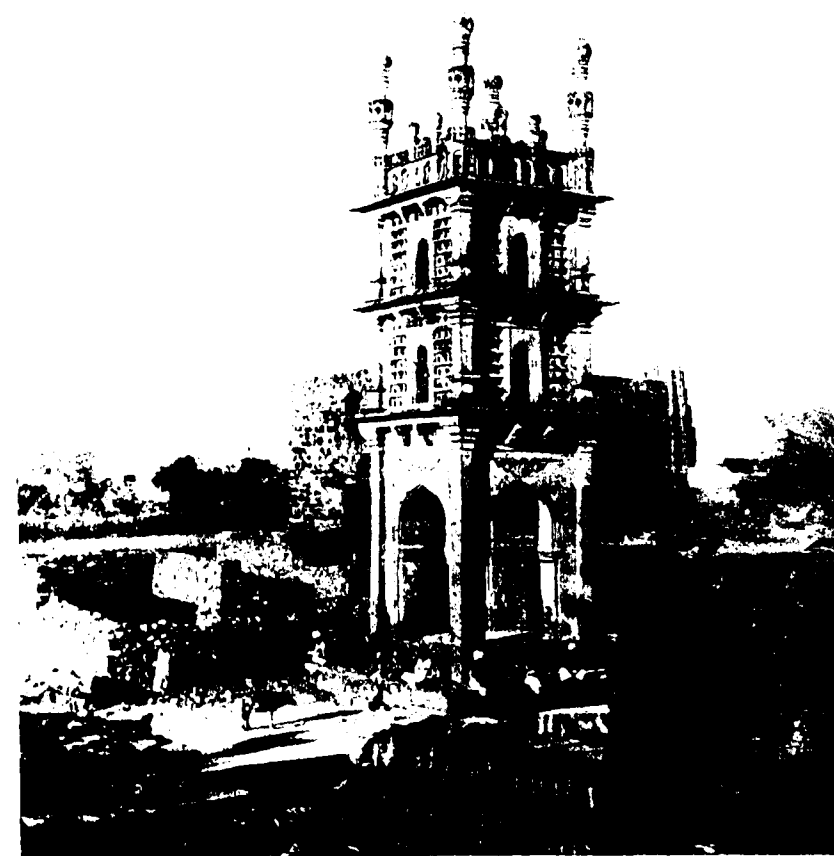
Fig. 5.

Gandhikōta in the Cuddapah District is another important fort which has undergone repairs, the preliminary account of which appeared in a previous paper. The work has made considerable progress during the year under review and several buildings have been attended to. Among these is the masonry-vaulted building known as the Magazine, which was disfigured by mud walls built between the arches and by heaps of *debris* in the rooms. These have now been removed. Another interesting building is the lofty tower known as the Chār-minār. (Fig. 5) It was

generally in a fair state of repair, but some attention was needed for the decayed stucco work, particularly in the perforations of the upper windows. Some displaced stones of the basement, which seemed likely to endanger the security of the foundations, were fixed in position. The figure illustrating this building also shows one of the granaries, of which several remain. These are rectangular structures, with walls of great thickness, and with the interior spaced with lofty masonry piers supporting barrel-vaulted roofs.

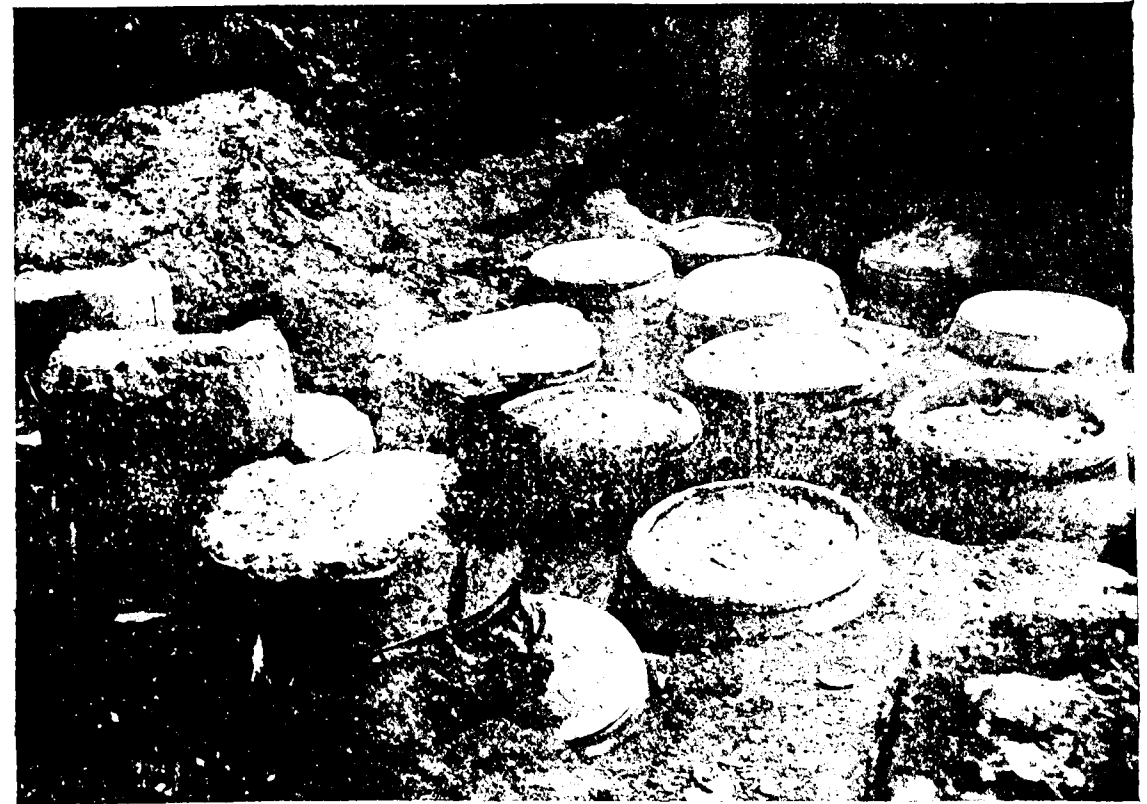
Fig. 2.

For there can be no doubt at all but that the tombs are of the neolithic type. They lie some seven feet underground and contain earth, broken pottery, and a number of small *kalasams* or pots of red polished ware of the same kind as those found at the prehistoric site of Perambair (Fig. 2).

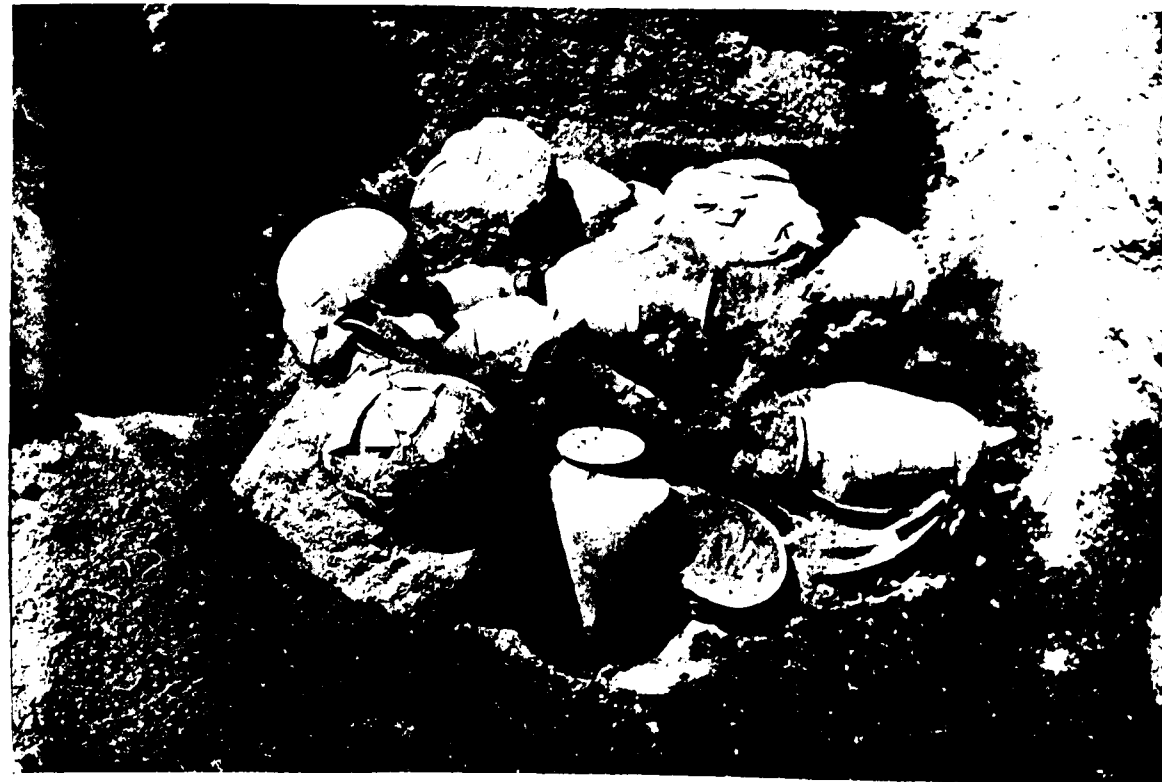
Fig. 2.

Text illustration, Fig. 2, shows a group of pottery in the centre of cromlech No. 7 at a few feet below the surface. The main deposit consisting of a skeleton with a grinding stone and a few pieces of pottery lay below. Their position is shown below on Fig. 3. Fig. 4 shows an oblong cist with attached pottery from cromlech No. 8 as it appeared just after excavation.

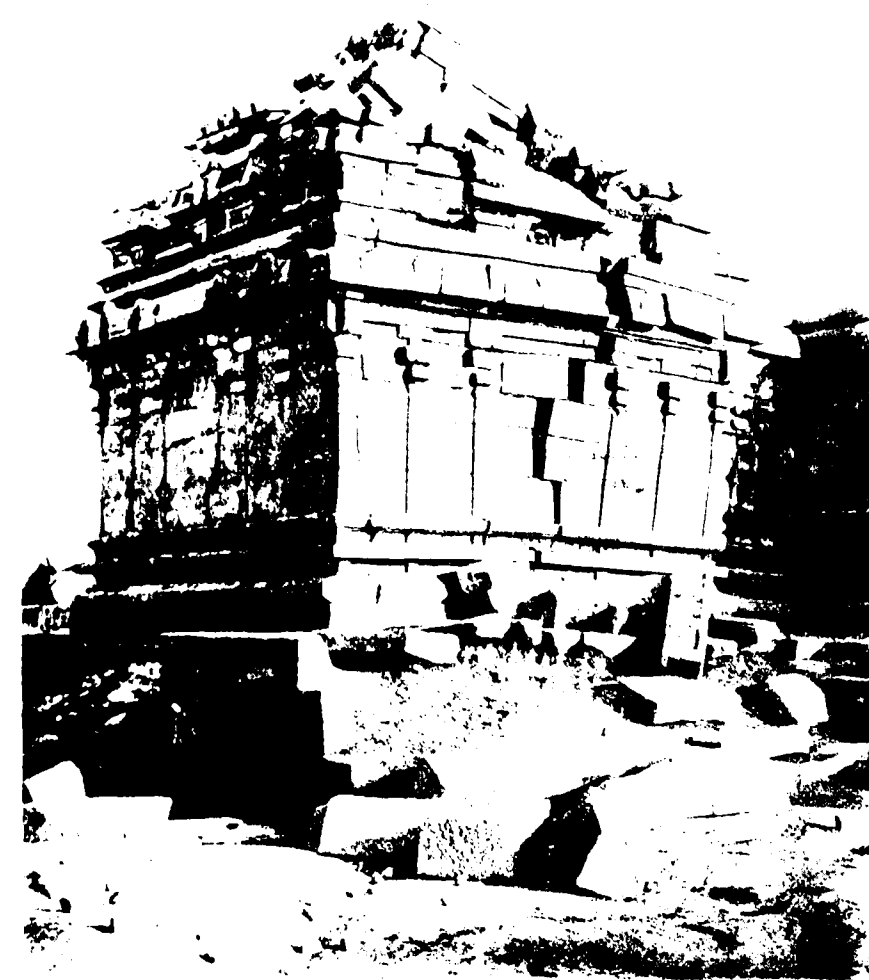
Fig. 1.

Some of the repairs, however, present difficulties which tax the skill of the engineers to the utmost, as will be realized without detailed description by a reference to Fig. 1, which represents the Hēmakūṭam Jain temple at Vijayanagar. Its ruined condition is almost solely due to defective foundations. These have been

built on soil placed above the rock on which the temple stands, and enclosed by revetments to prevent the spread of the earth from under the temple walls. By the removal or collapse of the retaining walls the foundations have sunk, with consequent fracture of the superstructure. Several of these Jain temples are in varying stages of similar decay, all due to the same cause, the above being an extreme example. Some have been successfully preserved and others are being attended to.

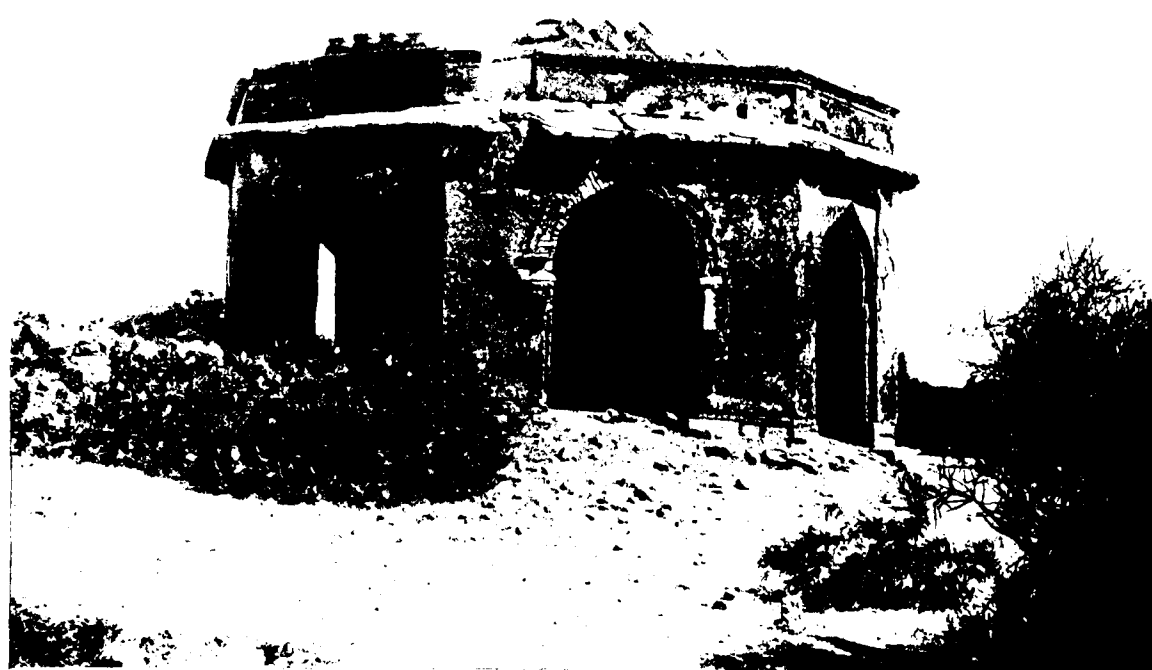
Fig. 2.

The several groups of buildings contained in the ancient palace received attention, which was generally a continuation or completion of previous repairs. Most of these buildings have been described in previous papers, but one not mentioned hitherto calls for notice here. This is the building known as the “watershed,” on account of its containing a reservoir which was originally supplied with water from the pipes of the ancient irrigation system, which still exists (Fig. 2).

The building evidently took the place of a public well, and was supplied with water by gravitation from the great tank near Kamalāpuram.

The building above illustrated is covered with an arched masonry dome, which, together with the arches of the doorways, was fractured in several places. The reservoir in the centre was also choked up with *débris*, which has now been removed.

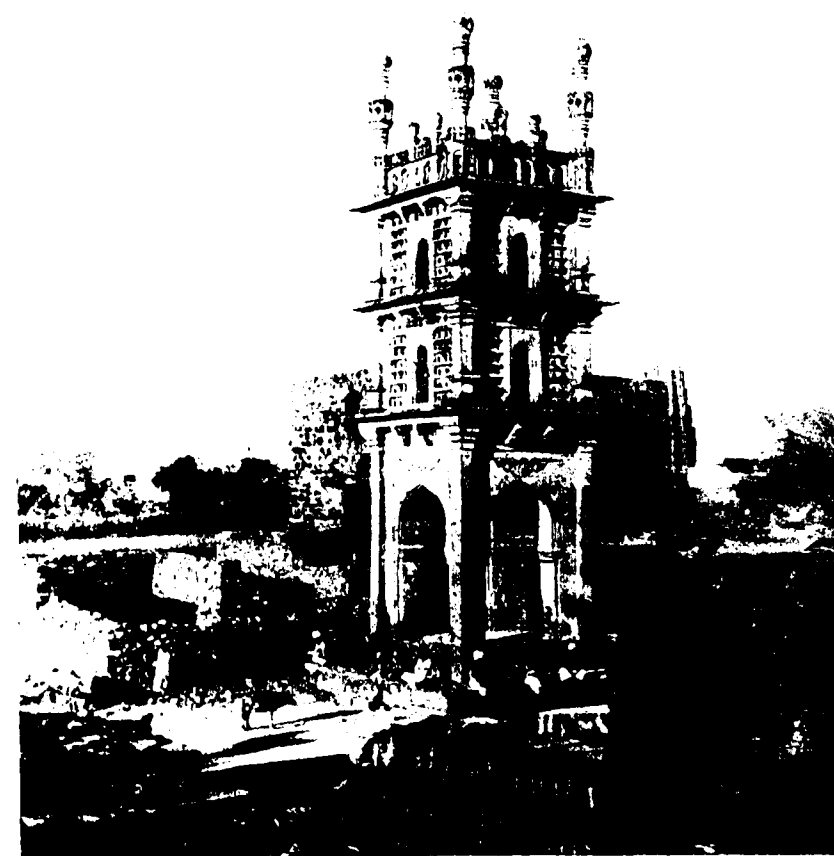
Fig. 5.

Gandhikōta in the Cuddapah District is another important fort which has undergone repairs, the preliminary account of which appeared in a previous paper. The work has made considerable progress during the year under review and several buildings have been attended to. Among these is the masonry-vaulted building known as the Magazine, which was disfigured by mud walls built between the arches and by heaps of *debris* in the rooms. These have now been removed. Another interesting building is the lofty tower known as the Chār-minār. (Fig. 5) It was

generally in a fair state of repair, but some attention was needed for the decayed stucco work, particularly in the perforations of the upper windows. Some displaced stones of the basement, which seemed likely to endanger the security of the foundations, were fixed in position. The figure illustrating this building also shows one of the granaries, of which several remain. These are rectangular structures, with walls of great thickness, and with the interior spaced with lofty masonry piers supporting barrel-vaulted roofs.
