Paper No. 230

## "PARKING IN MOUNT ROAD"

R. THILLAINAYAGAM,\*

P. S. SRINARI, B.E. \*

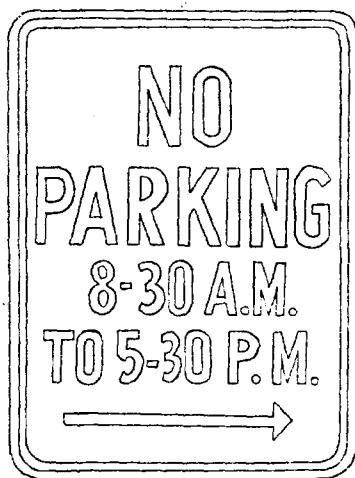
Fig. 11.  
Size 12 in.  $\times$  18 in.  
Background white letters  
red

It is suggested that the time during which parking is prohibited may also be noted and parking sign, Fig. 11, standardised for uniform adoption. Where parking is permitted for a restricted time or during certain hours, special signs as shown in Fig. 12 may be posted.
