Indian Road  
Congress

Paper No. 164

**"Testing to Destruction a 96-foot Prestressed Concrete Bridge Girder"**

K. K. NAMBIAR AND P. V. RAJ

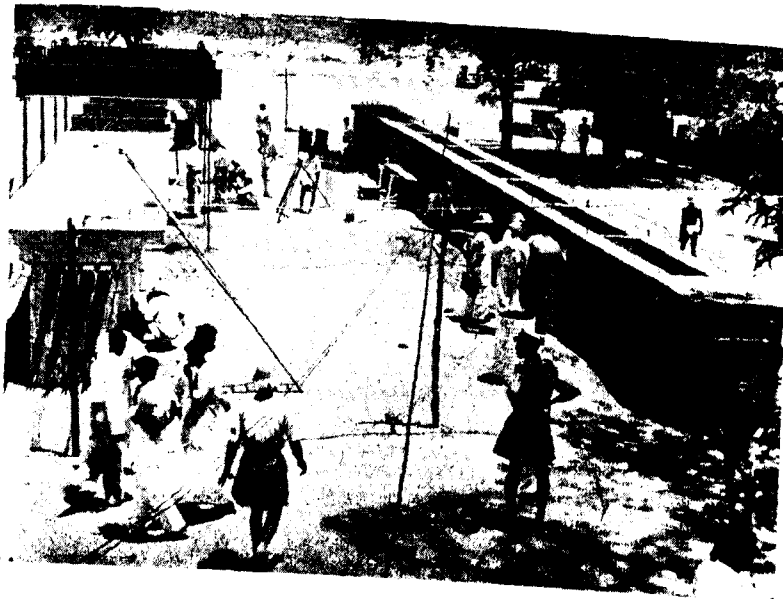
Photo 2: Test beam under load. Beam on the right is ready for prestressing.

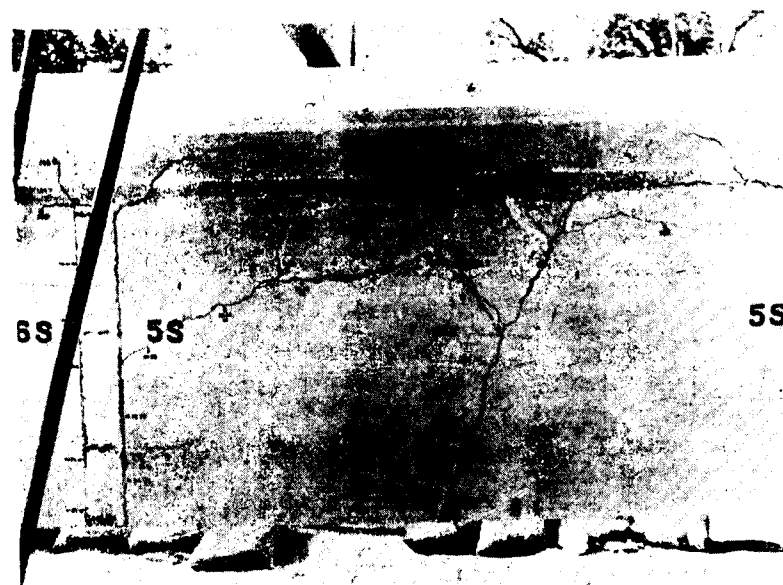
Photo 4: View showing the Cracks at the Centre of the Beam on the South side.

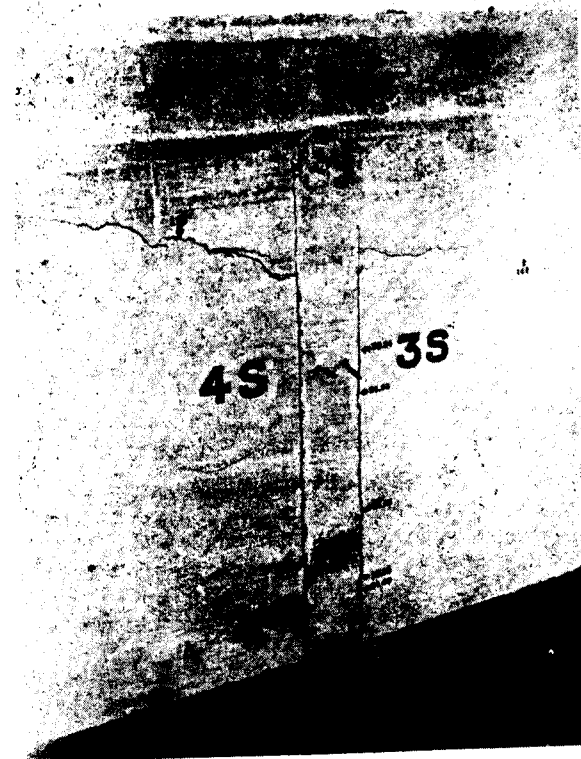
Photo 6: Another View Showing Cracks on the South Face of the Beam.
