Journal of the  
Indian Roads congress.

V. XXIII-3

1959

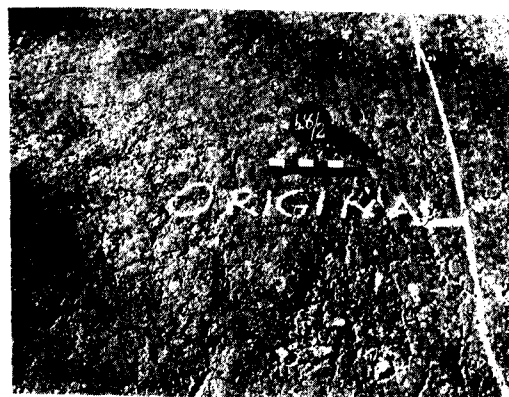
Photo 9.  
Development of  
cracks on the  
whole width of  
the road

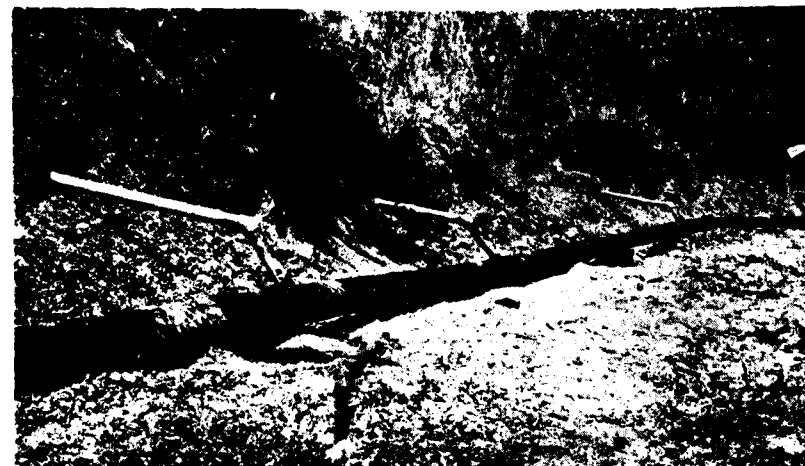
Photo 8.  
Horizontal drains working to release the  
hydrostatic pressure

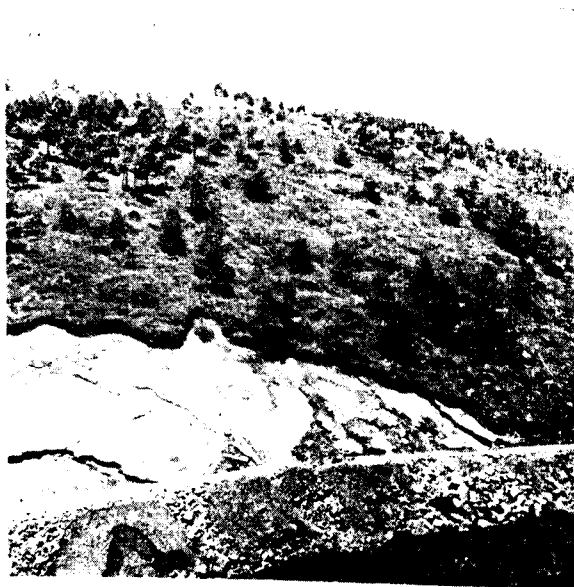
Photo 9.  
Face of secondary slips
