ANNUAL REPORT

ARCHÆOLOGICAL DEPARTMENT,

SOUTHERN CIRCLE, MADRAS,

1910-1911.

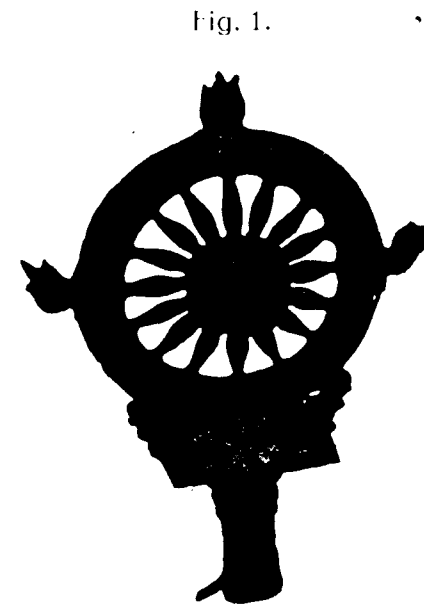
Chakram.

A Vishnu image, a *pīṭam* and a *chakram* (Plate I, Figure 1), found in a Treasure Trove case of Viragalūr, in the Trichinopoly district, were recommended to be purchased for the Madras Museum. **Viragalūr.**
