HISTORY  
OF THE  
HARDINGE BRIDGE  
UP TO 1941

by  
T. S. N. Rao, ENGINEER-IN-CHARGE, HARDINGE BRIDGE,  
B. A. RAILWAY.

Technical Paper No. 318.

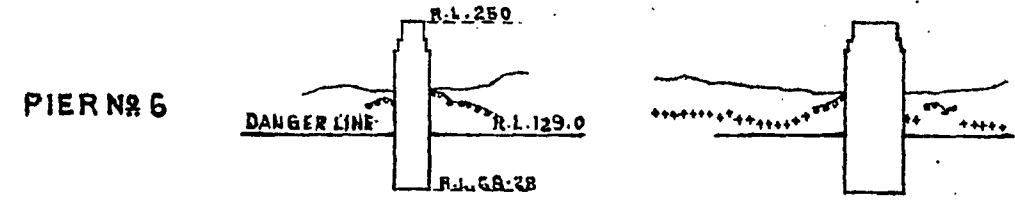
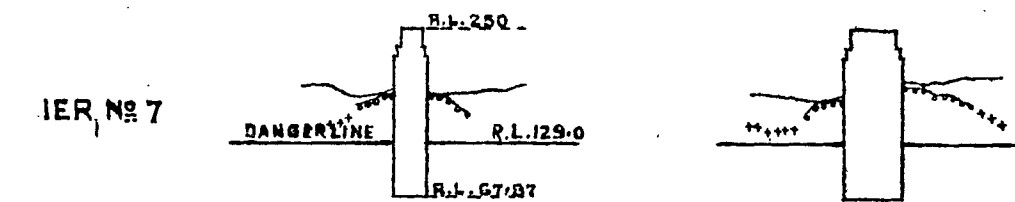
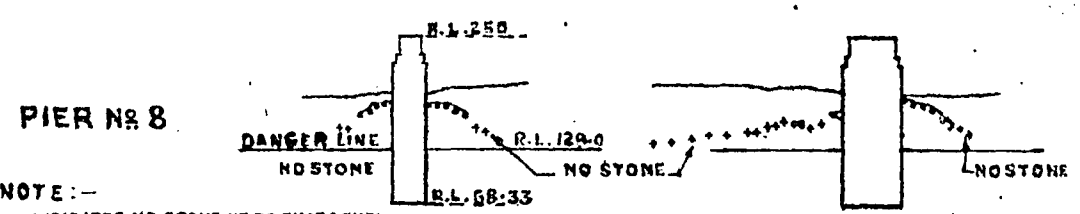
FIG 3 F  
12 C.

# PRICKING RESULTS ROUND PIER NO 3 TO 8 AFTER FLOOD OF 1931

The chur on the left bank of the river having widened so considerably this season, the whole of the discharge of the river was confined to 5 spans, *i.e.*, between piers 2 to 7, and consequently the channel was deepened very considerably. Prickings showed no stone at No. 3 pier and very little at Nos. 4, 5, 6, 7 and 8 piers (vide Fig. 3F). Heavy pitching was, therefore, done round these piers especially round No. 3 where a deep scour hole 17 feet below the "danger level" was discovered only 300 feet south of this pier.

Piers Nos. 2, 3 and 5 were again pitched at low water season. A deep scour hole 104 feet below low water level was found to exist opposite chains 17 to 22 of the Right Guide Bank.

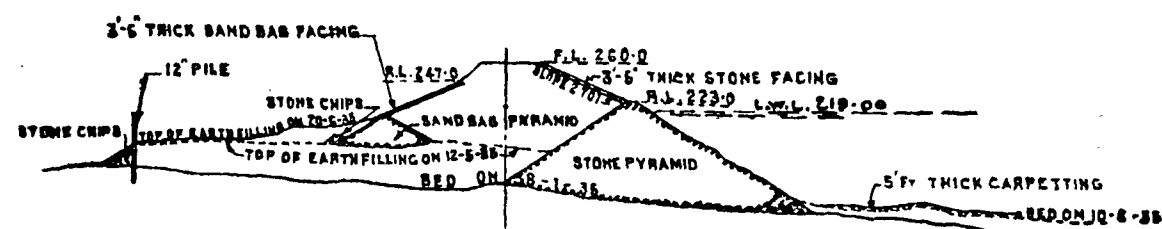
FIG. 9

This restoration is of the same design as the 'Mole', namely, a dyke of stone, sealed behind with clay and backed with earth which is held from spreading by a pile and matting barrier. The quantities of earthwork and boulders were, however, considerably greater than in the 'Mole'; for the bank was 1,600 feet long and the average depth of water at low water level over the length was 65 feet. The bank of earth and stone has at its maximum section a base of 450 feet wide standing 105 feet high and this reduced only very slightly over the greater part of its length of 1,600 feet. Fig. 9 shows a typical section of the restored bank.

## TYPICAL SECTION OF "RESTORED GUIDE BANK"

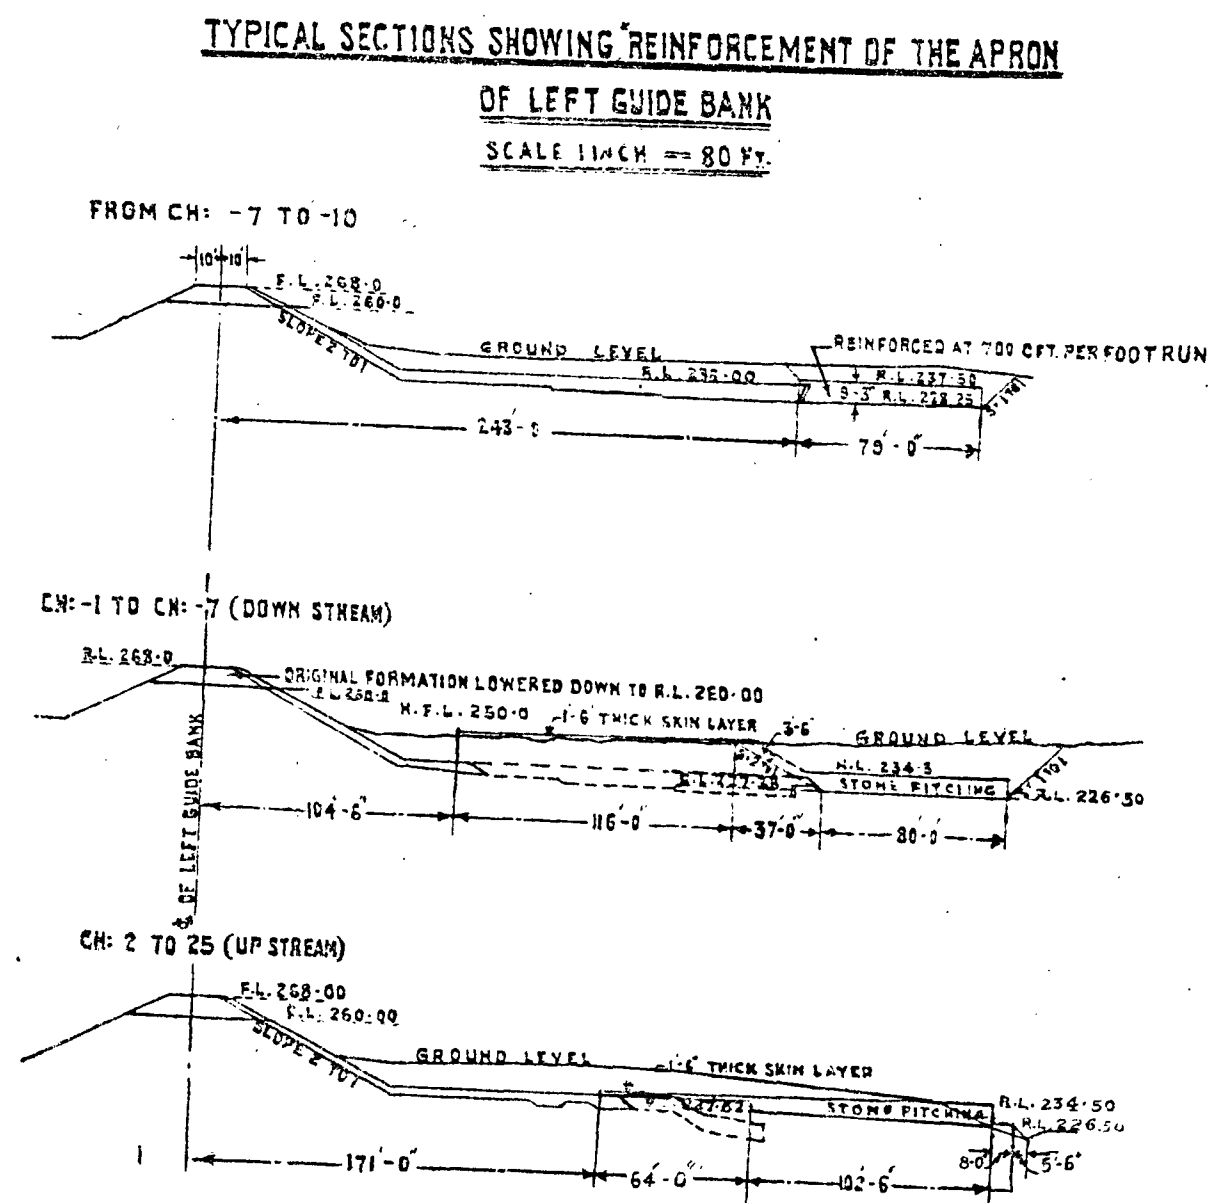
FIG 11.

The apron of the original Left Guide Bank was designed for a maximum scour of 100 feet below low water level ; but from observations made since 1934 it was found to be found entirely inadequate. It was, therefore, decided to widen the apron so that it would be able to withstand the maximum probable scour which might occur, i.e., 160 feet below water level, as was done in the case of the Right Guide Bank. The original apron which had been put down at the Left Guide Bank had served its purpose and acted in the manner in which it was designed to act, but, during the period when the river gradually translated towards the right bank considerable amount of silt was deposited over the original apron, which had launched partially. The reinforcement of an apron was covered with sand to a maximum depth of 100 feet, at places, was not practicable in the ordinary way. This would have to be done either by laying a completely new apron designed for the greater scour at low water level or else by waiting till the sand over the fallen apron was scoured away, and extending the apron by dropping boulders through grids from barges. The former method was decided to be adopted at the Left Guide Bank using as much of the old apron as had not launched in the design. Fig. 11 shows typical section of the reinforcement of the apron as was actually carried out.

During the course of reinforcing the apron of the original Left Guide Bank an incident occurred which requires mentioning. A considerable amount of silt deposited over the apron originally laid had to be removed before additional pitching was done. The local engineers found no space to dispose of the spoil earth and they dumped the earth over the chur land beyond the apron edge and upstream of pier No. 15. The Steam Navigation Company who used to ply their steamers through the Paksey Channel during the high floods objected to this on the ground that the river bed lower down might silt up and hinder navigation. They represented the matter to the Railway Administration who finally decided to remove the earth thrown over the chur above the top level of stone pitching, and this was done. It appears strange how a couple of lakhs cubic feet of earth thrown over the chur could silt up lower down to such an extent as to prevent navigation. It is true that the Paksey Channel has been gradually silted up and the rate of silting rapidly increased since 1936. The cause of this, however, is to be found in the abandonment of the Sara Protection Bank. So long as there was a "protuberance" at Sara, an off-shoot below the "protuberance" found its way through the Paksey Channel. As soon as the clay at Sara eroded and the spur disappeared, the flow through the Paksey Channel gradually dwindled and whatever silt it carried during high floods was deposited there.

The extension of the Left Guide Bank was done in three stages. In the year 1938 the apron of the old Left Guide Bank was reinforced and the extension of the bank was completed up to chain 40, while only the earthwork in bank was completed in the remaining portion, viz., between chain 40 and chain 80. In the year 1939, the apron between chain 40 and chain 60 was completed and the curved head of the old guide bank was abandoned. In 1940, the guide bank was extended up to chain 80. About 371 lakhs cubic feet of earthwork and 148 lakhs cubic feet of pitching were done in the total extension up to chain 80 and in the reinforcement of apron of the old guide bank. The cost of these works amounted to Rs. 26,24,000 approximately.

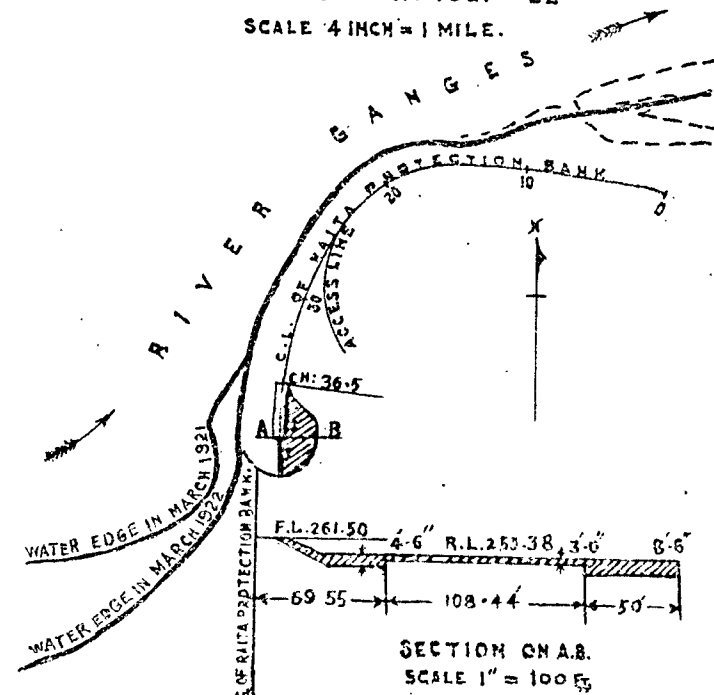
FIG 3C  
12

**1921-22.**—In 1921-22 the Raita Head was extended round the back to meet any embayment that might occur from the Govindapur Bight (vide Fig. 3C). The erosion between Sara and the bridge continued and, in places, into the “Danger Line”—a line fixed between the Left Guide Bank and Sara beyond which erosion of the left bank of the river was considered dangerous to the Railway Colony at Paksey.
