GOVERNMENT OF MADRAS.

PUBLIC WORKS DEPARTMENT.

Division Office at Chettipet

Instructions to Superintending Engineer,  
I Circle, for preparing estimate for a new  
building for the —.

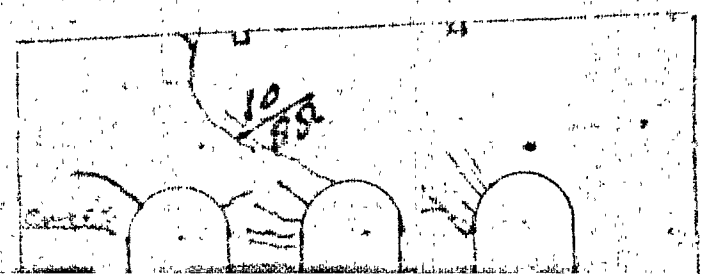
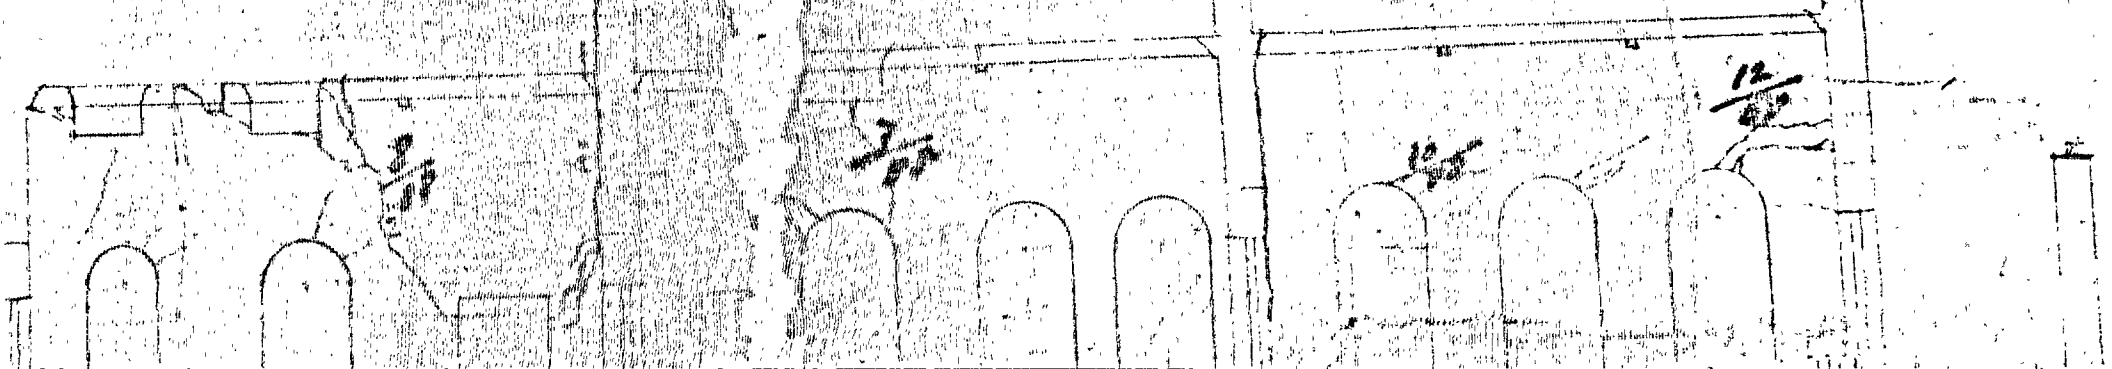
N.B. sepia colored lines denote  
all cracks in the walls of  
building and foundation

Vertical lines  
denotes cracks  
in the columns

the plaster on the West wall is  
being cracked out at about the  
level of Verandah roof.  
The West cracks at present are  
(1) the one above mentioned  
(2) the three cracks shown in section  
III. The one on the left of the section  
was at one time about 2 months ago  
1" wide but has since closed up the  
lower part of the wall has moved  
up to the W.  $3/4$  to S. The center crack  
is the most dangerous. It is widest  
under the ridge about  $3/4$ " and the  
upper part of the wall is falling  
over towards the Assistant Engi-  
neers Office, this crack has increased  
rapidly & joined quite recently  
to that from the left hand  
angle of door marked W. The  
crack which is shown in the enlarged  
elevation has not increased much  
recently but when it first began  
widened rapidly. This crack shows  
a movement of the lower portion  
of

of the wall of  $3/4$ " west &  $3/4$ " South. The  
cracks in the draftsmen's office are  
all recent and are still increasing.  
New cracks are also appearing in the  
arches of windows in Draftsmen and  
31 Executive Engineers Office rooms. This  
extensive cracking of the office seems  
mainly to have taken place since

1) the construction of the back drain  
& 2) the 1886 floods. The drain how-  
ever as you saw seems to be in good  
condition. The crack in the angle  
filler at the S.W. corner occurred I  
believe before the drain was laid  
and was I think attributed by G.

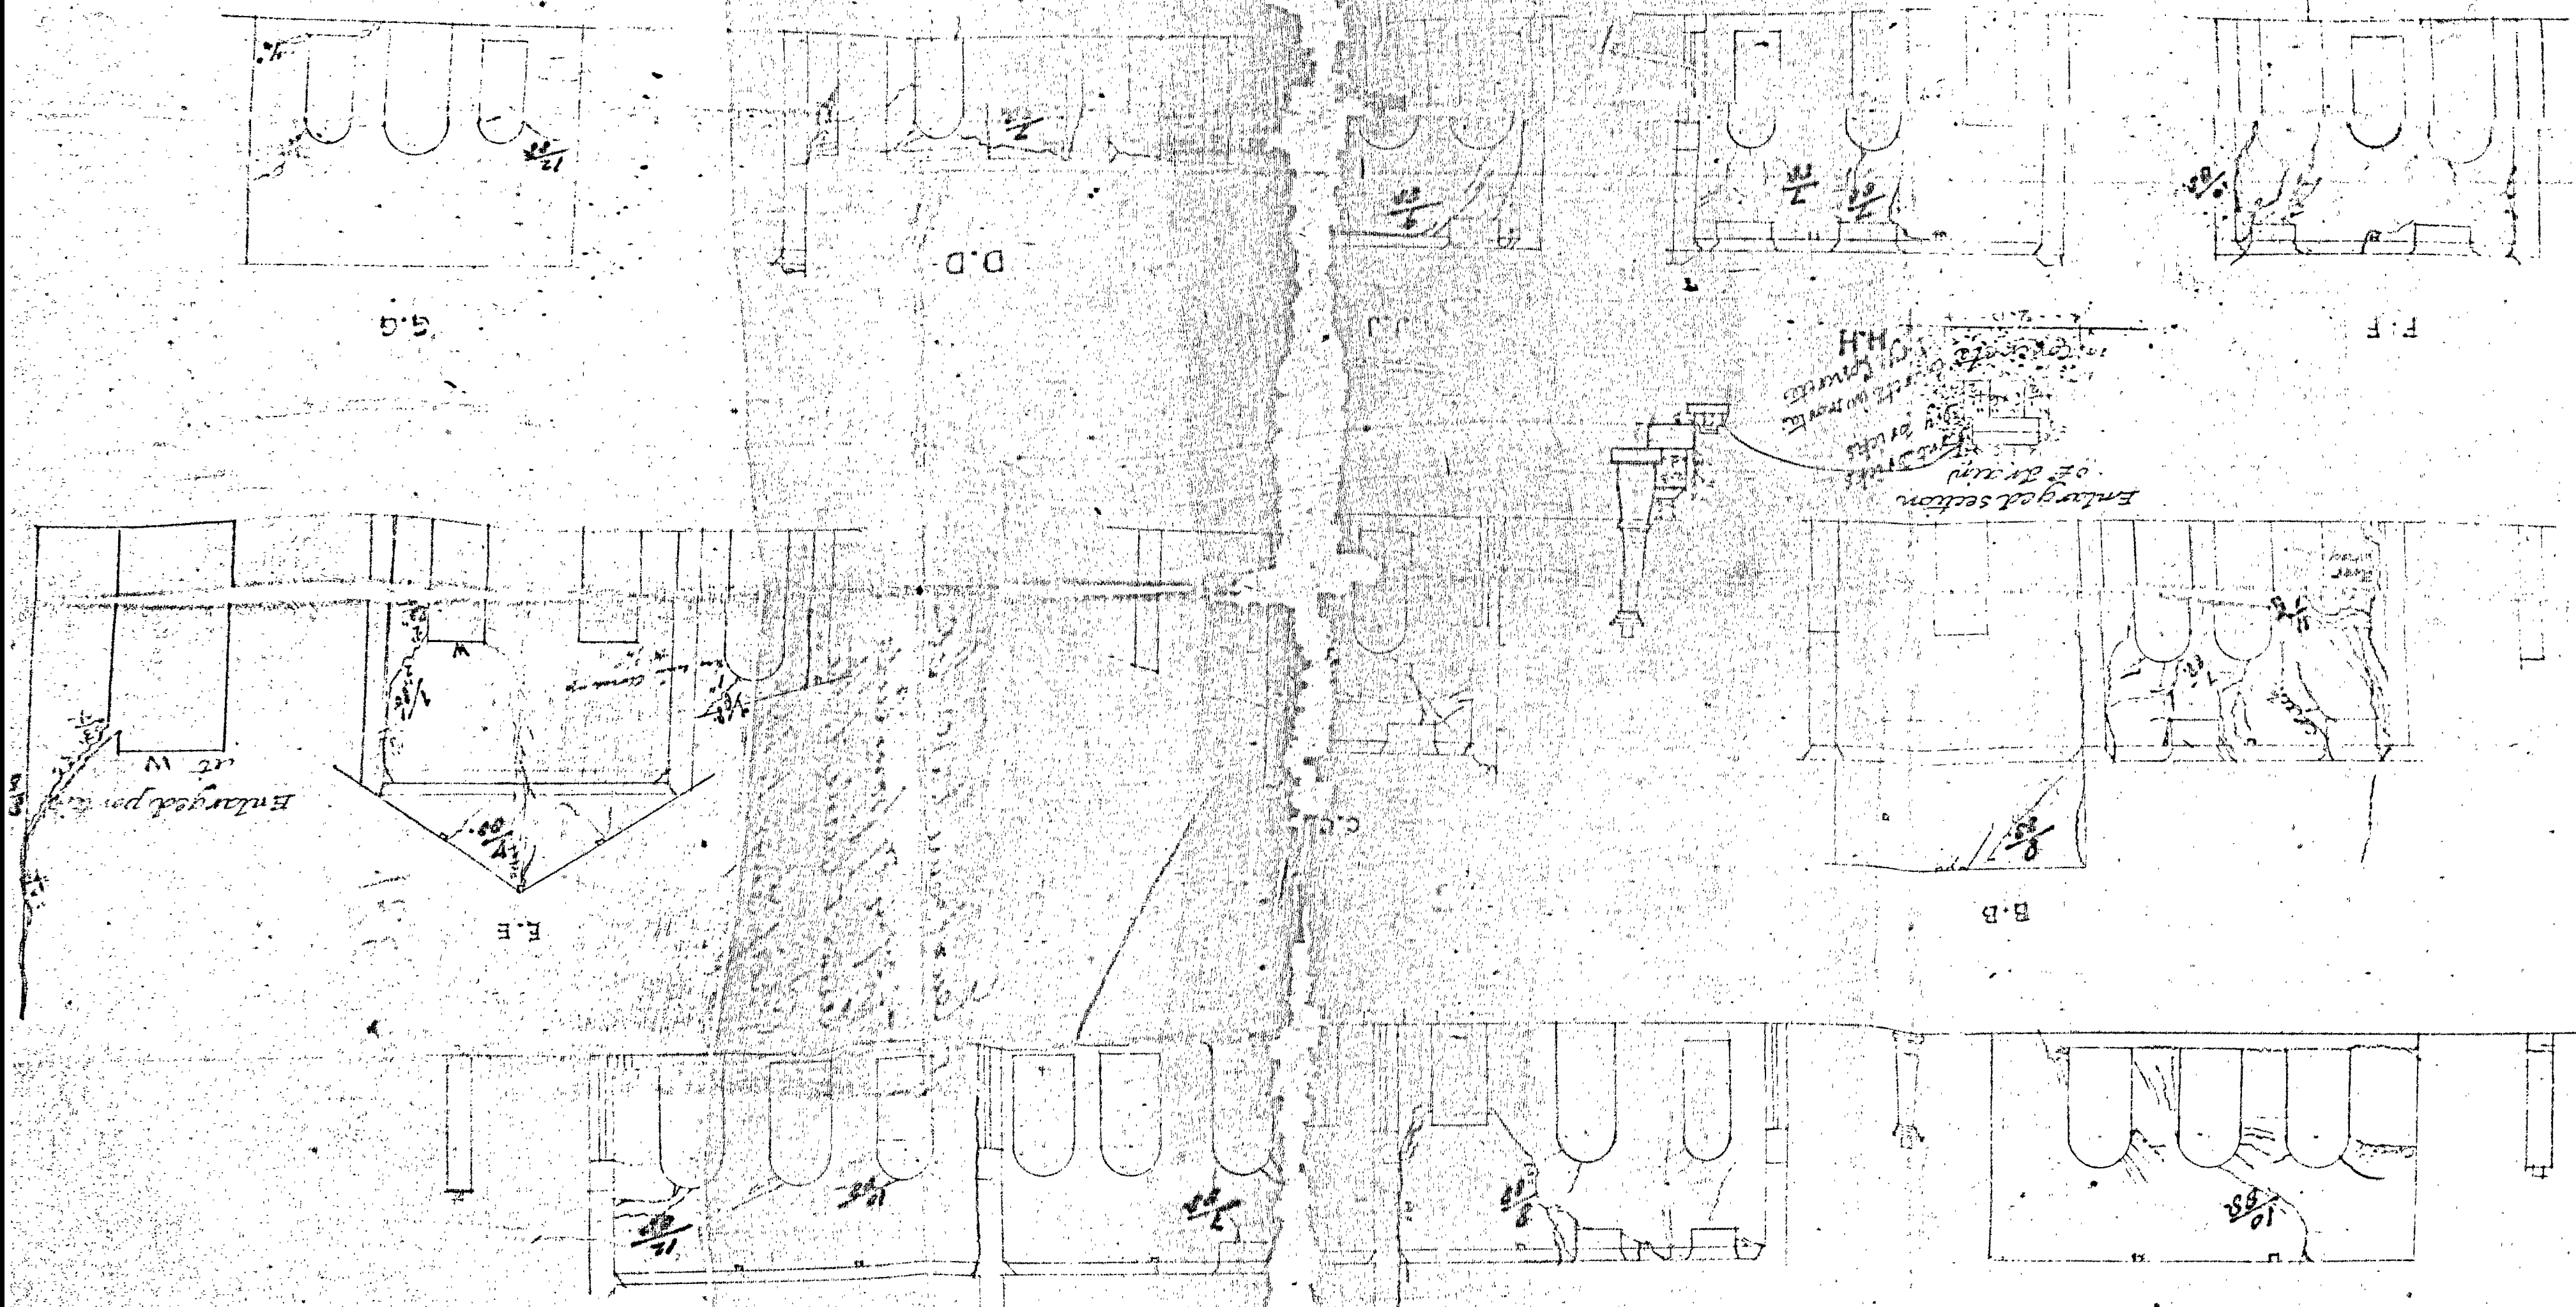
I have the honor to report that, having been informed that the Division office building at Chettipet in the Western Delta was in a dangerous state, I inspected it on the 12th instant and found it very much cracked, so much so that I ordered one room which I think in danger of collapsing to be at once vacated and I consider the whole building to be unsafe, and I recommend that it be pulled down, the materials being used in the construction of another office; it is too much cracked for buttressing or tying to be of any use.

2. I enclose a tracing and copy of a letter from the Assistant Engineer in charge of the division giving details of the cracks. The office was constructed in the year 1877 at a cost of Rs. 11,882, and for many years showed no signs of cracking; in fact it was not till after the floods of 1886-87, when the compound was under water for several days, that any serious settlement took place, and it is only in the last few months that the cracks have been getting rapidly worse. The soil on which the building stands is extremely bad and I measured some cracks in the vicinity nearly 6' deep, and I think the failure is due to the ground cracking after being thoroughly saturated by the floods.

4. The *old* cracks in the verandah pillars (on the *outside* of them) undoubtedly arose from the drag inwards of the top of the pillars when the verandah rafters sagged slightly as they had been notched to the bressummers too rigidly; those cracks had nothing to do with the present state of affairs. I see nothing for it but to pull down the building and erect another on the same general plan, so that roof timbers, doors, windows and other woodwork and fittings (the most expensive part of the building) may be used again, and of course the tiles and many of the bricks will be fit to use again.

5. In rebuilding I would keep further away from the weir channel and from the canal.
