Tower of the Convent = Library at Madras.  
 Forwarding copy of P.O.: showing the  
 actual condition found to exist during the demo-  
 lition of the tower of the —

I submit, herewith, a report from the Consulting Architect of the actual conditions found to exist during the demolition of the tower of the Connemara Library.

Submitting a full report  
describing the conditions  
found to exist during  
the demolition of the  
tower of the Court  
Library &c  
building

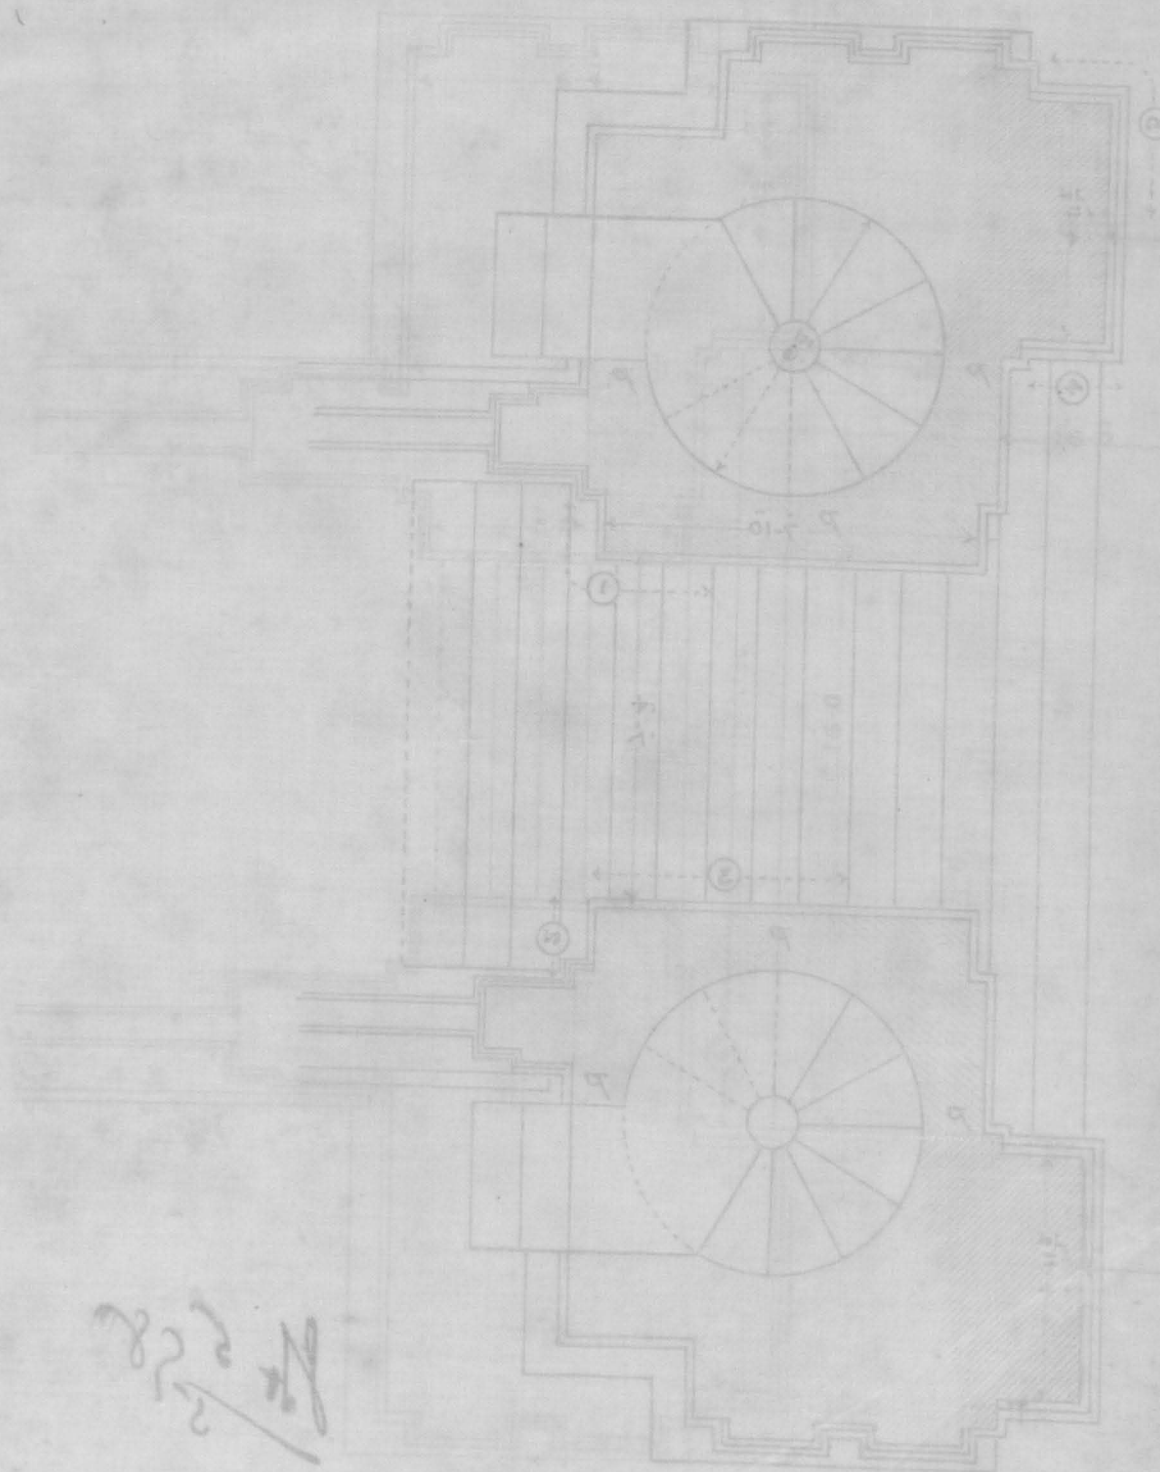
PLAN TO ACCOMPANY CONSULTING ARCHITECT  
LETTER NO. DATED APRIL 1898

(3) At the point of greatest pressure,  
marked blue in plan, nearly -  
every brick was cracked or -  
shattered, and all the mortar  
was crushed to powder.

piers. I do not agree with Colonel Pungnick  
that there was no defect in the original  
design: At p. p. p. the brickwork was  
found to be 14 to 15" thick, and on to the  
springing plane which slightly widened towards  
extremities (hatched blue) were turned arches  
four bricks thick <sup>(2 1/2")</sup>. At the springing line,  
at these points the haunches of the arches  
lay bare within the staircase wells - it  
was not possible at these points to complete  
any ring to encase the wells & travelling  
along the haunches upward the steering  
could have been of no strength it could  
not in fact have been complete till the  
horizontal distance of the haunch was  
equal to the width of the steering: -  
In actual construction the arch was  
turned, & the well built in at these  
places any how. It may be said that  
the staircase treads would offer resistance,  
they possibly might if strong enough,  
but were broken to pieces.

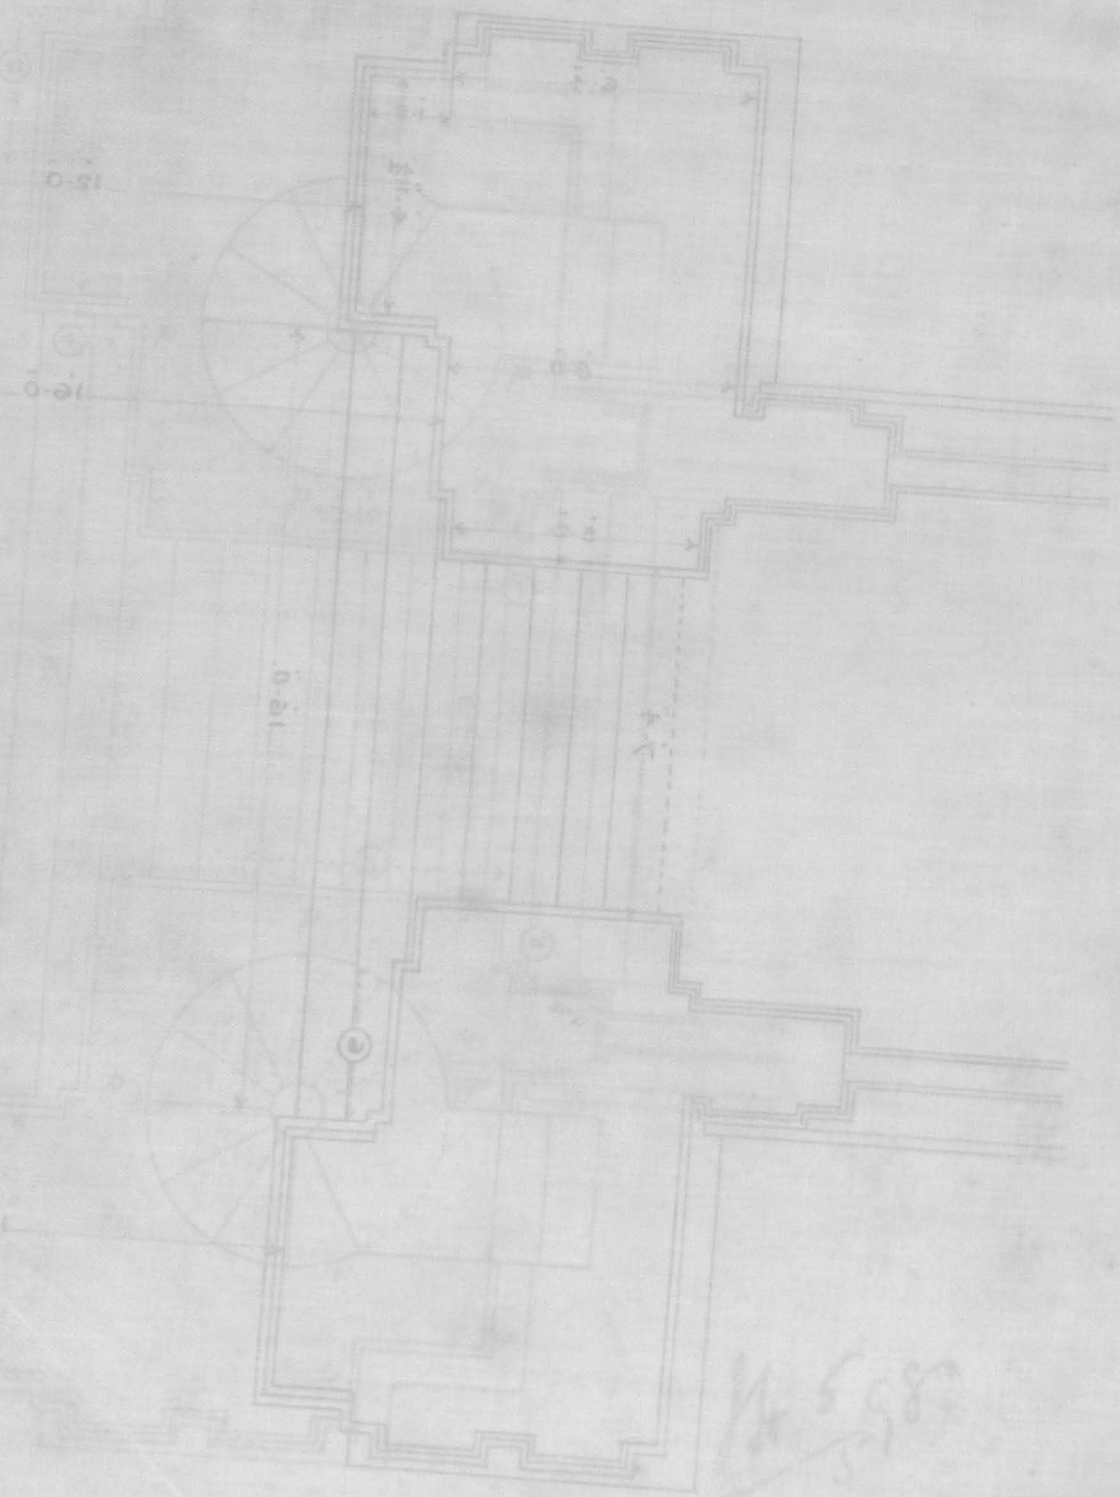
PLAN TO ACCOMPANY CONSULTING ARCHITECT  
LETTER NO. DATED APRIL 1898

3. The brickwork showed as a matter of course the greatest signs of failure immediately beneath the porch arches. These arches I had carefully removed & I then examined the brickwork on to which they were turned. The work in that portion hatched in blue was shattered, hardly a whole brick was taken out, many were crushed, the mortar was dust, & it was easy to pick the work to pieces by the hand. That portion hatched in red was in a very similar condition, but not quite so bad. Every tread of the staircase was broken.

5. Not only was the brickwork in a shattered state in the several layers, but in 3 places cracks had occurred downwards and through portions of the brickwork under the cornice, this can be seen in photographs numbers 1. 2. 3. 4.
