# TRANSPORT- COMMUNICATIONS

MONTHLY REVIEW

OCTOBER 1955—No. 102

#### LOOP CHANNELS AND DAMAGED BRIDGES

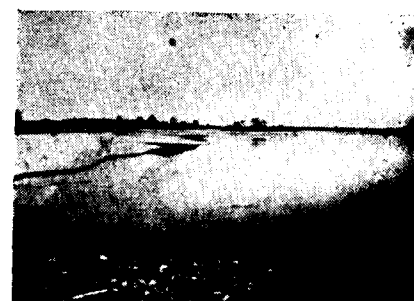
Fig. 6.

**NEW RIVER BANK FORMED BY  
A LINE OF IMPROVED "BANDALS."**

A study of the Table shows that the line of "bandals" *A B C* caused only slight difference in the velocity in the river on the embayment and river side of the line. But as the power of transportation of silt of a current of water varies between 3.2th to the 6th power of the variation in velocity, this slight decrease in velocity caused a current of water to deposit a considerable part of its silt load on the embayment side of the line of "bandals". As there was no dead-water area in the embayment, the silt deposit
