*Proceedings of the Madras Government, Public Works Department,  
30th January 1862.*

No. 167. Read the following Endorsement of Lieutenant-Colonel J. OUCHTERLONY, for Deputy Chief Engineer Southern Circle, dated Chepauk, 22nd January 1862, No. 9,669.

Read the following letter from Captain R. F. OAKES, District Engineer, to the Deputy Chief Engineer, Southern Circle, dated Lower Anicut, 15th January 1862, No. 265:—

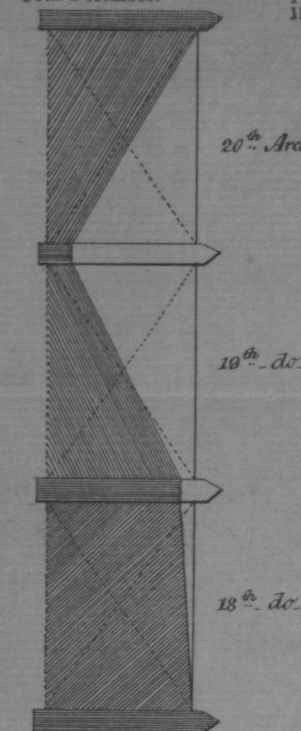
26th December.

1. In continuation of my reports on the Lower Anicut on the 30th November and 12th December, I have the honor to inform you that after the leaks referred to in letter No. 226 had been stopped or nearly so, other leaks appeared to the northward or in front of the 19th arch from the north end; similar means were adopted to stop those leaks as had already proved successful.

2. A small embankment was run across the bed of the river in front of the injured portion of the Bridge and Anicut to prevent further scour and to admit of some means being adopted to shore up and secure the arches on either side of those injured. The Bridge was thus deprived of the support afforded by the buoyancy of the water and on the morning of the 5th instant, a large portion of the pier common to the 19th and 20th arches sunk westward, carrying away with it the unshaded portions of the 19th and 20th arches and leaving only 3' 9" of the arch on the 19th pier standing. In falling the 19th arch dragged with it the cut water and about 2' of the 18th pier on the west side and about 2' of the 18th arch with the spandril and parapet. The 18th pier appears however to be entirely sound and the portion carried away was removed owing to the adhesion of the brick work and the fall of the parapet and face wall above it.

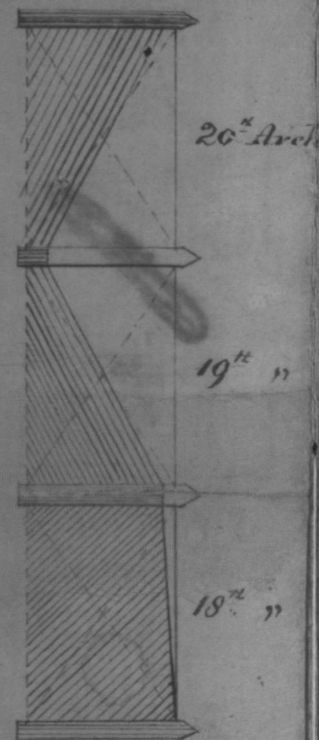
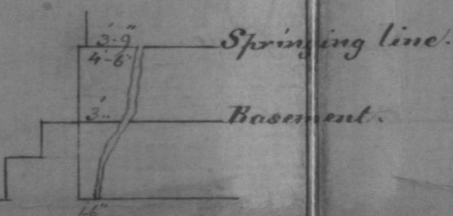
3 The Piers which support the 21<sup>st</sup> or Shuck arch do not appear to have settled more than they had done on the 30<sup>th</sup> December and the foundation of the extremities of the Piers seems to appear to be sound, the sinking or settling having taken place under the center of the Piers only.

4 The Ammiratt has as might have been expected been injured by the settlement of the Piers, but the injury sustained is very trifling.
