**MADRAS RECORD OFFICE.****Government of Madras.***Public Works* **DEPARTMENT.***P.W.D.*

G.O. No. 255.

No. 492. Read the following letter from the Chief Engineer for Irrigation, to the Secretary to Government, Public Works Department, dated Fort St. George, 9th January 1868, No. 18:—

I have the honor to submit a report on the condition of the works in progress at the Red Hill and Cholaveram Tanks, &c., (Madras Water Supply Project) which I lately inspected in company with the Superintending Engineer, Colonel Boileau.

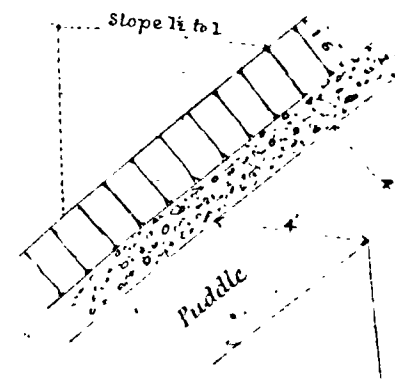
of on the line perpendicular to the face of the revetment. The consequence is that along a considerable portion of the work, the puddle has been carried to the height of about six feet of an insufficient thickness. This will be relieved by the insertion of a vertical wall of puddle, in the manner shown in the annexed diagram, equal in quantity to what has been omitted, but where the puddle is already filled in next against new earthwork. There it is backed by the compact earthwork of the old bund, nothing would be gained by disturbing it. The full quantity of puddle allowed for in the estimate will be filled in on all the work continued above the present level.

I think, wait till next monsoon  
before attempting to finish the  
work up to the full height  
4 The rough stone rivet:  
orient, so far as it extends a,  
apt is well executed. It is back:  
ed by a layer of gravel, so  
called but more correctly describ:  
ed as lumps of latite, of various  
sizes. Material of this kind  
must be more or less liable to  
displacement, and the Executive  
Engineer should be careful  
to fill in the interstices with  
latite gravel. The pavement  
and rough stone work are  
backed by a layer of puddle.  
By an oversight on the part  
of the late Executive Engineer  
and his Overseer, the thick  
ness of puddle allowed in  
the estimate was calculated in  
the horizontal line, instead  
of
